125 CUMBERLAND STREET

CIVIC SQUARE BANDSTAND STRUCTURAL CONDITION ASSESSMENT

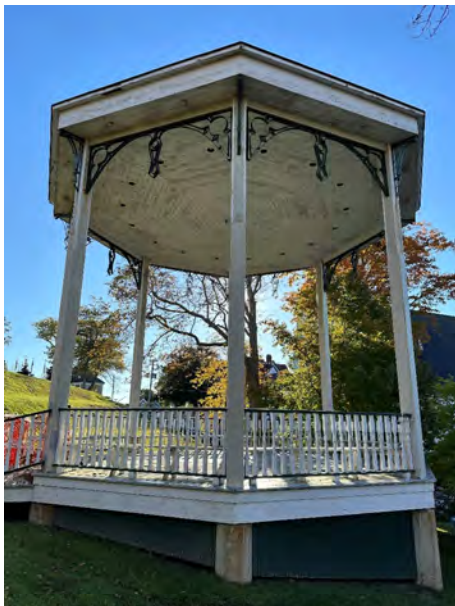
Lunenburg, Nova Scotia

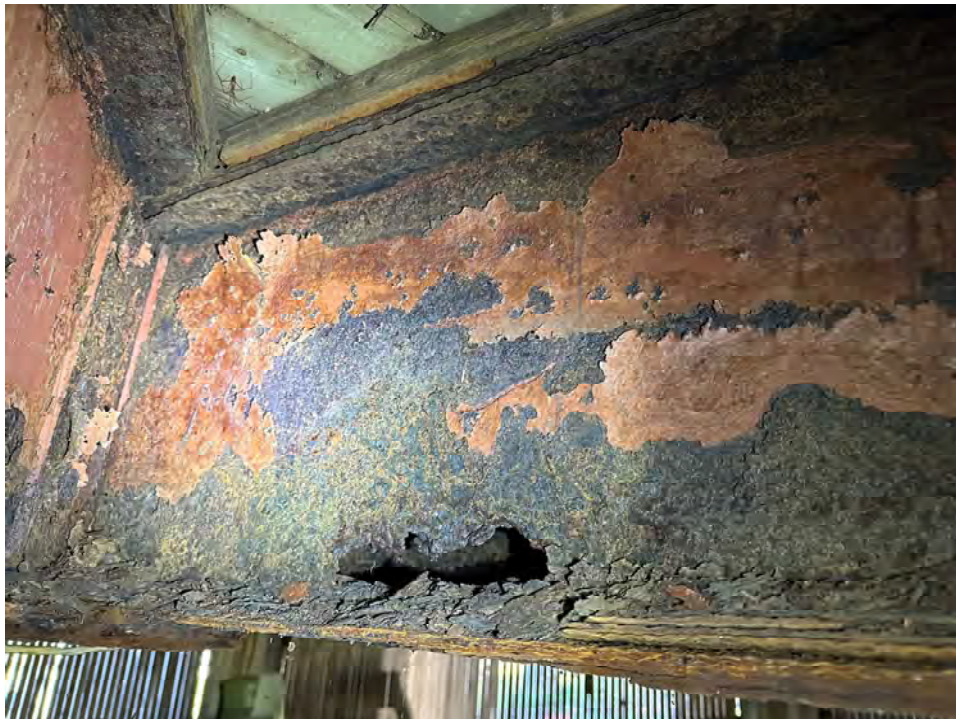
Photo 4: Full cross-sectional corrosion steel beam web

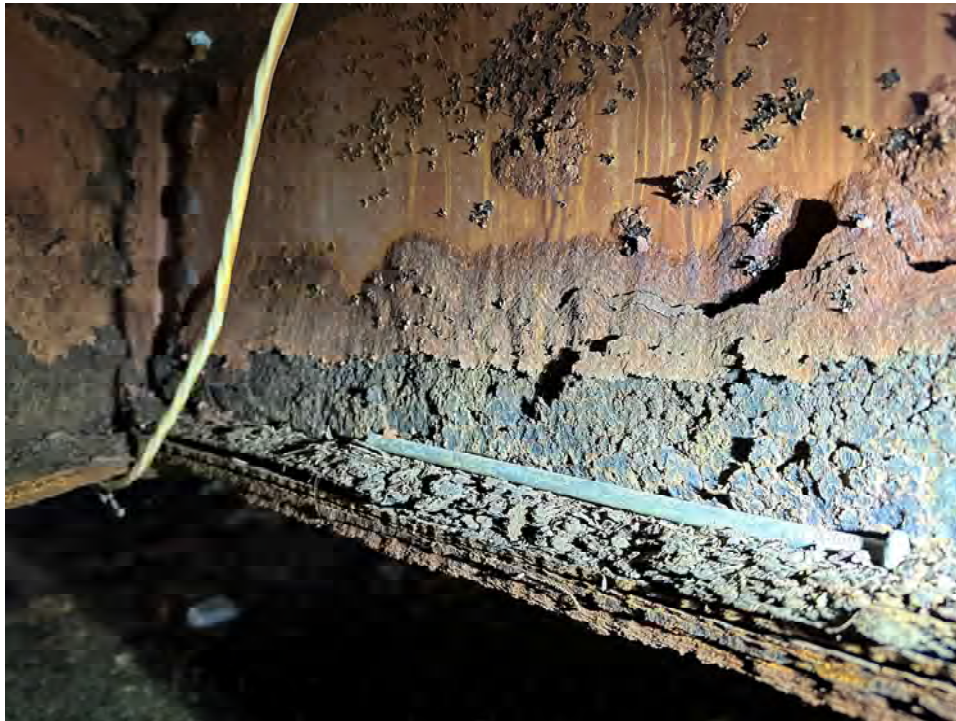
Photo 5: Corrosion and expansive corrosion by-products on beam flange

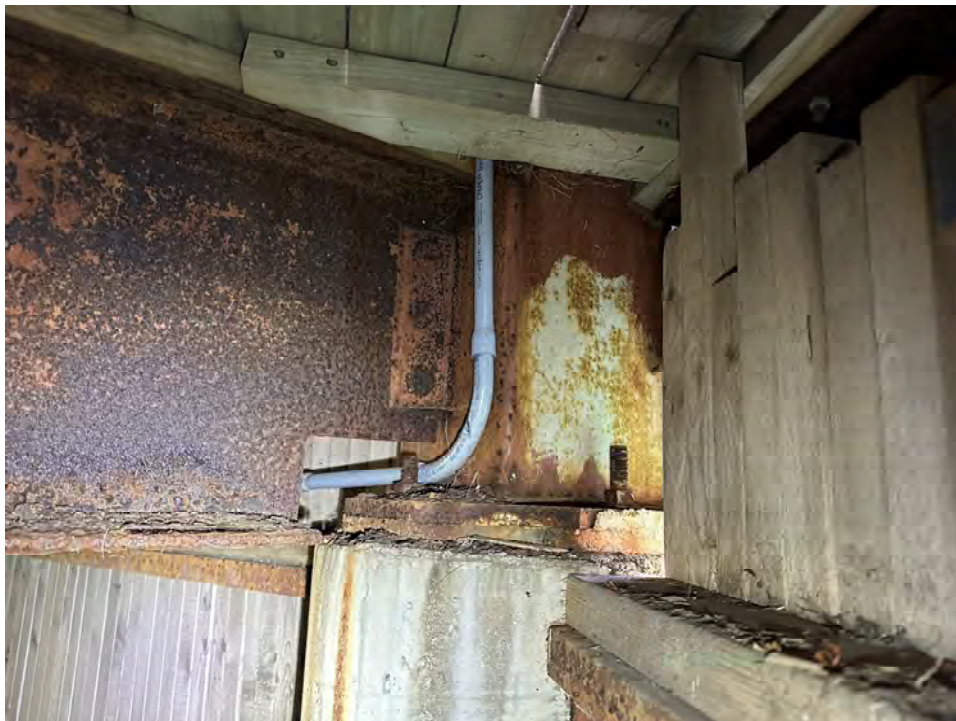
Photo 6: Structural steel beam to column connection (typ. at eight locations)

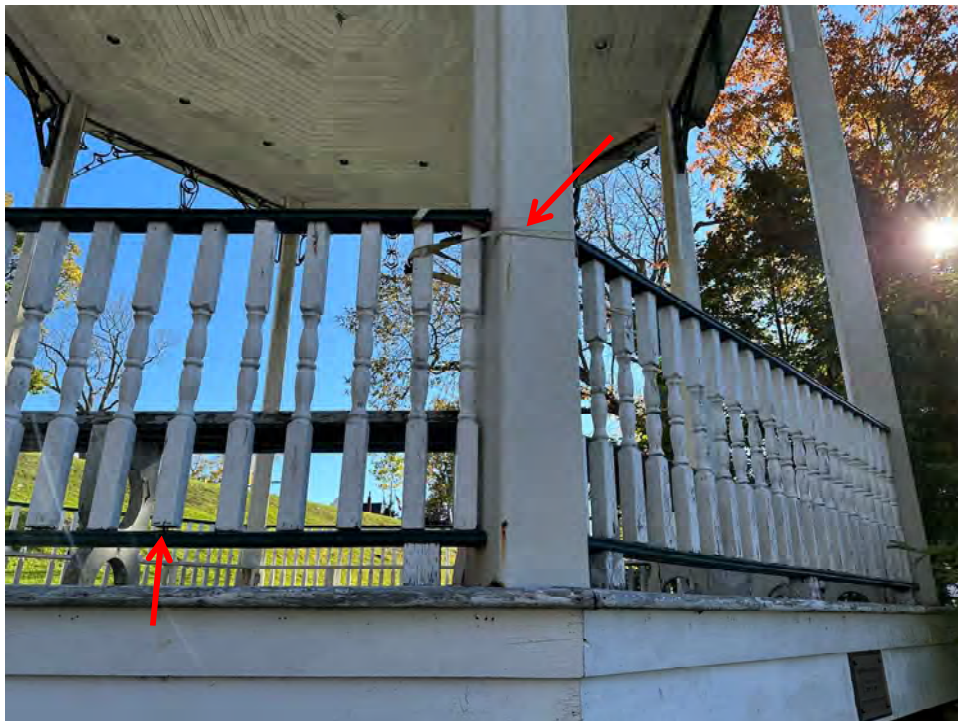
Photo 10: Guardrail with temporary strapping and loose balusters

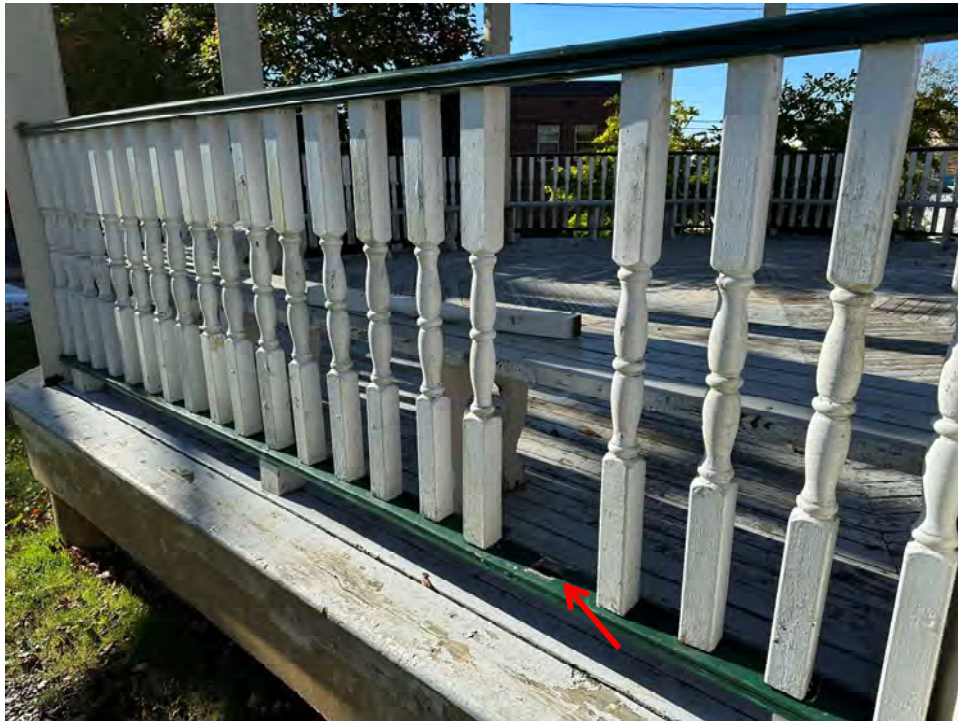
Photo 11: Section of guardrail with missing baluster

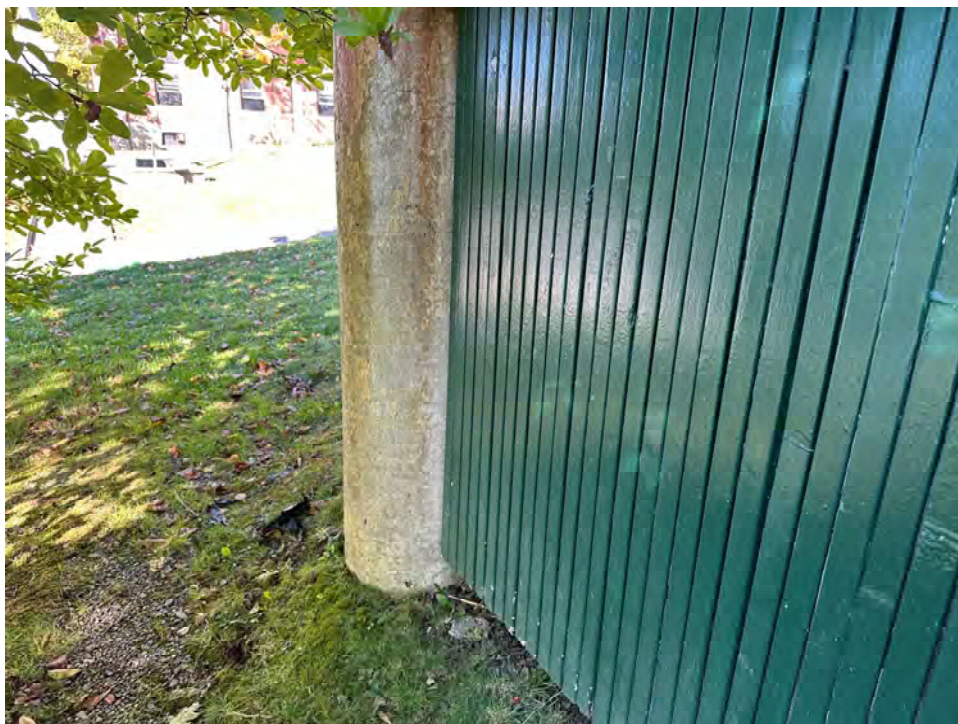
Photo 12: Concrete pier foundation and vertical trim below the Bandstand deck

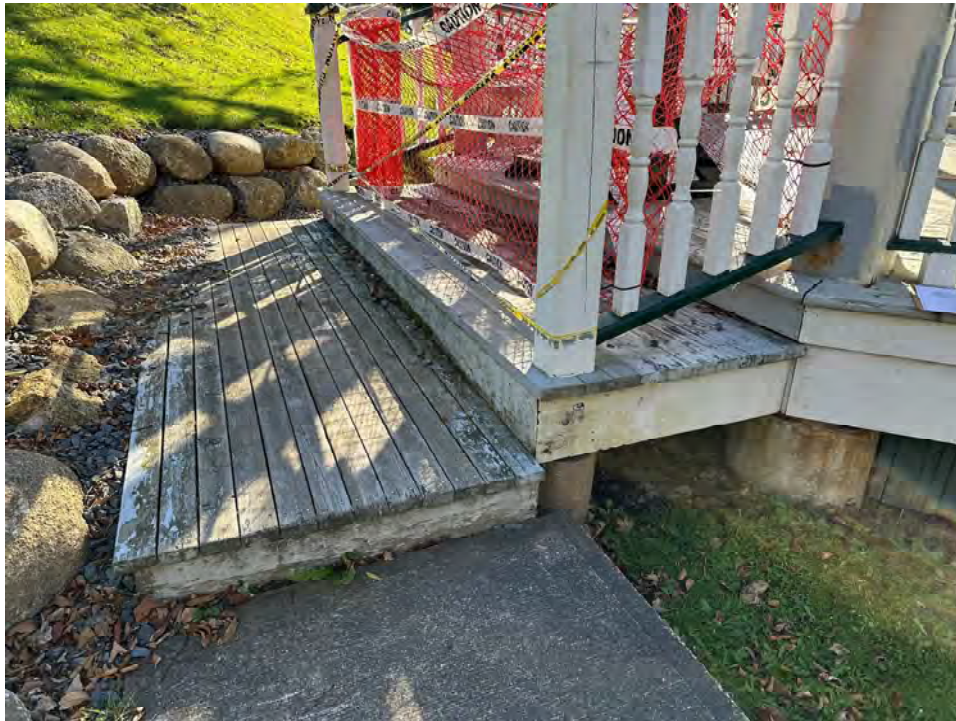
Photo 13: Access platforms on north side of Bandstand

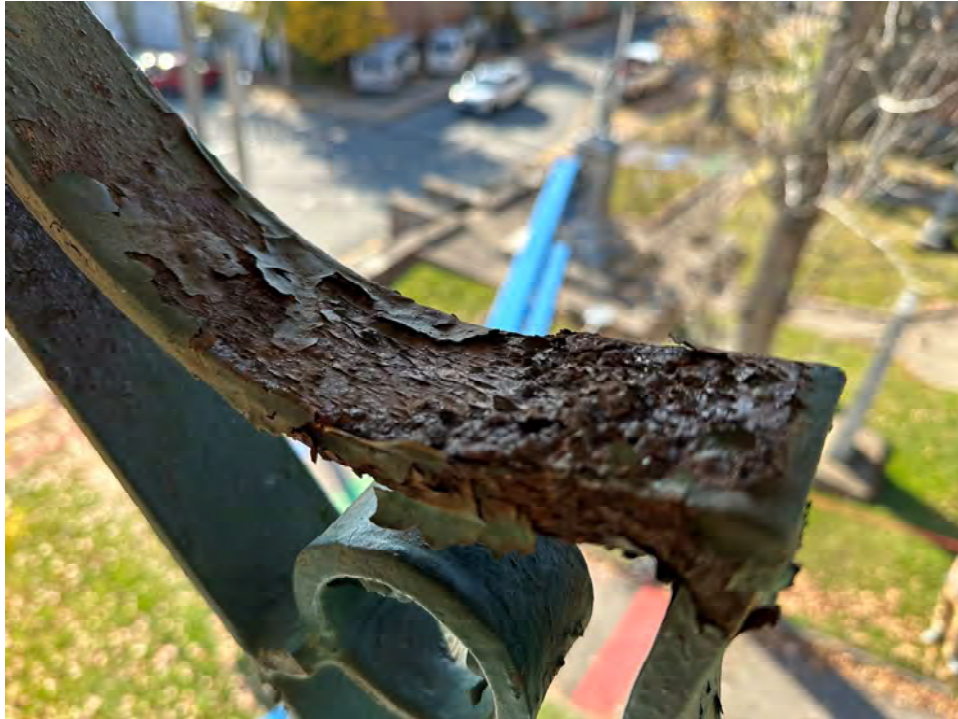
Photo 15: Peeling paint and corrosion on ornamental steel brackets

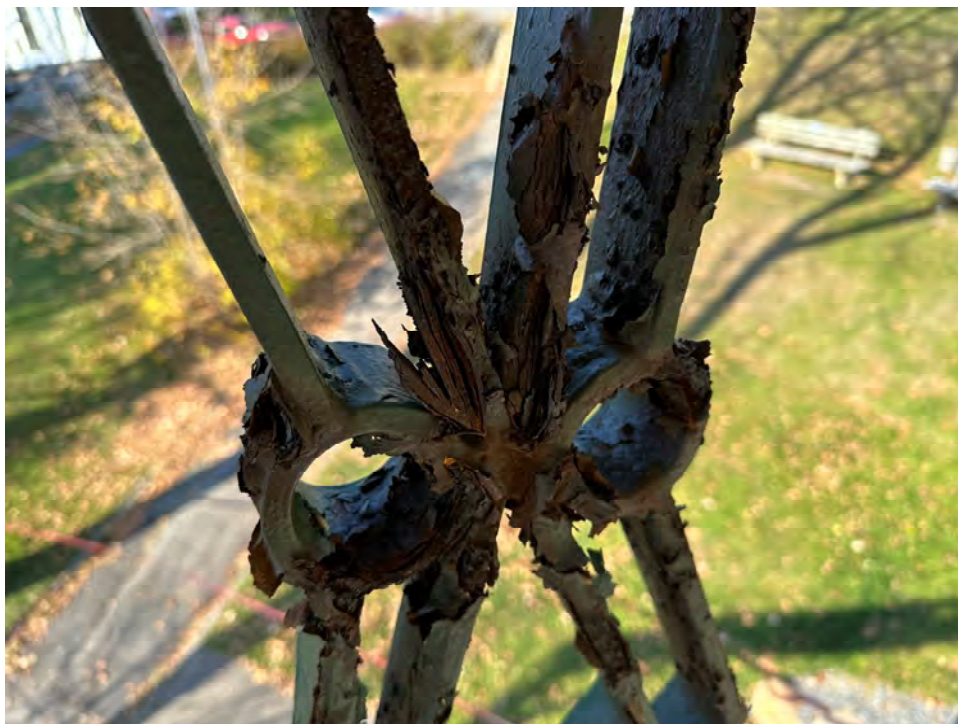
Photo 16: Peeling paint and corrosion on ornamental steel brackets

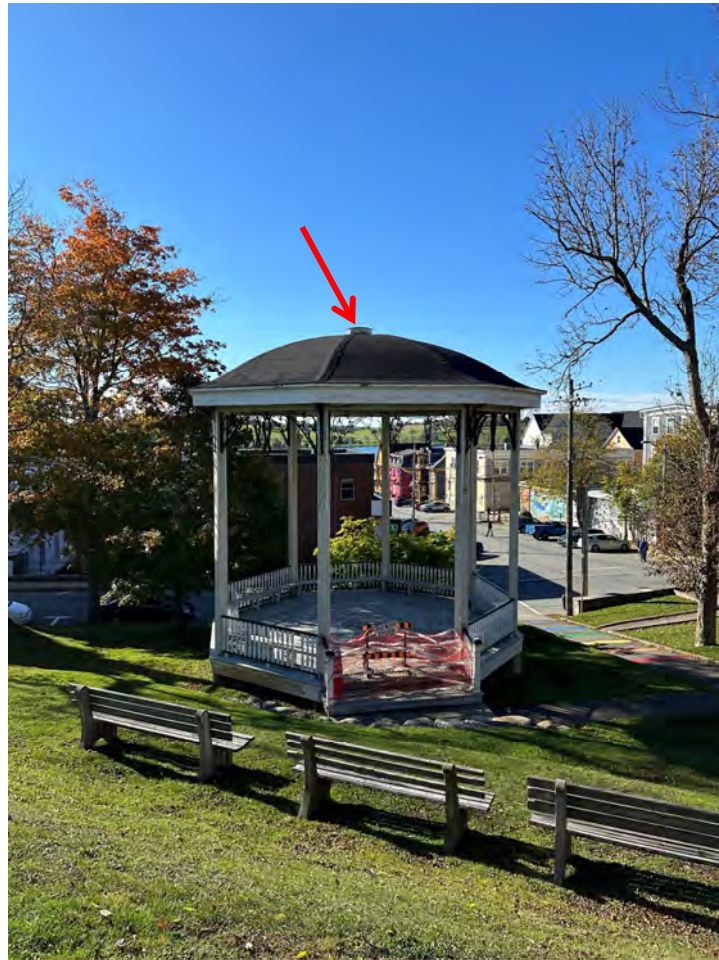
Photo 17: Ornament missing from roof of Bandstand

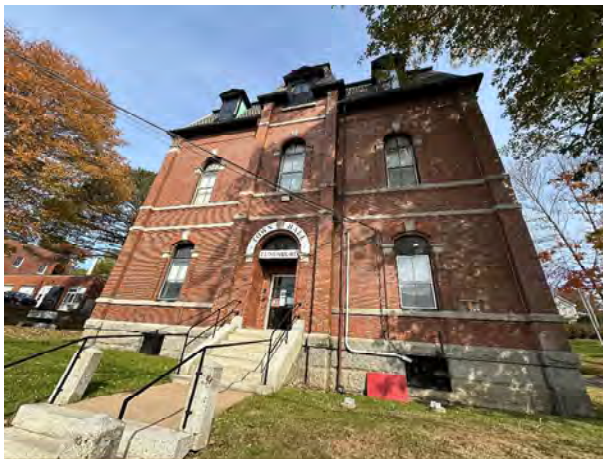
Lunenburg, Nova Scotia

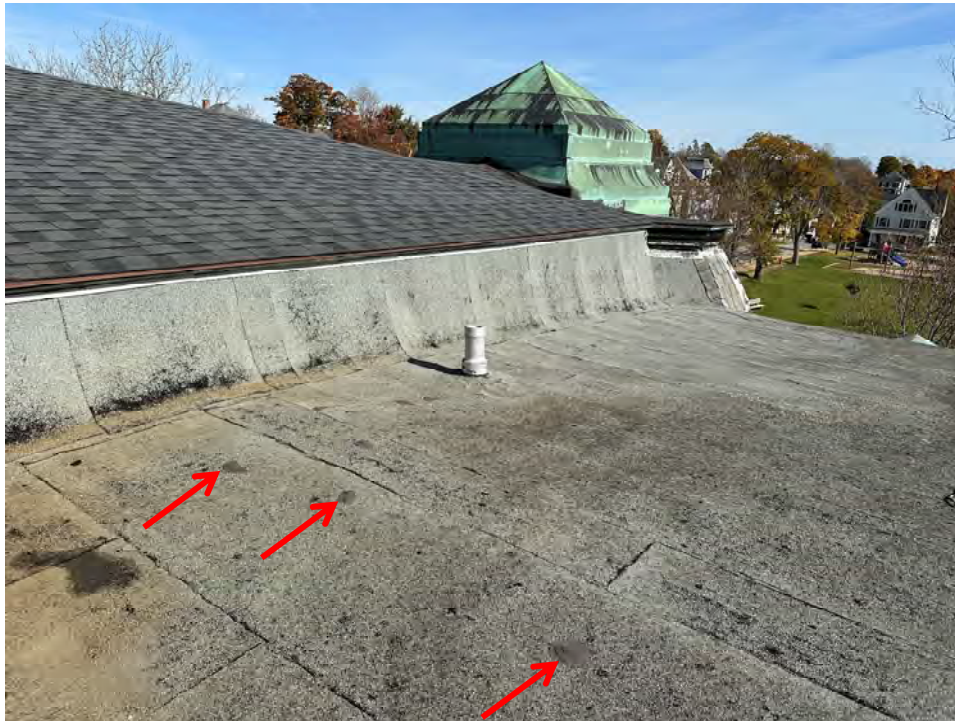
Photo 7: Newer asphalt shingle roofing, modified bitumen sheet membrane, copper roof projection. Note localized liquid-applied patch repairs

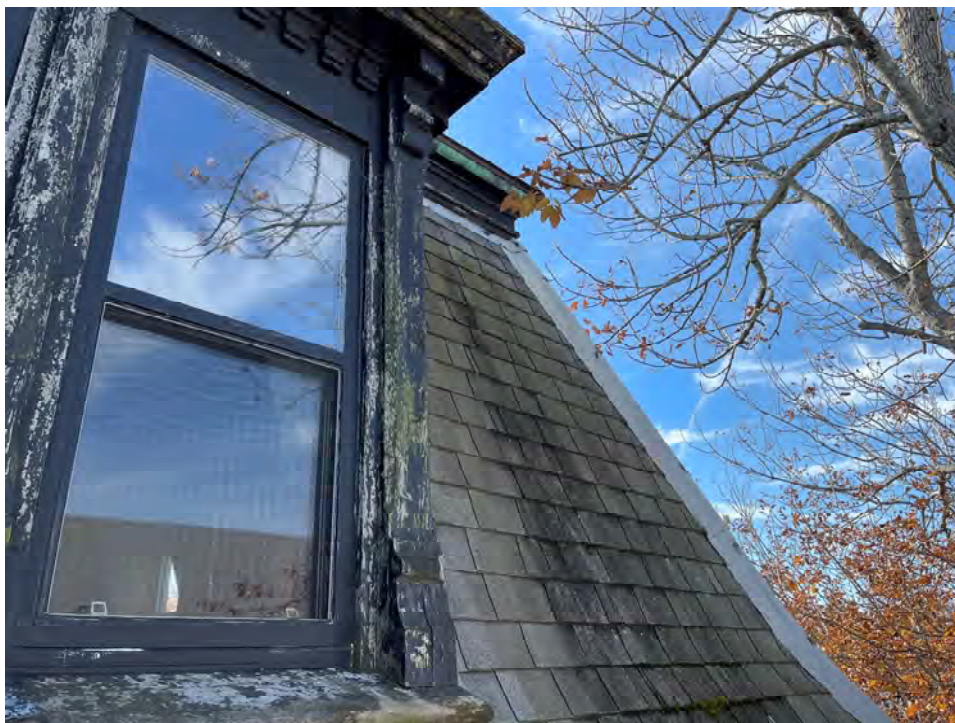
Photo 8: Stained asphalt shingle roofing around dormer window on steeply sloped Mansard roof face and failing window framing paint finish (north elevation)

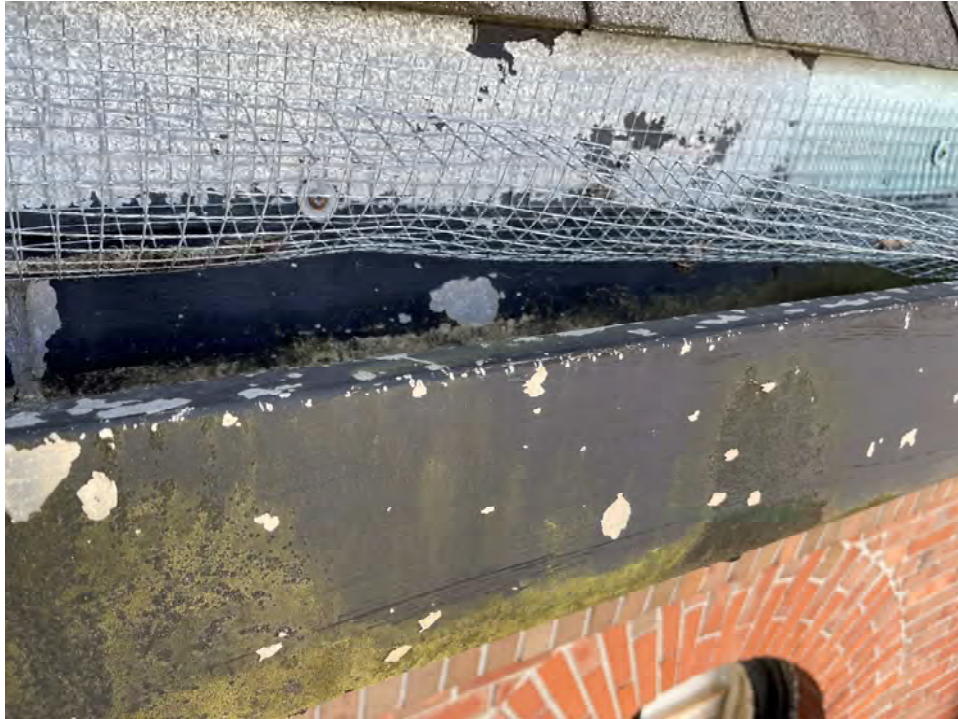
Photo 9: Close up of gutter with failing paint finish and deformed and detached leaf screen

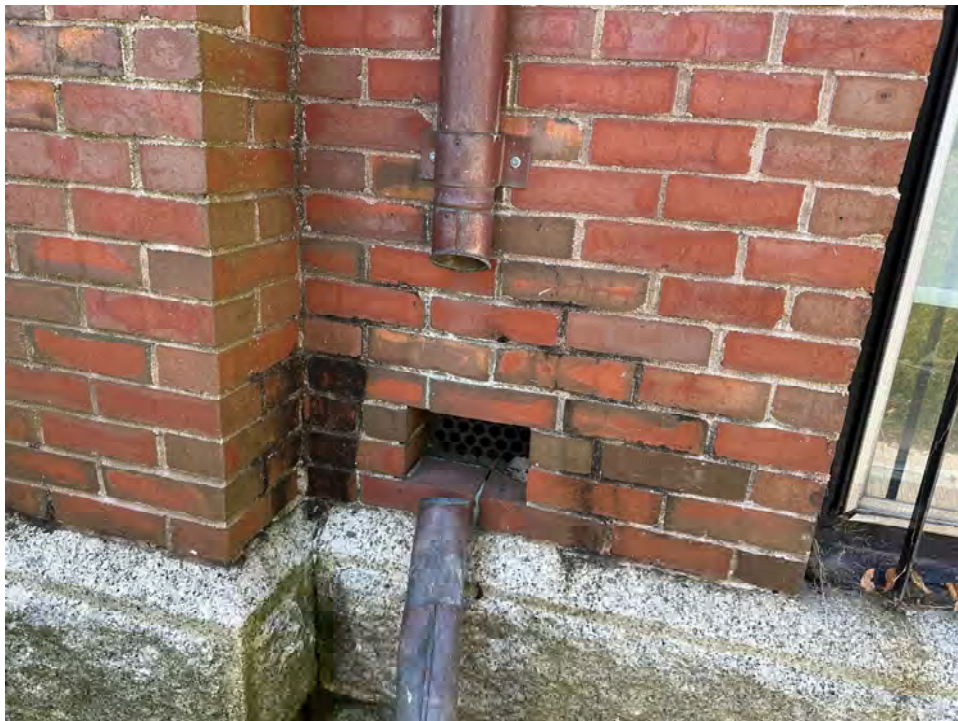
Photo 10: Copper downspout (note discontinuity)

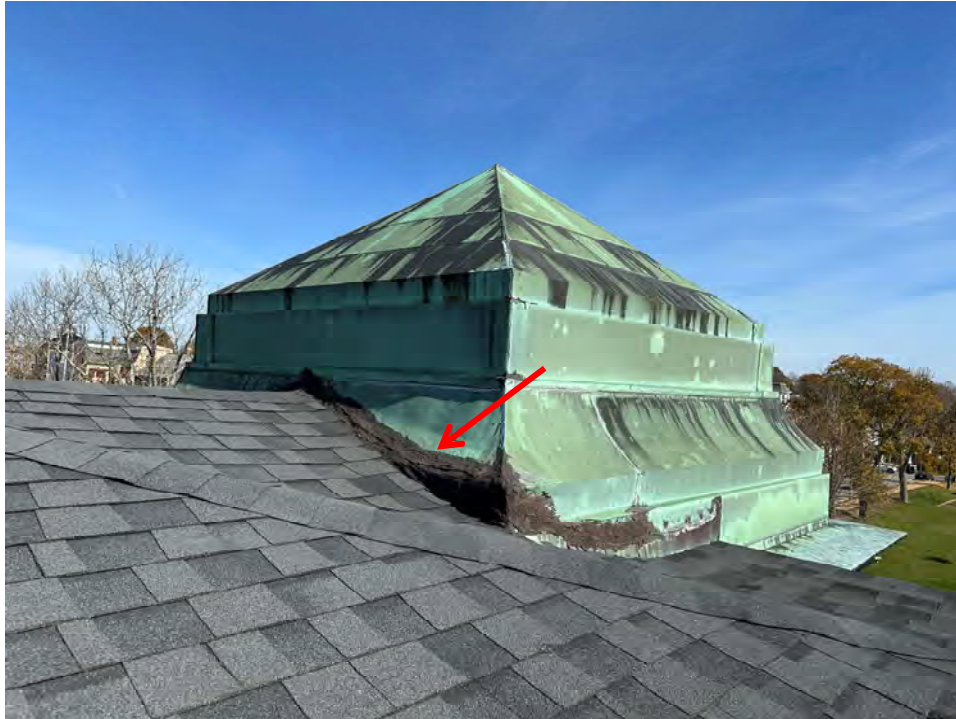
Photo 13: Roofing mastic tie-in in poor condition at transition between asphalt shingles and copper

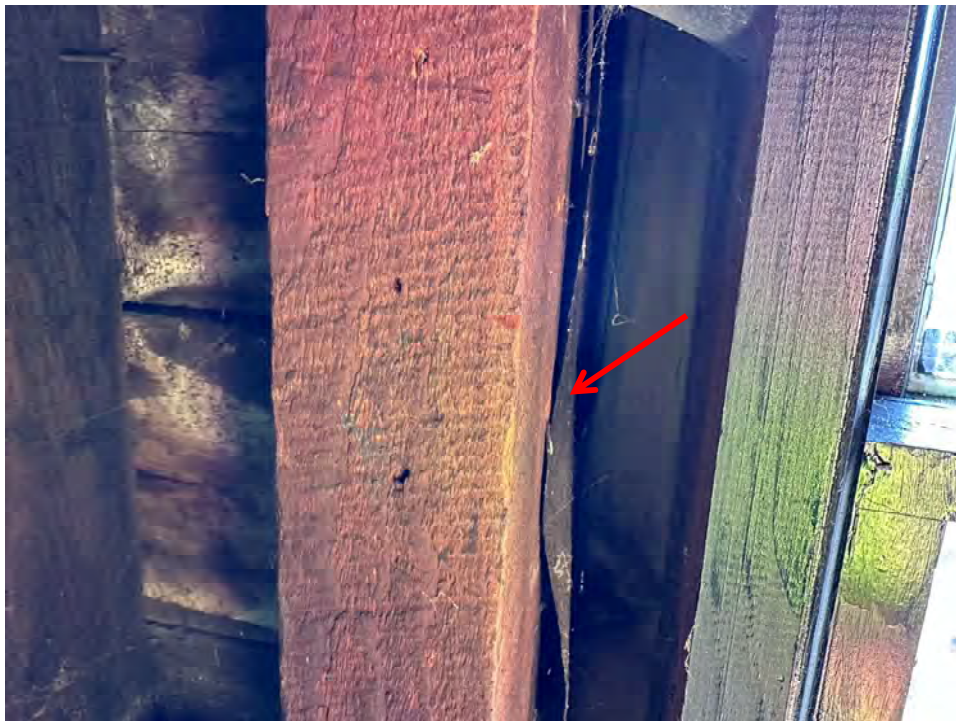
Photo 14: Building paper terminating inside attic/storage space at window opening

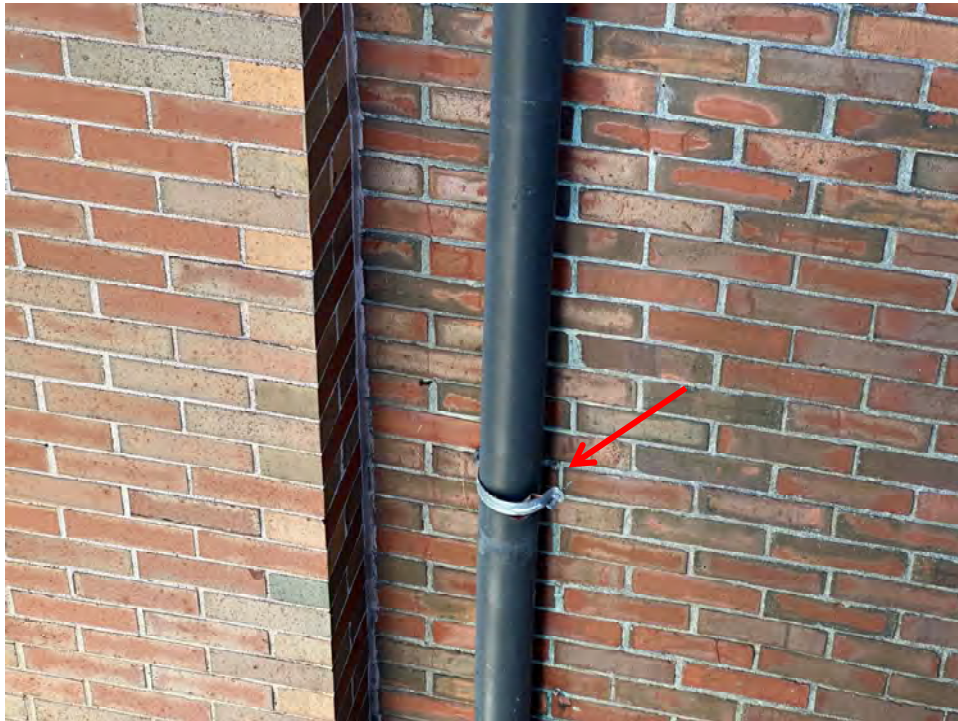
Photo 17: Pulled/failed anchor for downspout strapping

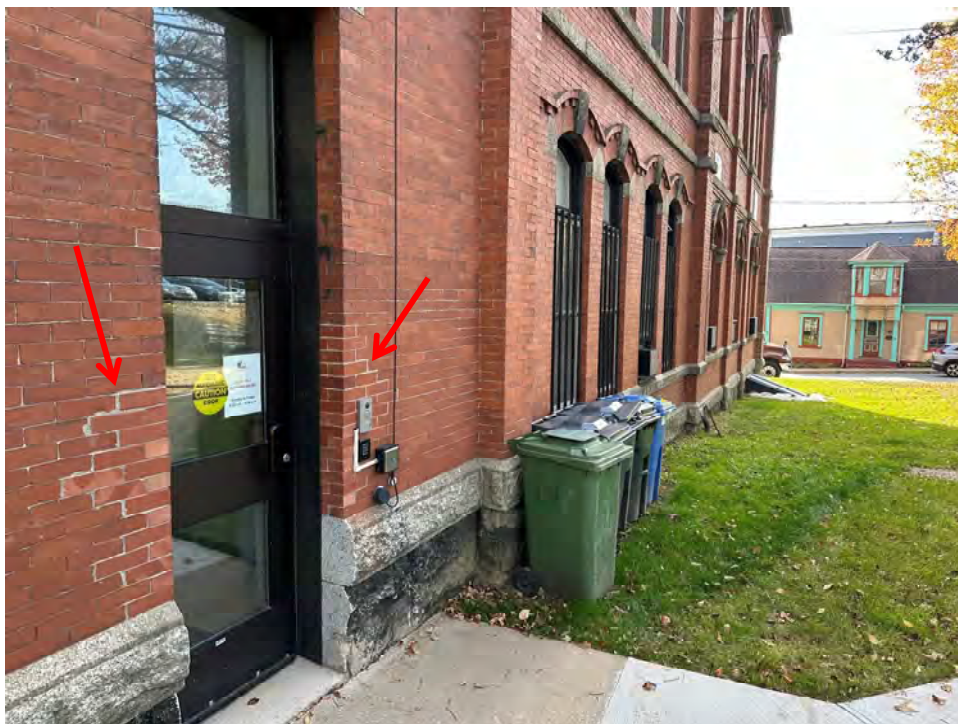
Photo 18: Existing brick repair areas near west elevation entrance

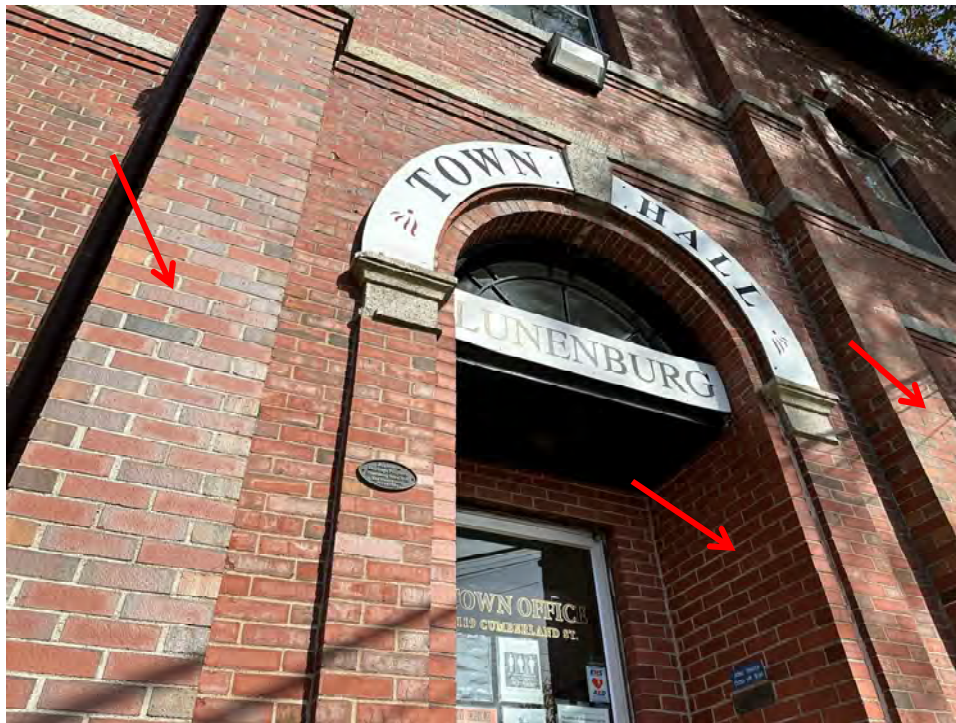
Photo 19: Existing brick repair areas near south elevation Cumberland Street entrance

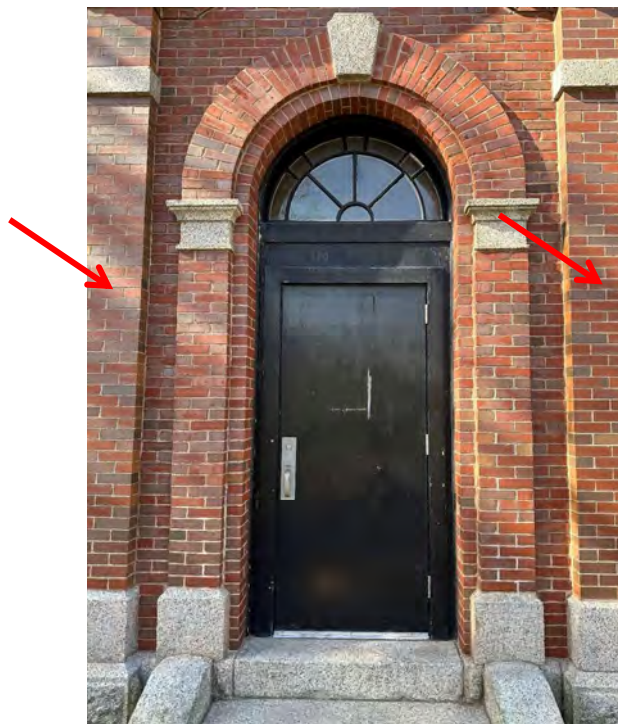
Photo 20: Existing brick repair areas near east elevation entrance

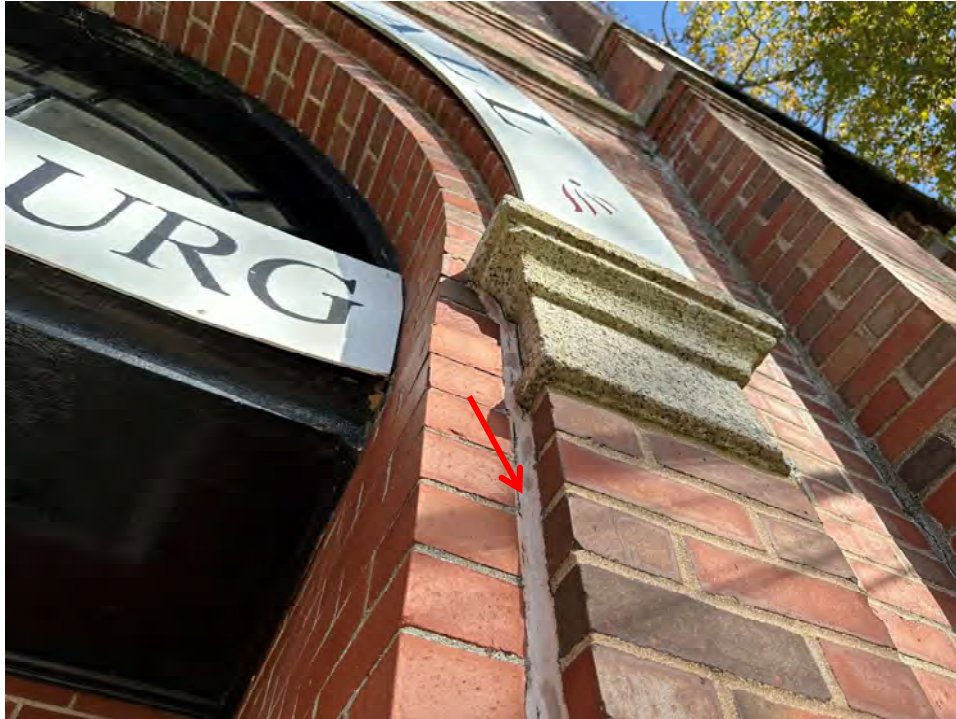
Photo 21: Sealant between different vintages of brick with cohesive tears

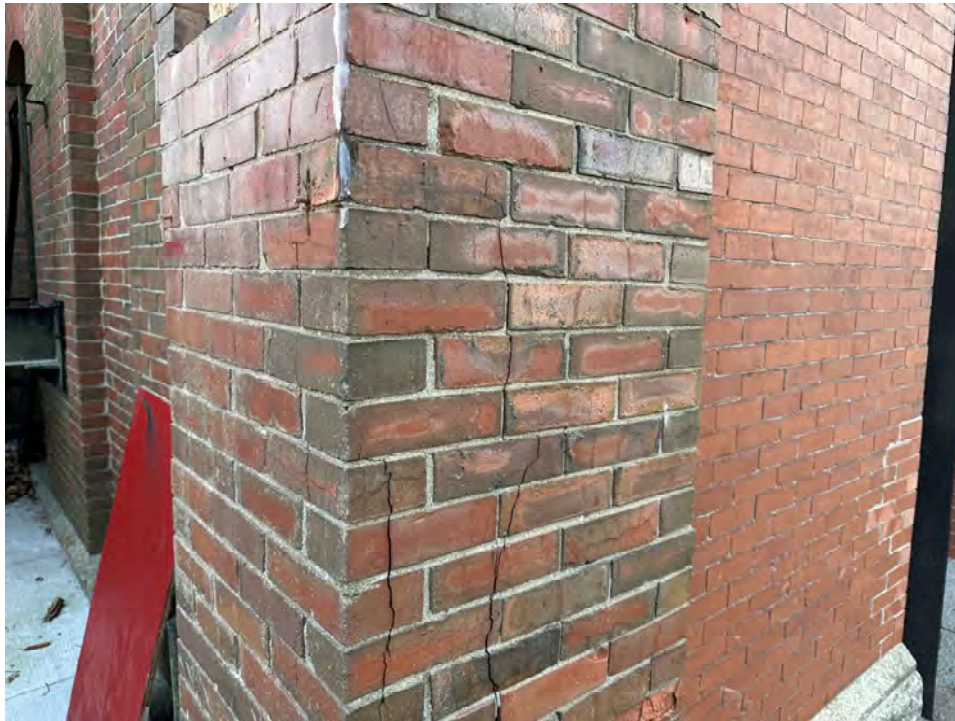
Photo 23: Close up of brick cracking and deterioration at northwest corner pilaster

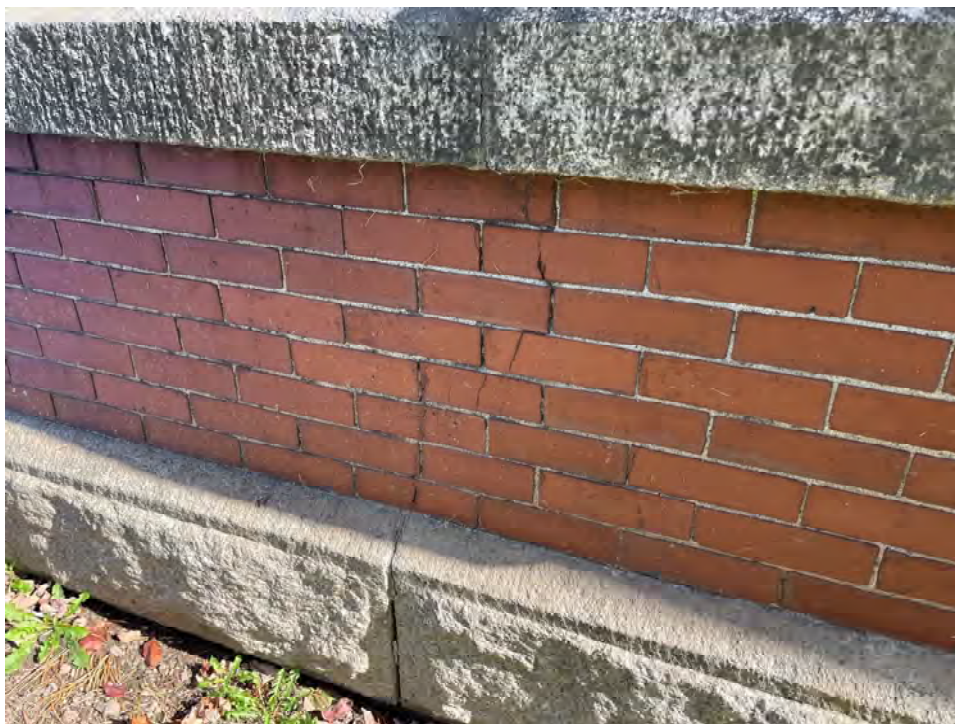
Photo 24: Close up of brick cracking and deterioration along west elevation

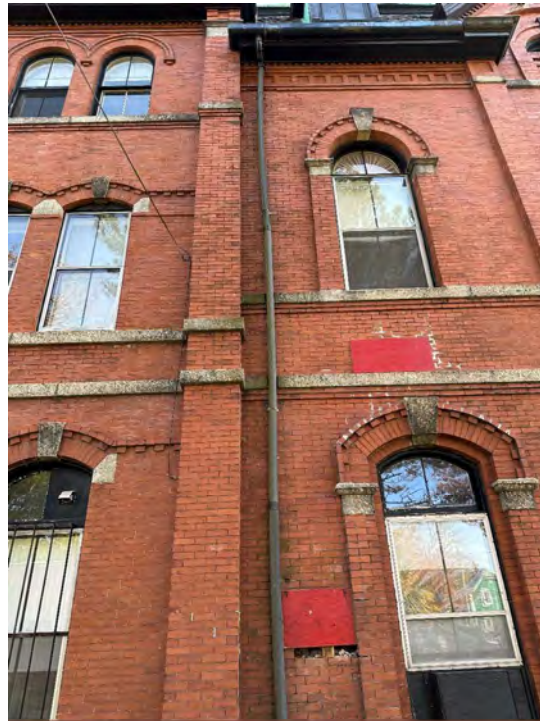
Photo 25: Overview of mortar joint deterioration in vicinity of west elevation downspout

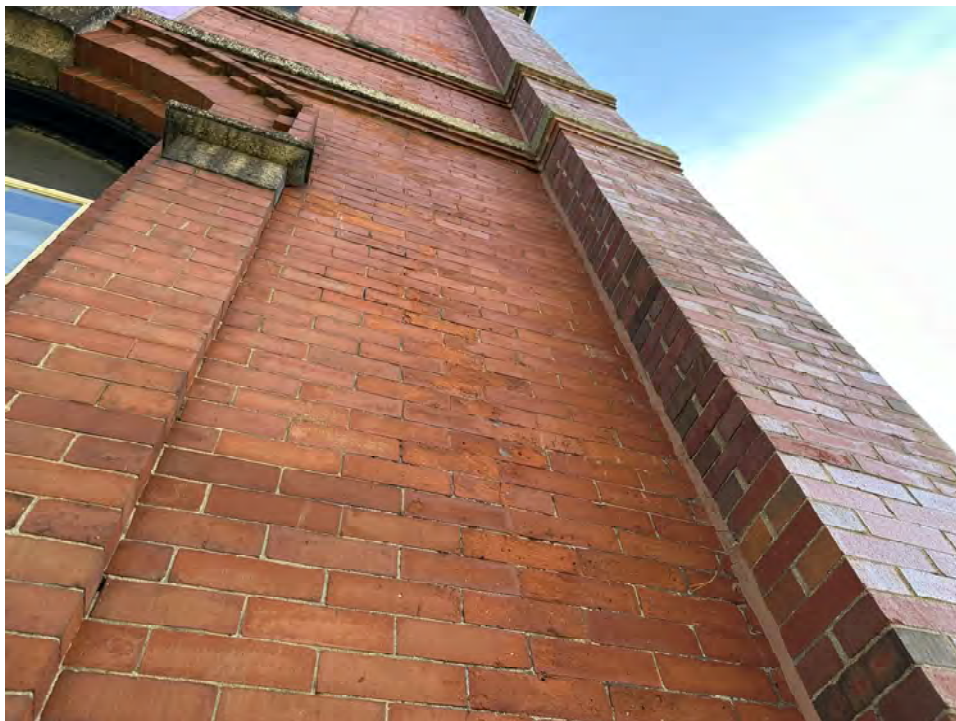
Photo 26: Overview of brick face spalling near southwest corner pilaster on west elevation

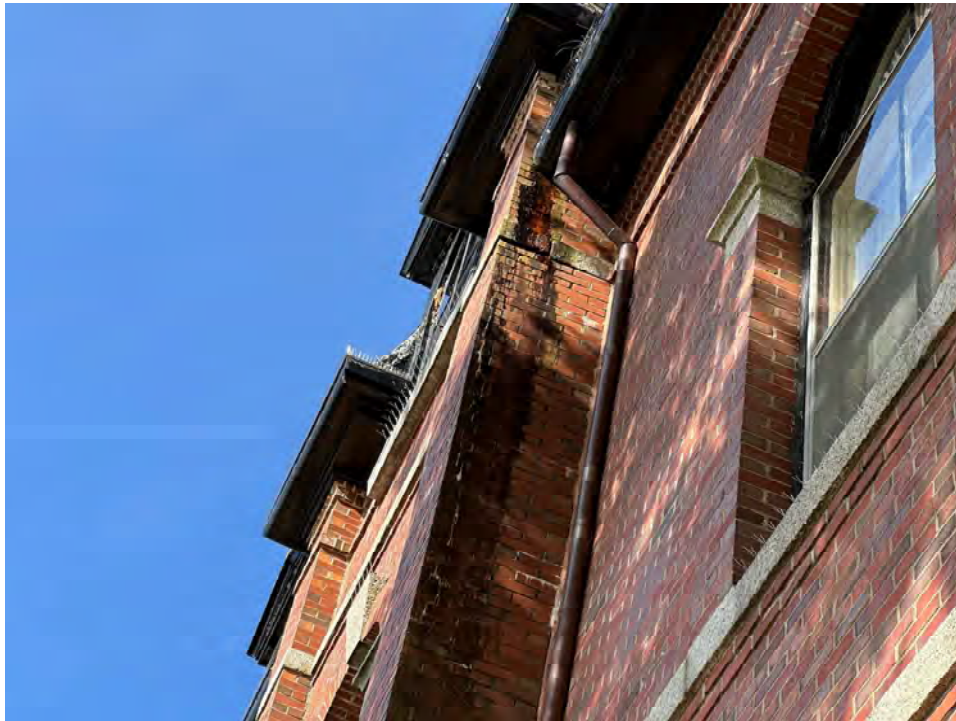
Photo 27: Overview of staining from gutter run-off on south elevation Cumberland Street entrance

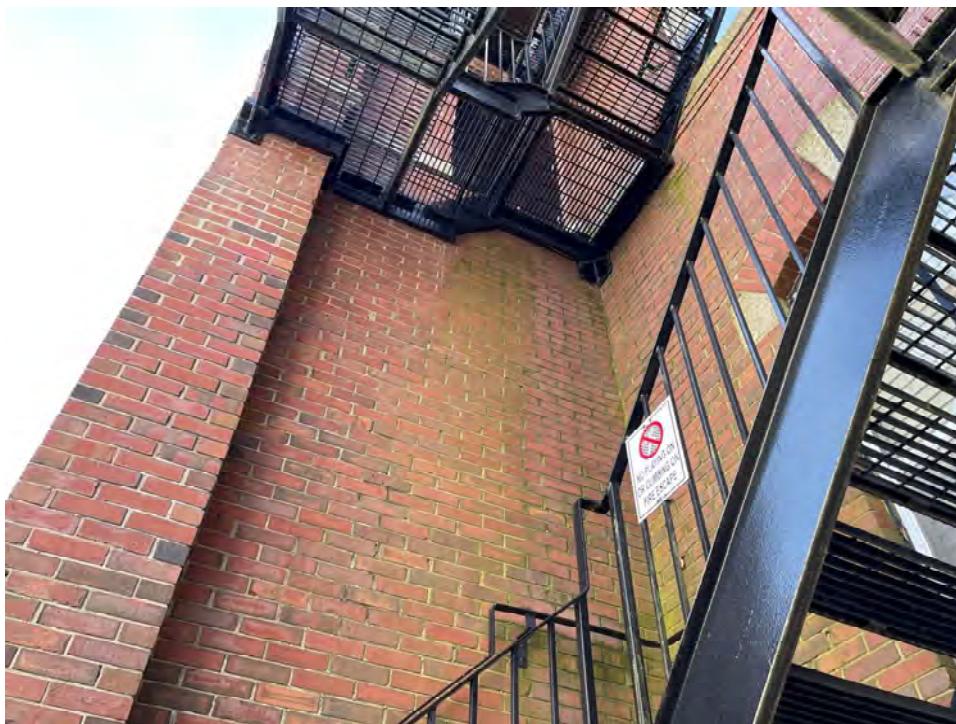
Photo 28: Overview of organics staining below fire escape stairs on north elevation Townsend Street entrance

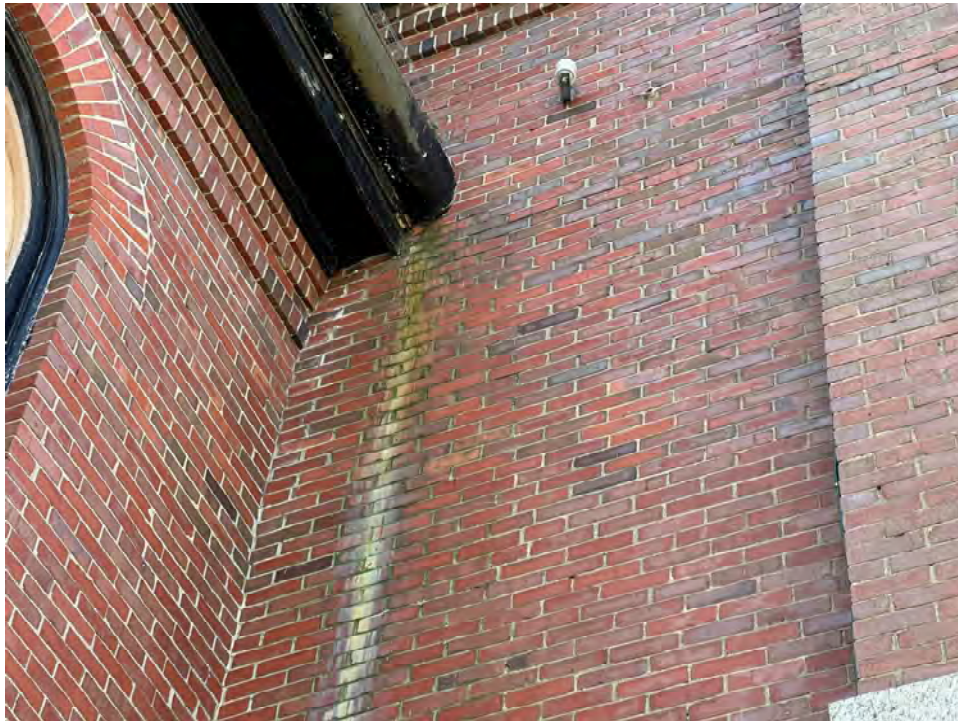
Photo 29: Overview of run-off and organics staining below gutter likely from overflow

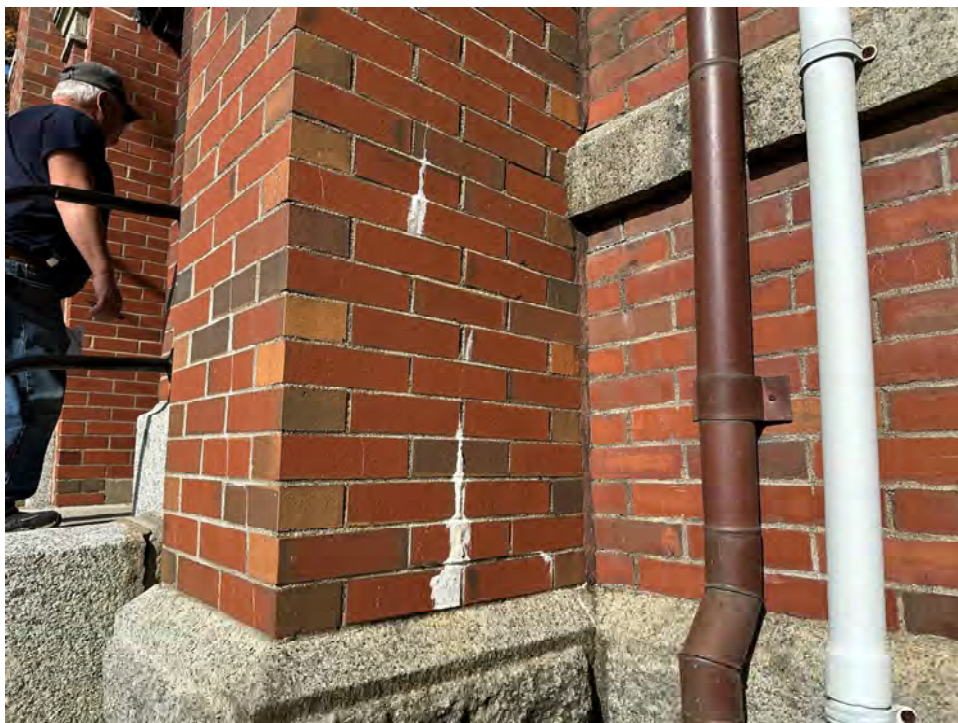
Photo 30: Efflorescence on pilaster adjacent to south elevation Cumberland Street entrance

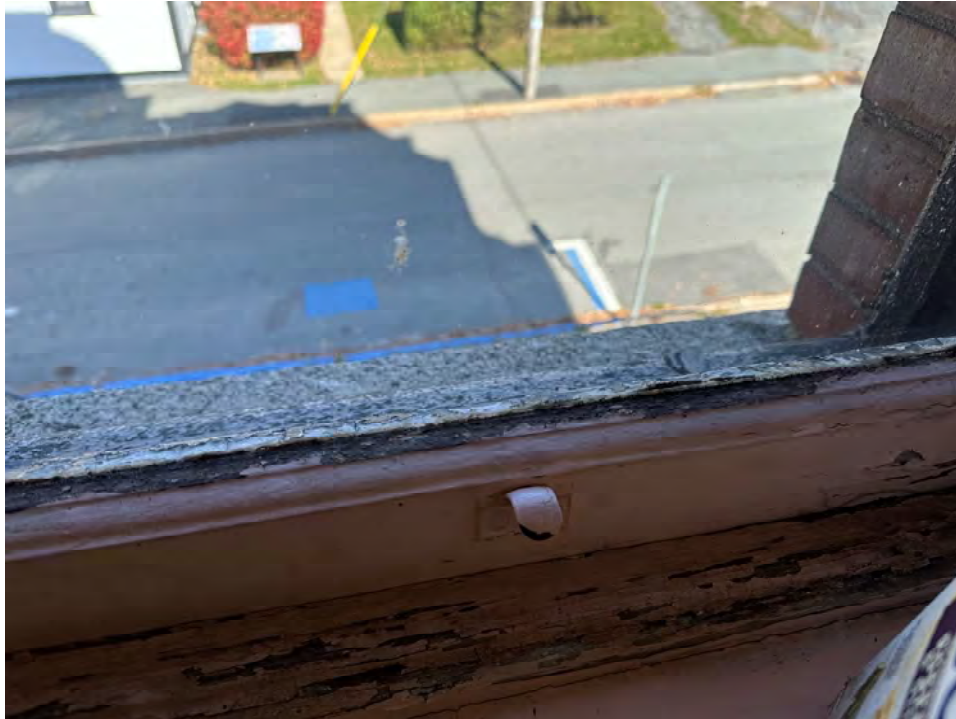
Photo 35: Peeling paint and deterioration on wood window, likely from condensation

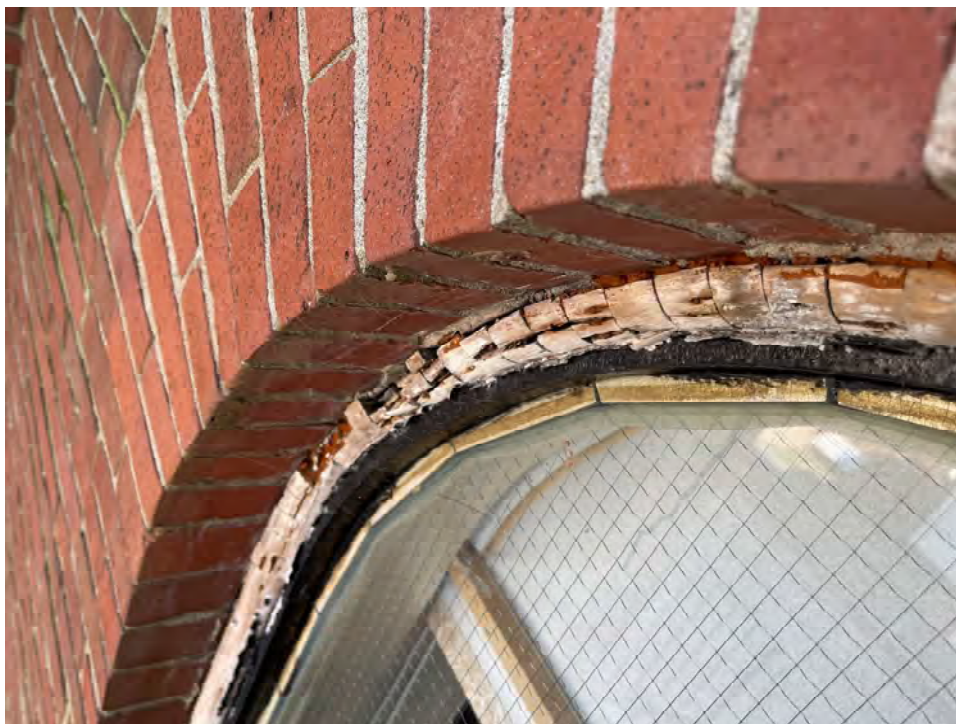
Photo 36: Peeling paint and deterioration of exterior wood detailing above retrofit vinyl window

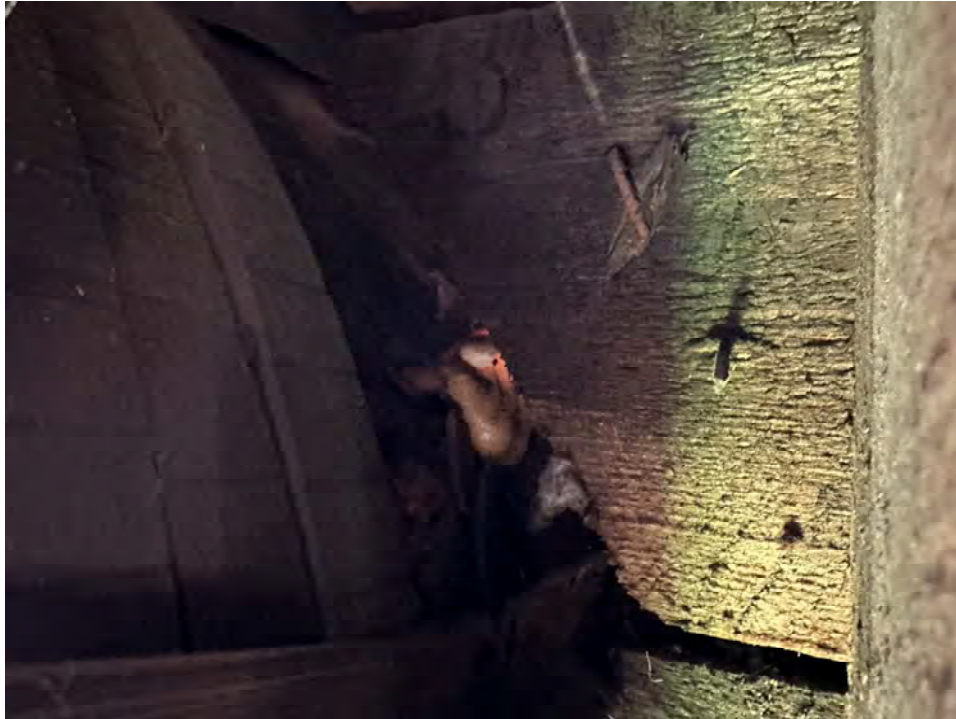
Photo 37: Daylight at window opening in attic/storage space
