125 CUMBERLAND STREET

CIVIC SQUARE BANDSTAND STRUCTURAL CONDITION ASSESSMENT

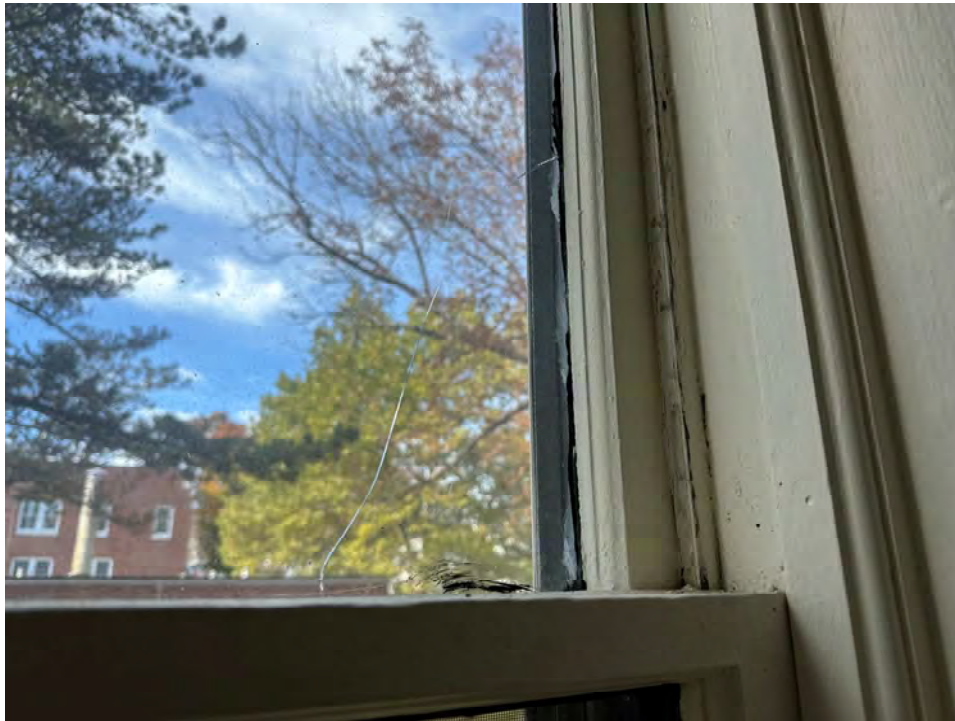
Photo 39: Cracked pane on second floor office window on west elevation

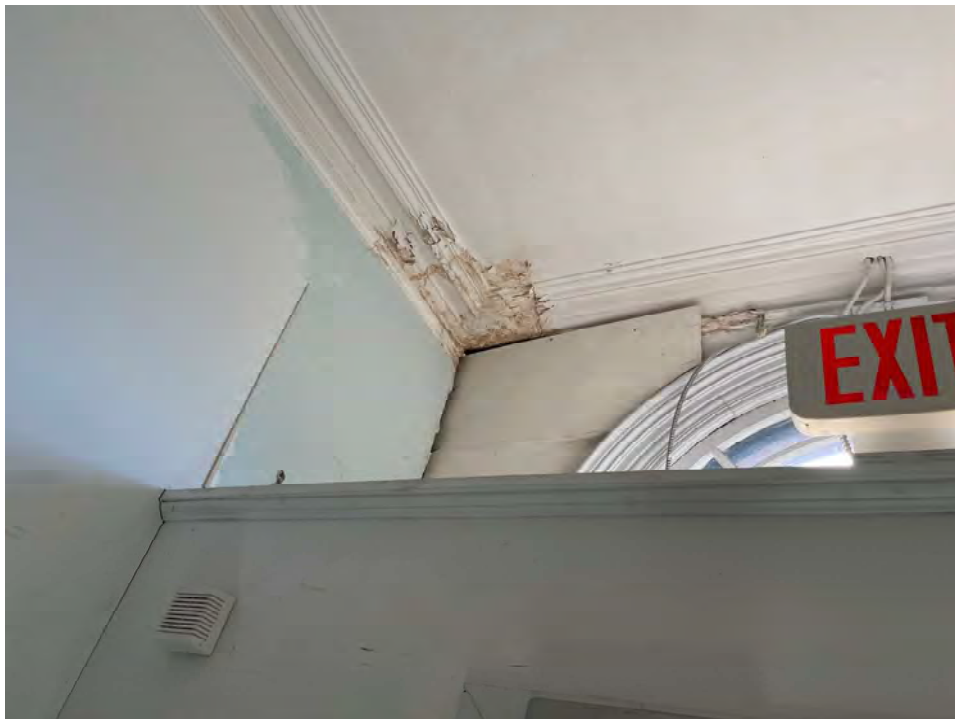
Photo 40: Moisture ingress deterioration above south elevation Cumberland Street entrance

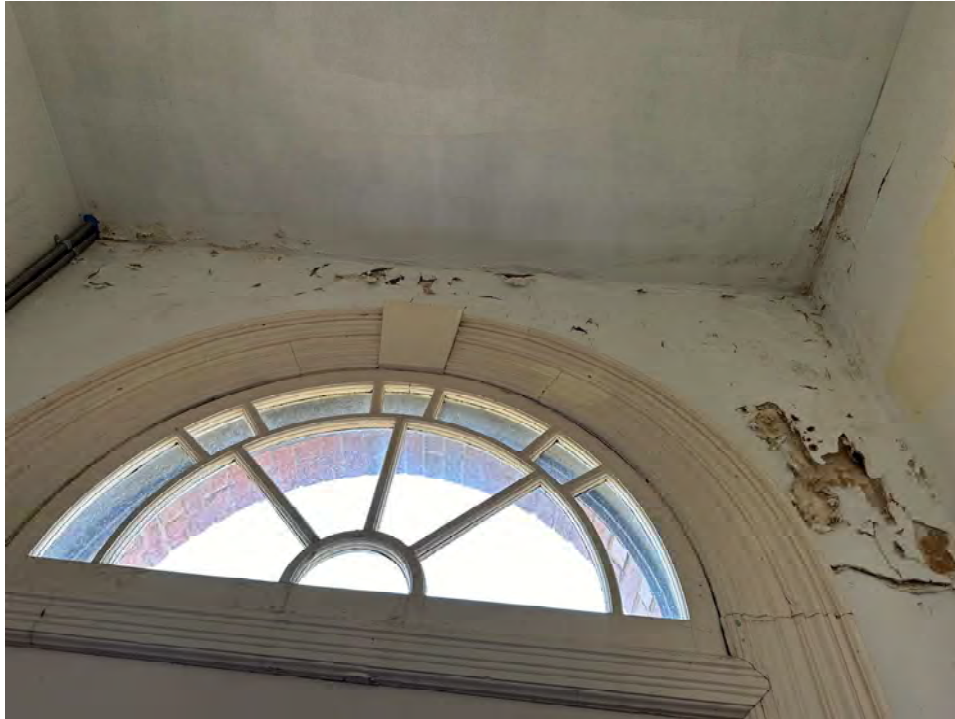
Photo 41: Moisture ingress deterioration above east elevation entrance

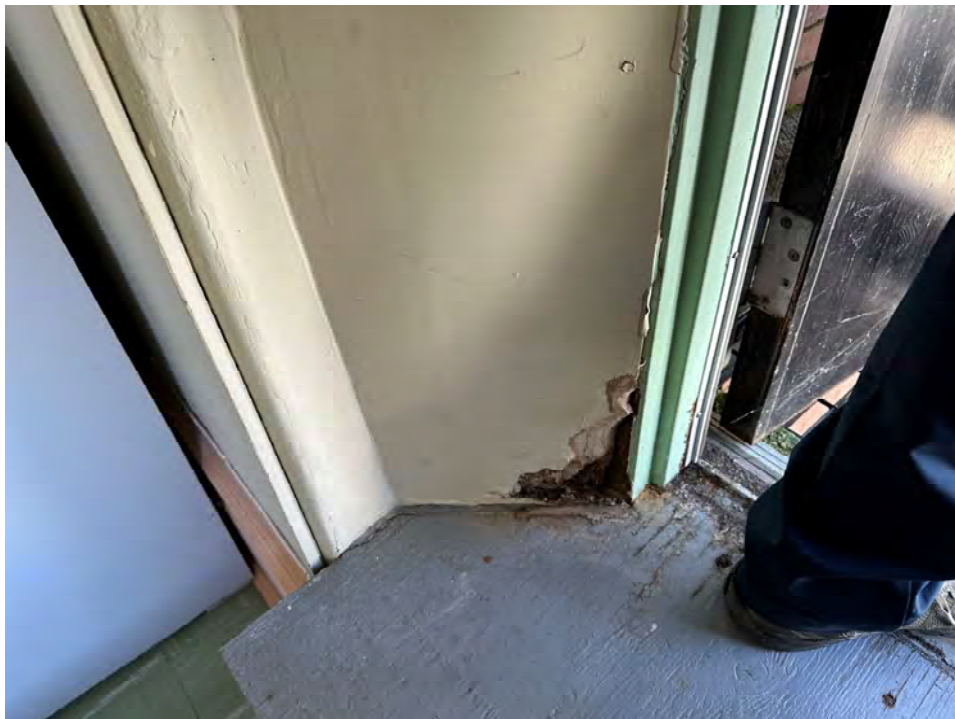
Photo 42: Moisture ingress deterioration at third storey fire escape door

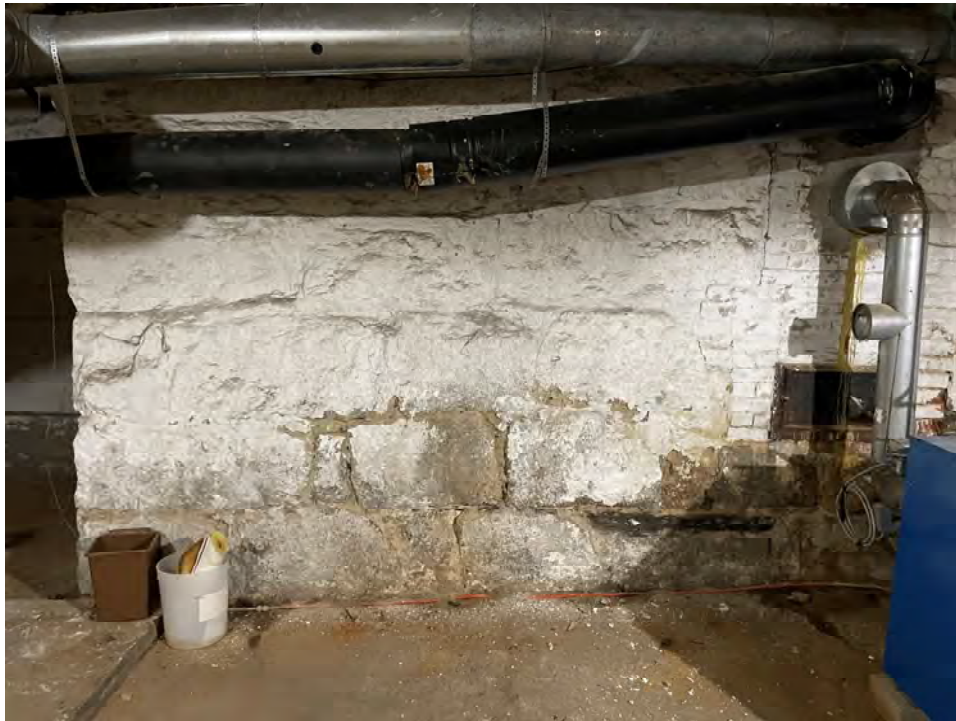
Photo 43: Stone foundation wall

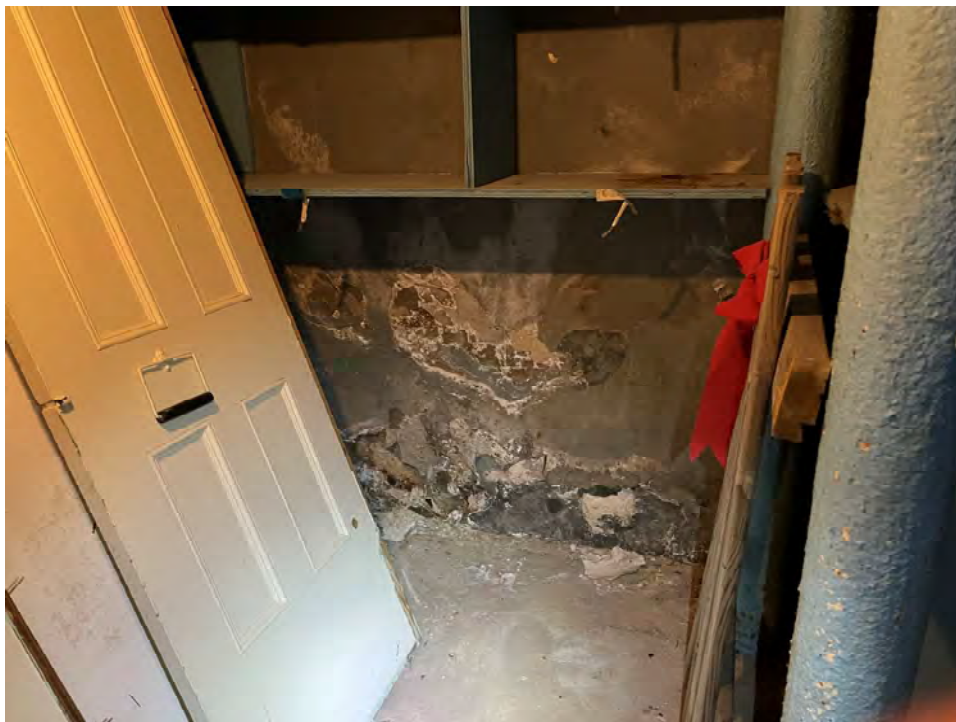
Photo 44: Deteriorated parging material on stone foundation wall

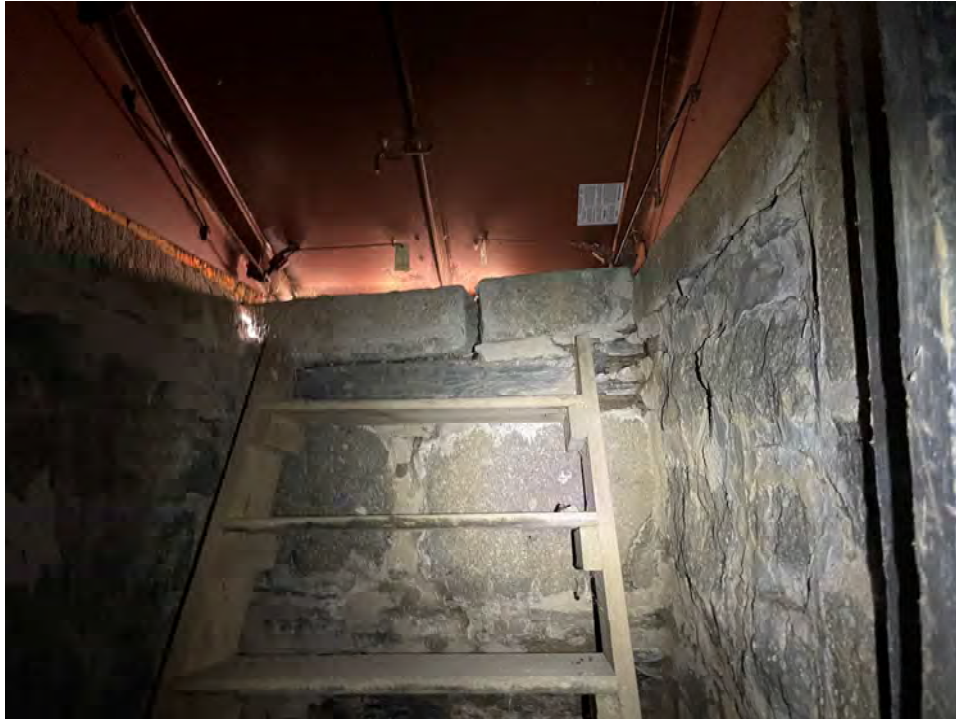
Photo 45: View from inside basement bulkhead hatch with daylight indicating no air or water seal in areas

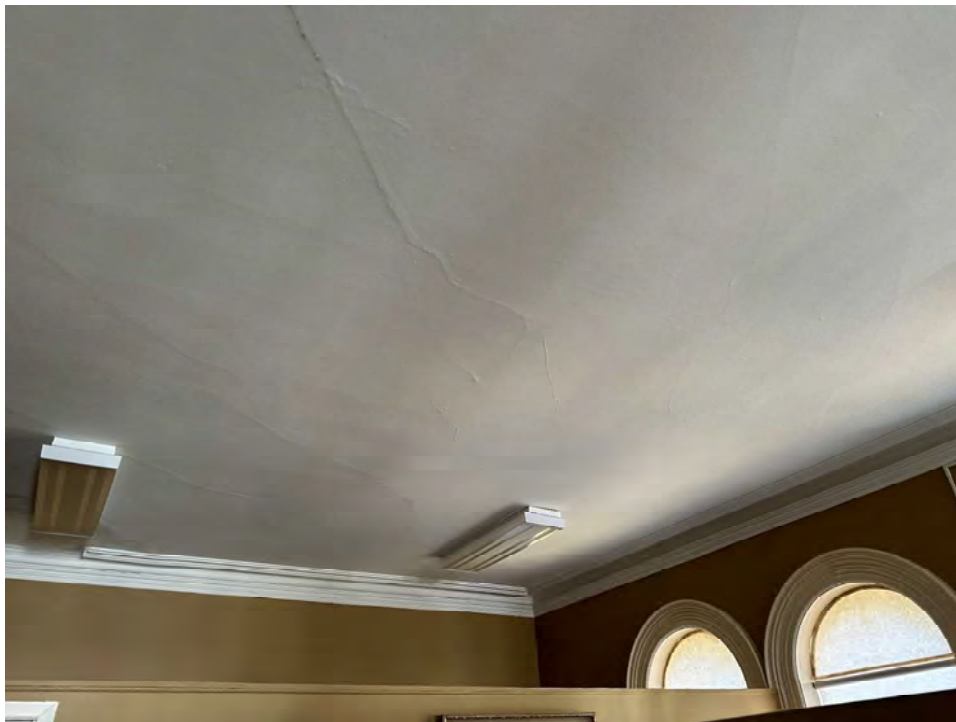
Photo 46: Cracking on ceiling inside building (typ. at several locations)

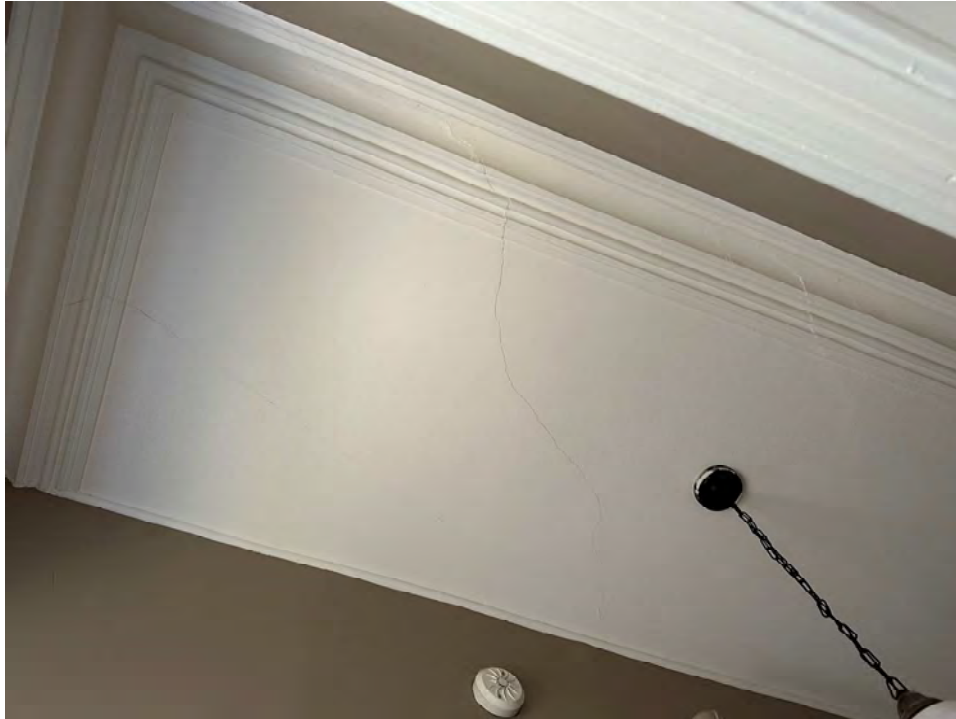
Photo 47: Cracking on ceiling inside building (typ. at several locations)

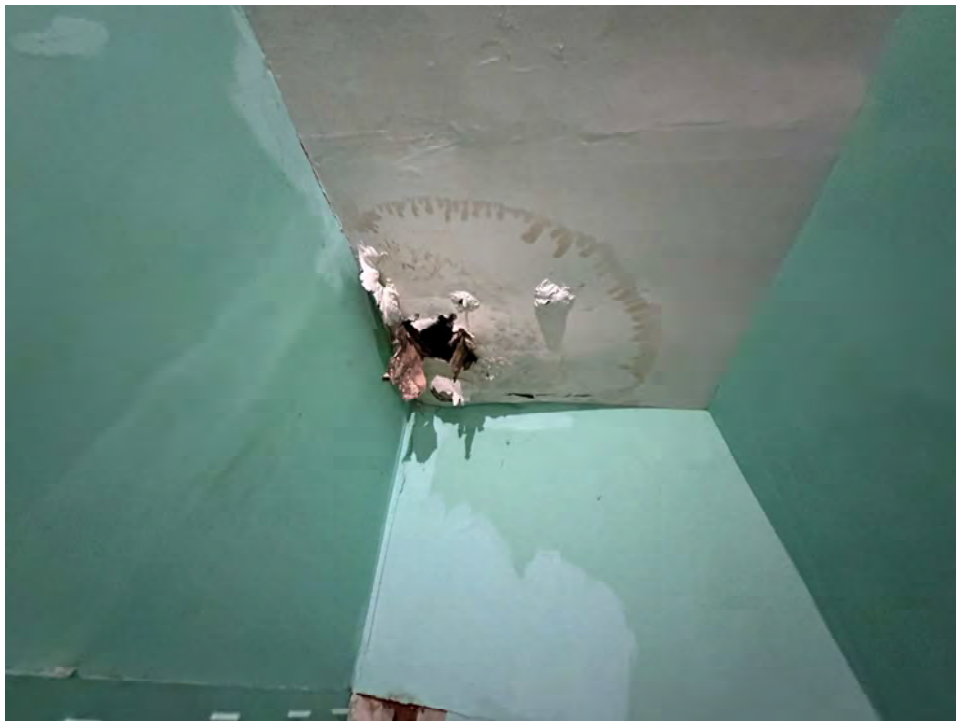
Photo 48: Deterioration from moisture ingress on third floor unoccupied space

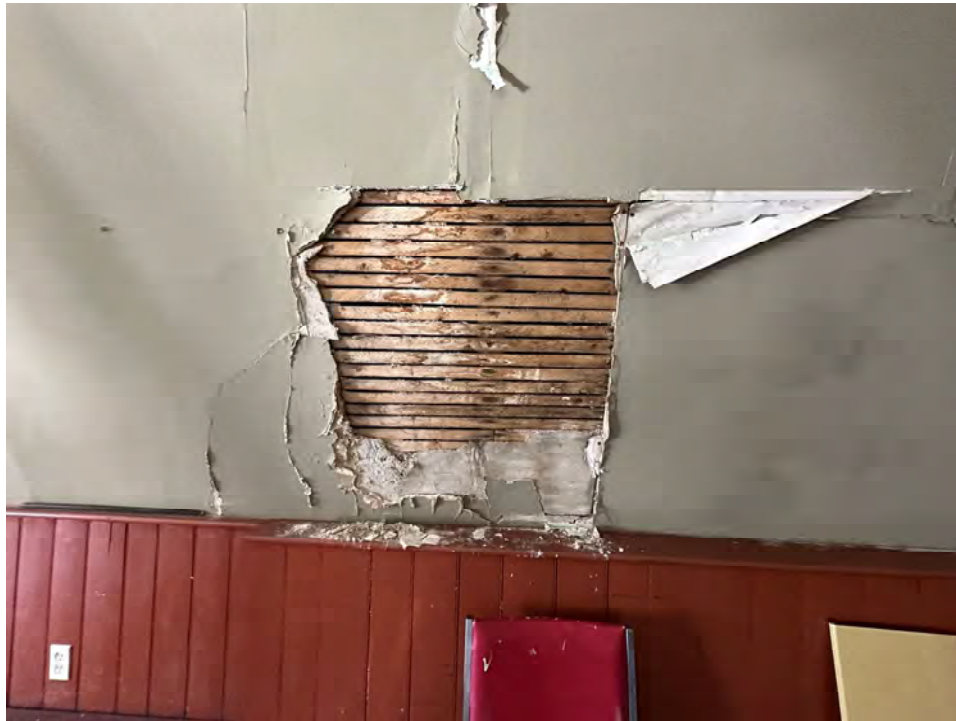
Photo 49: Deterioration from moisture ingress on third floor unoccupied space

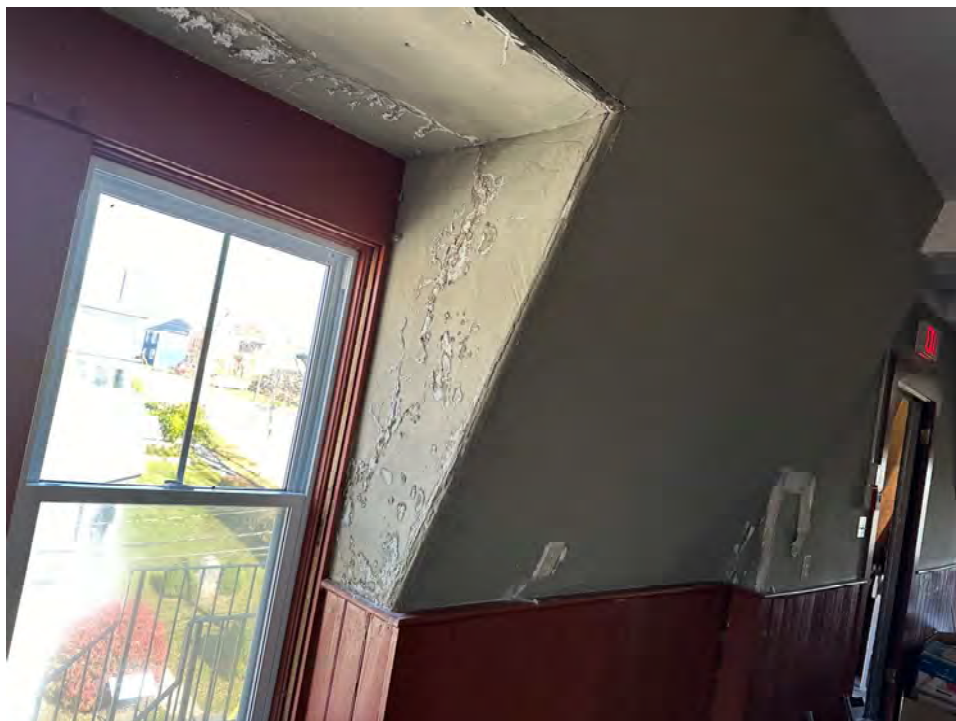
Photo 50: Deterioration from moisture ingress at dormer window on third floor unoccupied space

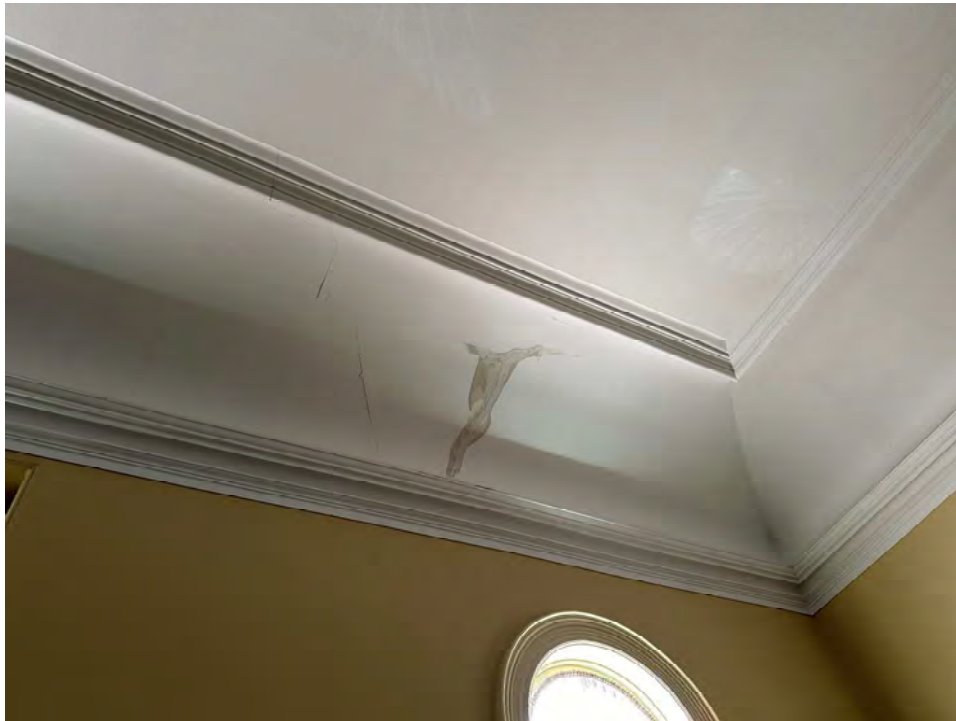
Photo 51: Deterioration from moisture ingress on second floor in Council chambers

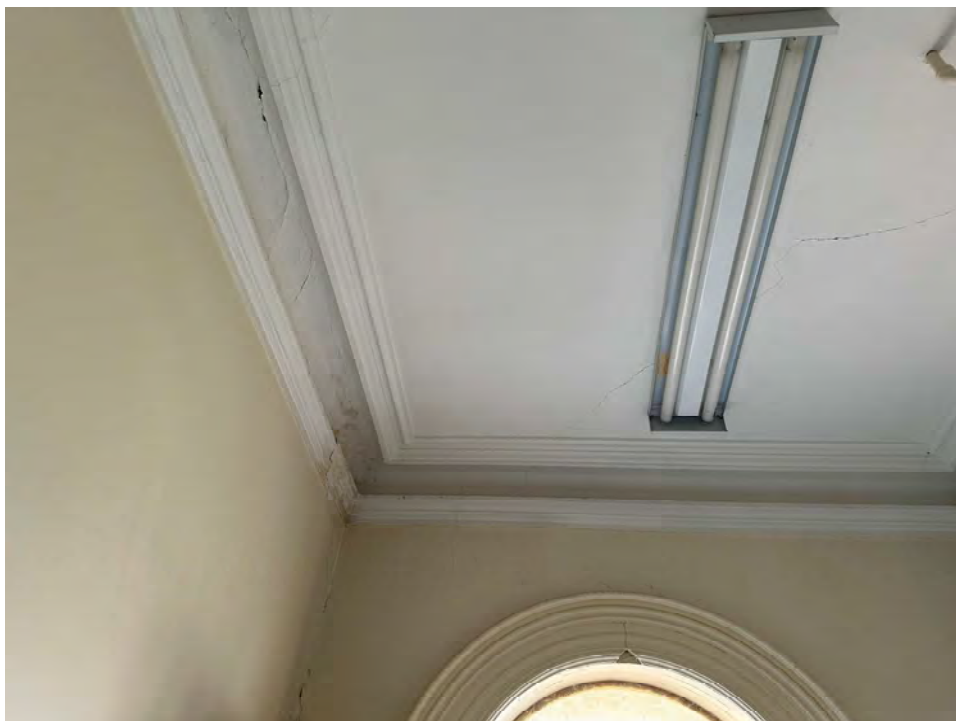
Photo 52: Deterioration from moisture ingress on third floor

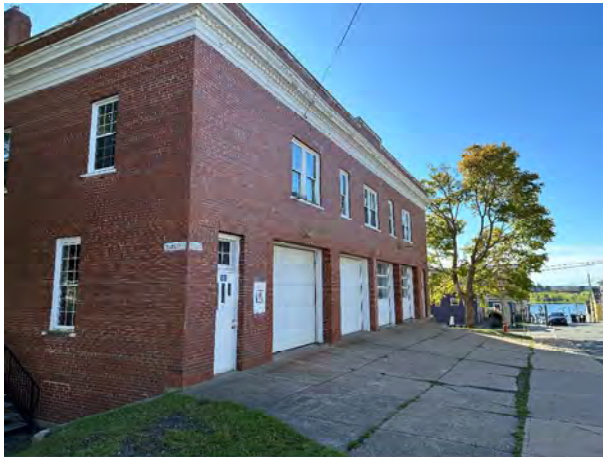
Lunenburg, Nova Scotia

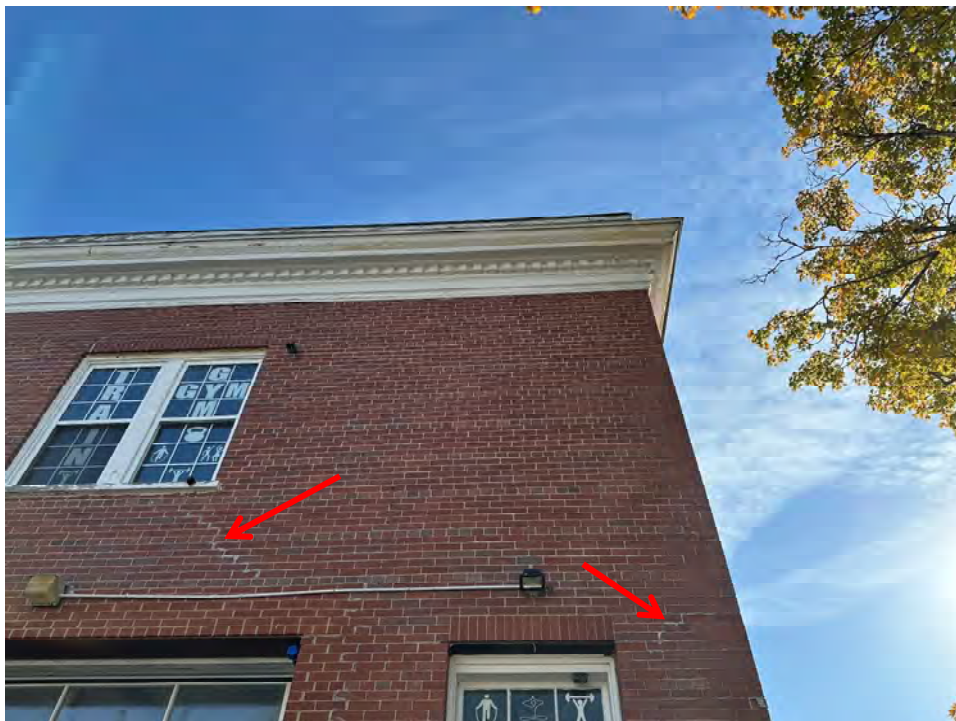
Photo 4: Localized step cracking with touch-up sealant repair attempts

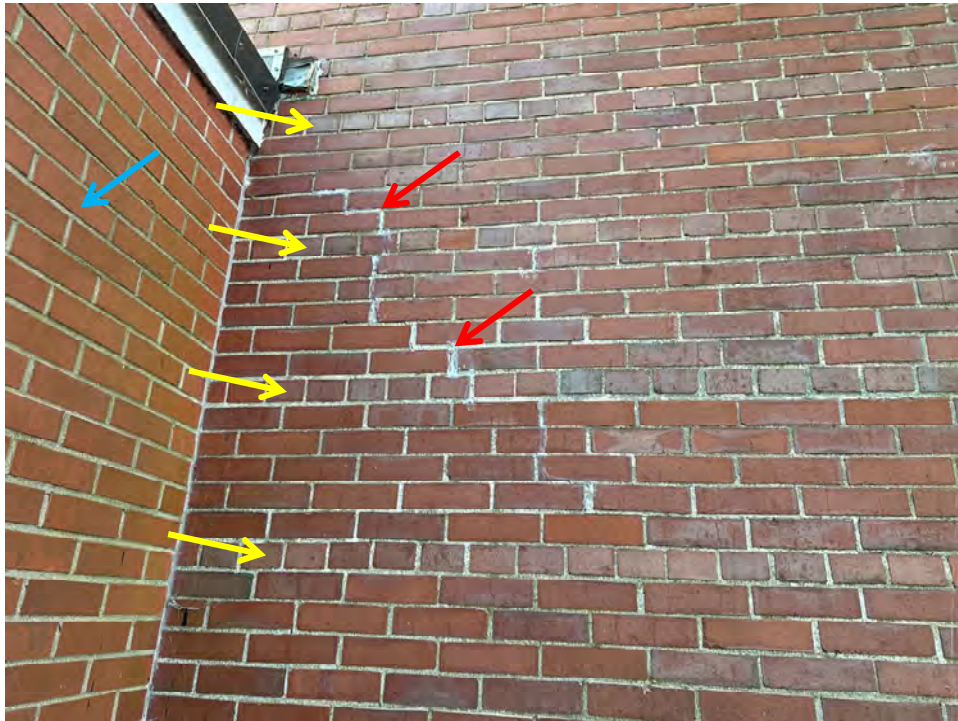
Photo 5: Typical brick masonry bond pattern. Yellow arrows at header courses. Red arrow at step cracking with touch up sealant repair attempt. Blue arrow on west wall of Electric Light Shop

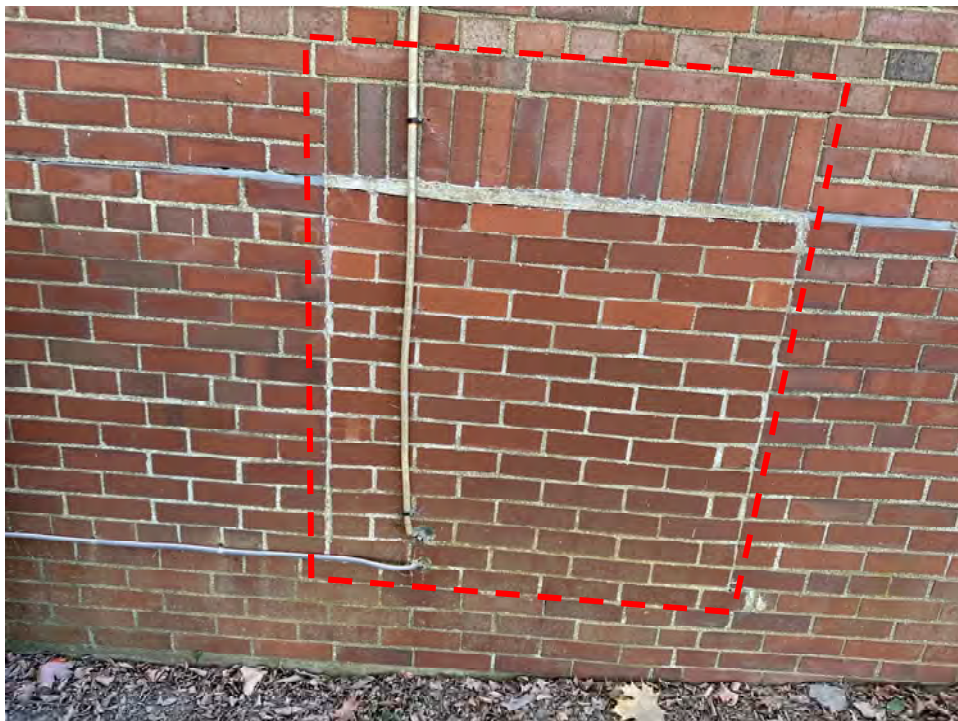
Photo 6: Brick infill at pre-existing window opening (typ. at two locations)

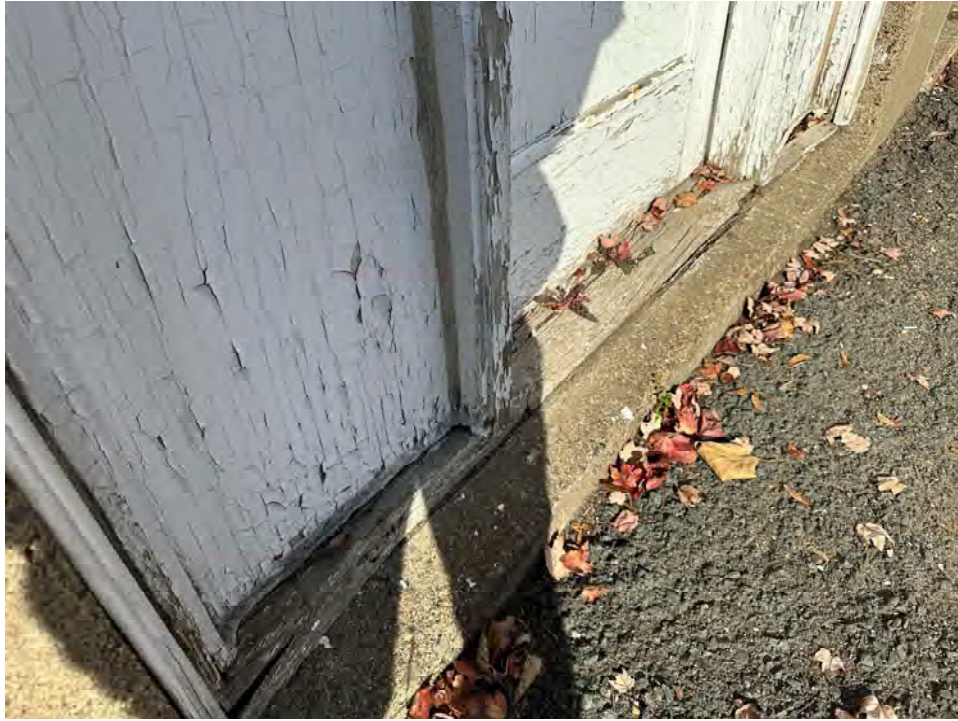
Photo 10: Close up of east elevation door with deteriorated wood threshold and failing paint finish

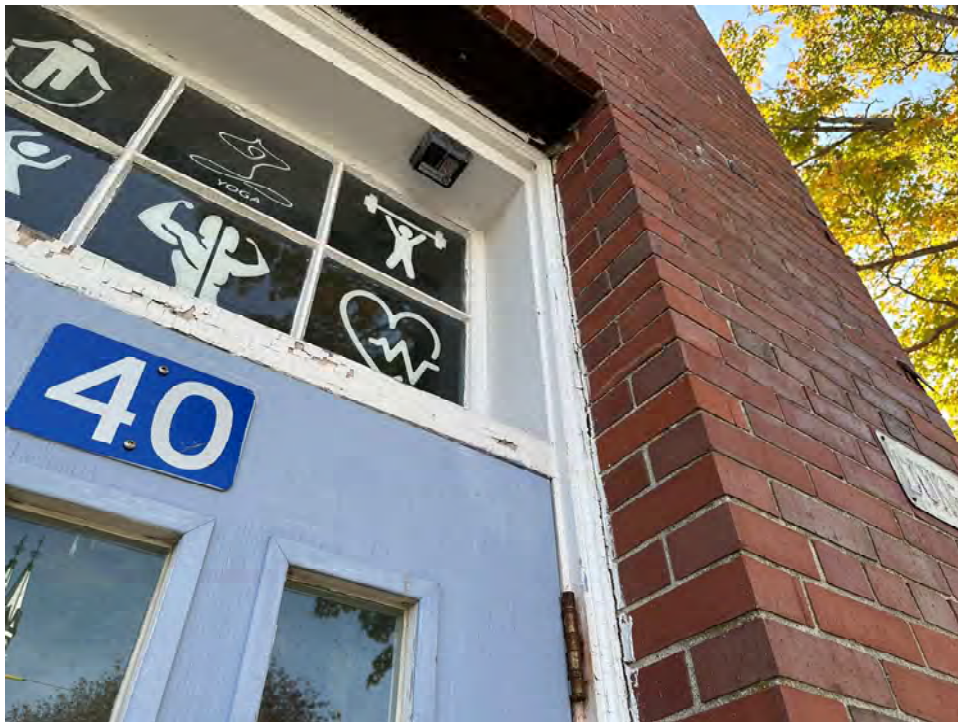
Photo 11: Close up of west elevation door with failing paint finish near southwest corner of building

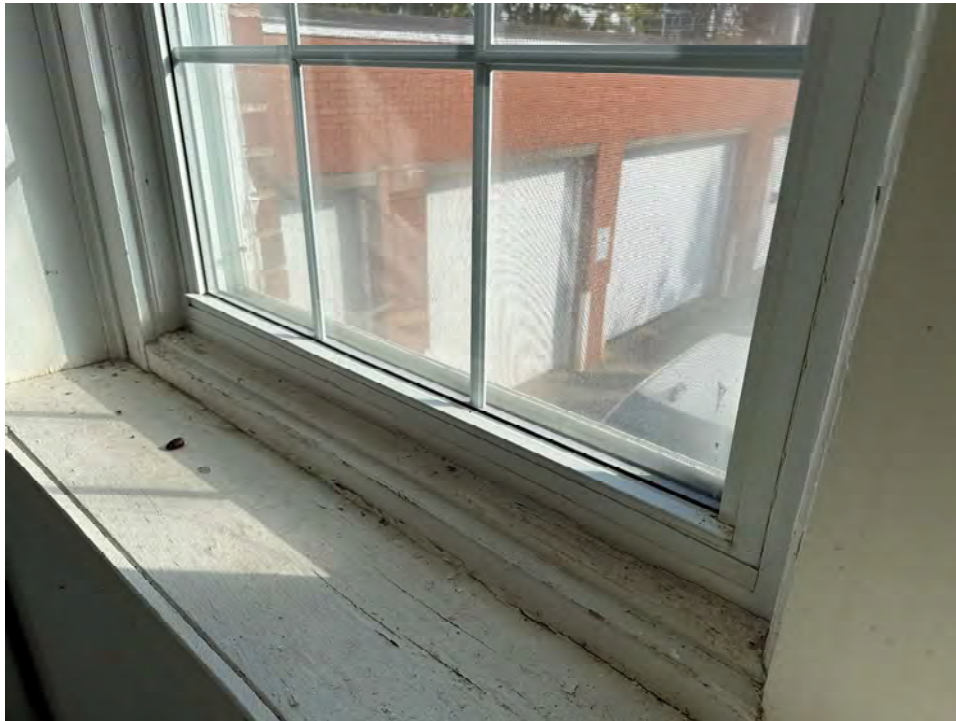
Photo 12: Interior close up of newer vinyl window (typ. throughout building) set in original wood frame in fair to poor condition

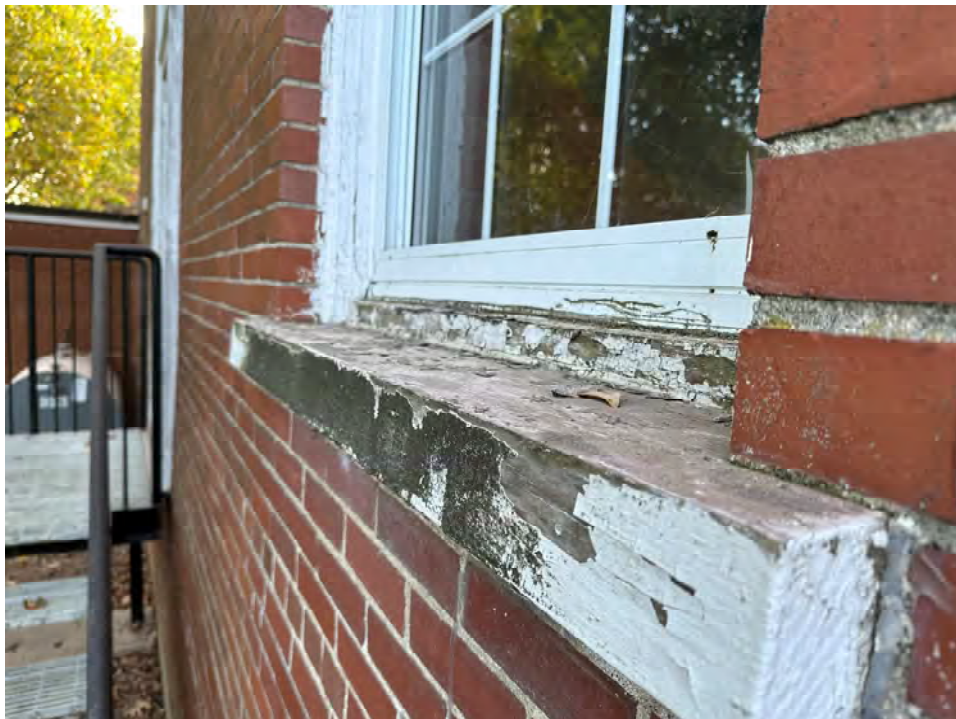
Photo 13: Failing paint finish on exterior window sill (typ. condition at others)

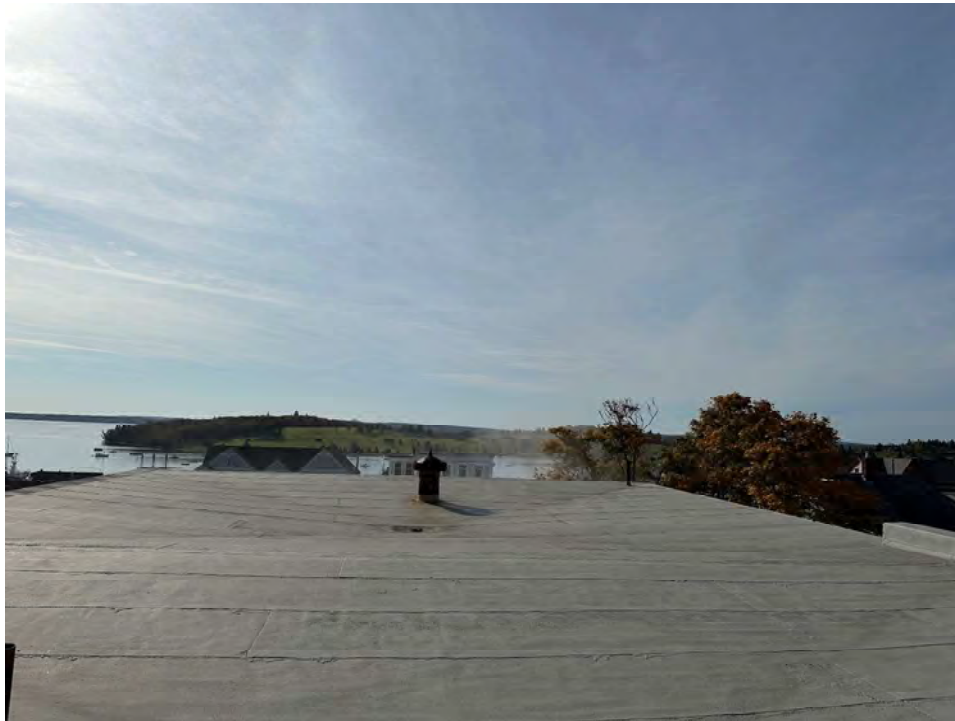
Photo 14: Overview of existing roofing membrane

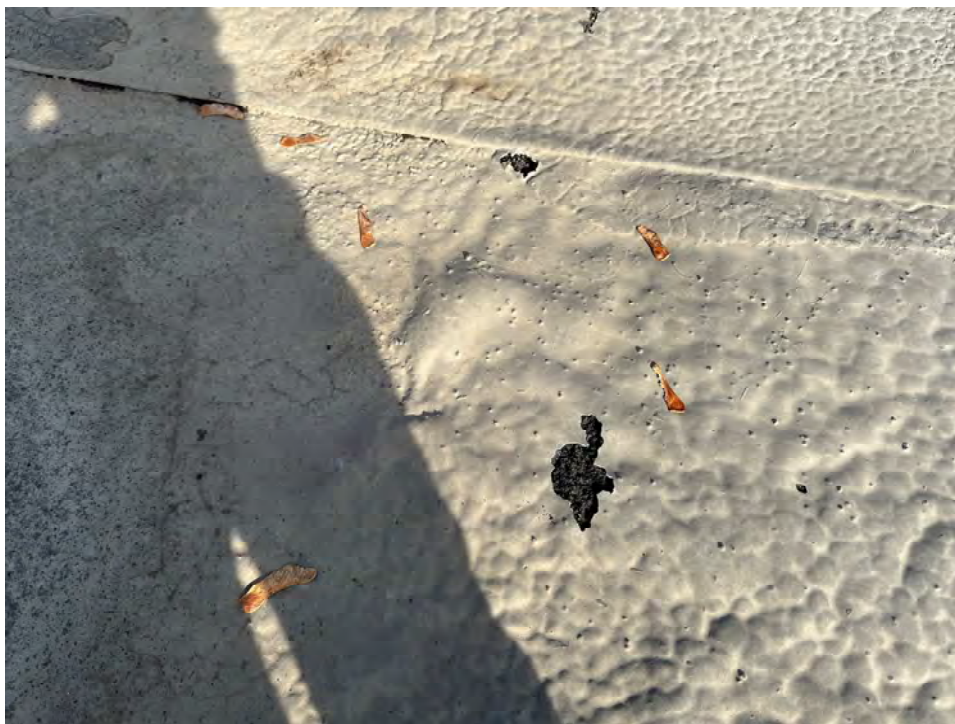
Photo 15: Close up of deteriorated roofing membrane that had a coating applied overtop

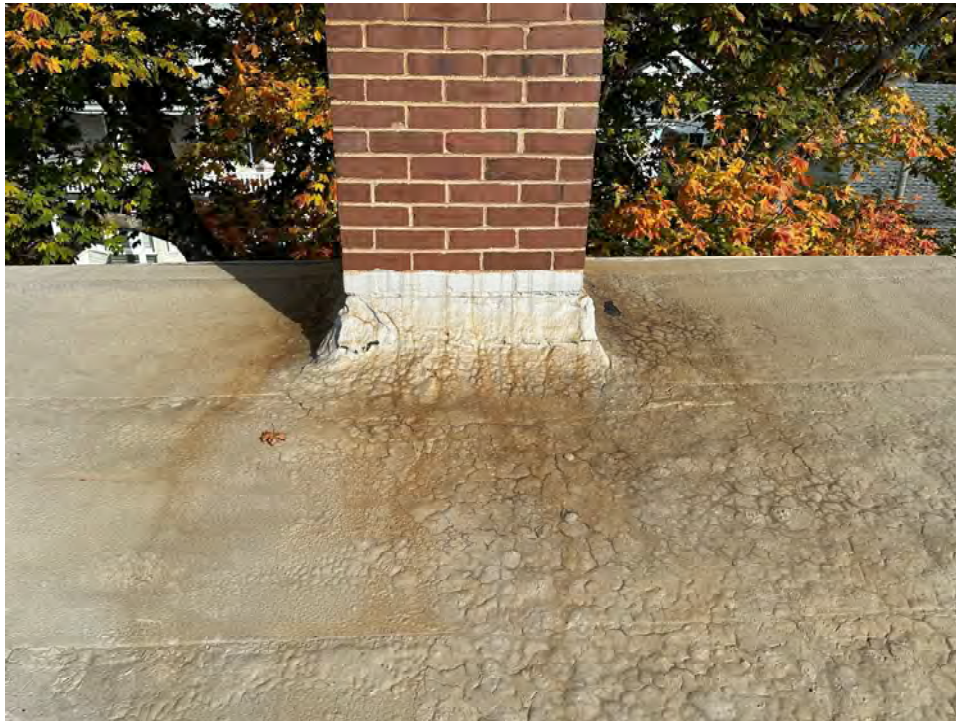
Photo 16: Alligator cracking on roofing membrane telescoping through the coating at north chimney

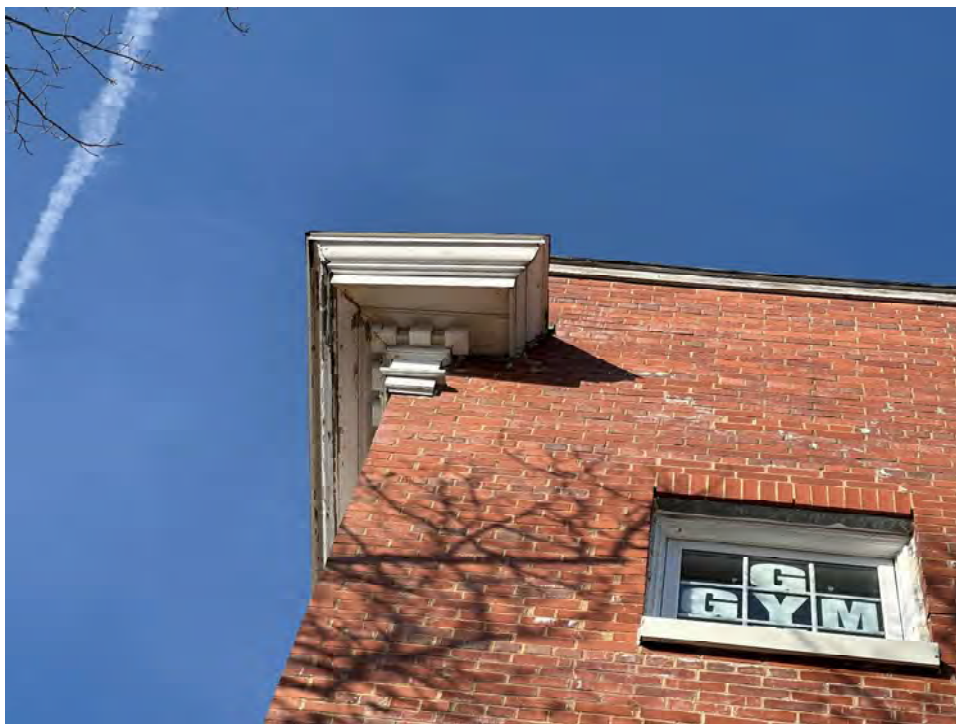
Photo 17: Failing paint finish and deterioration on underside of wood cornice at southeast corner

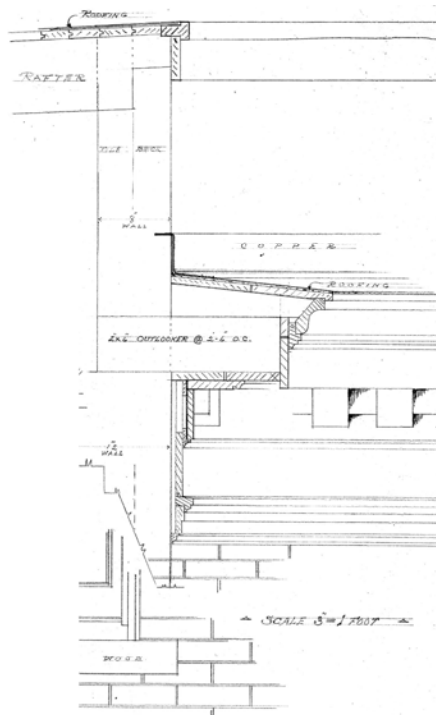
Figure 2: Original (circa 1928) typical cornice detail. Note, moisture ingress has potential to deteriorate “outlooker” and wall cavity if the cornice detailing is poor

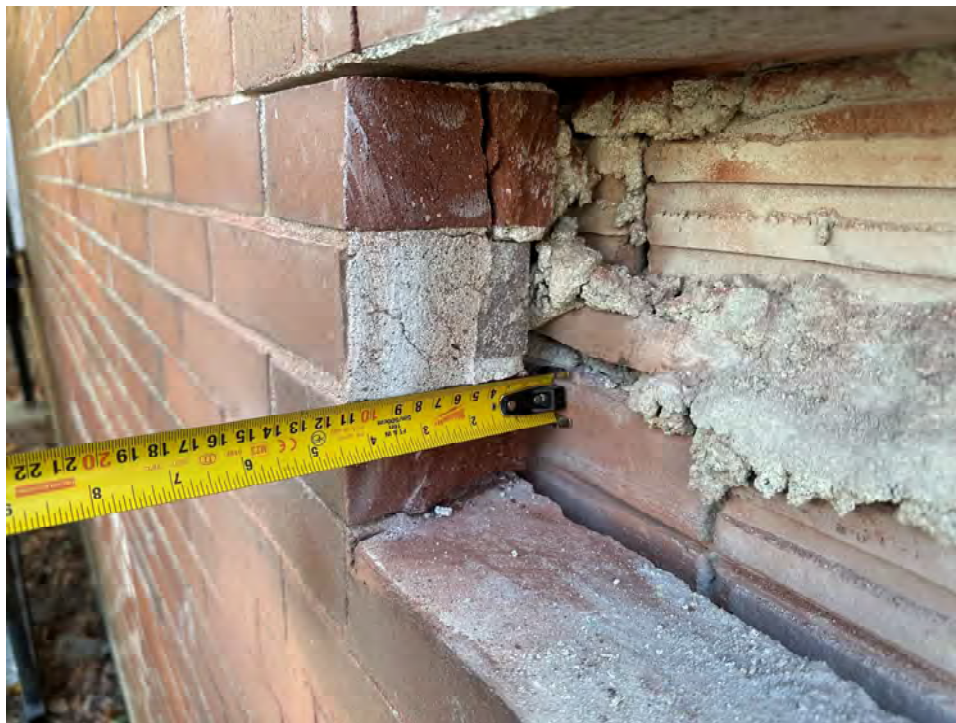
Photo 18: Exploratory brick opening on north elevation

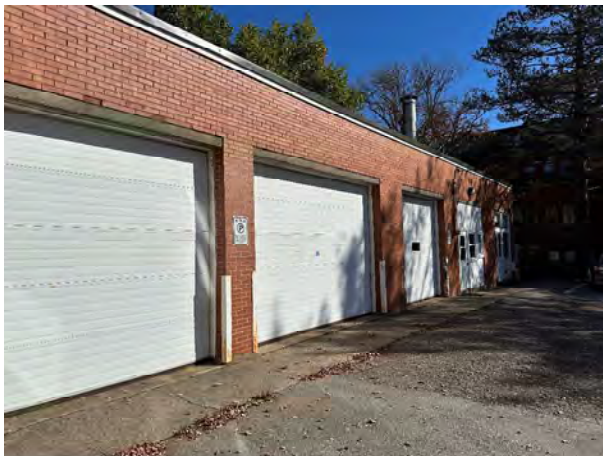
Lunenburg, Nova Scotia

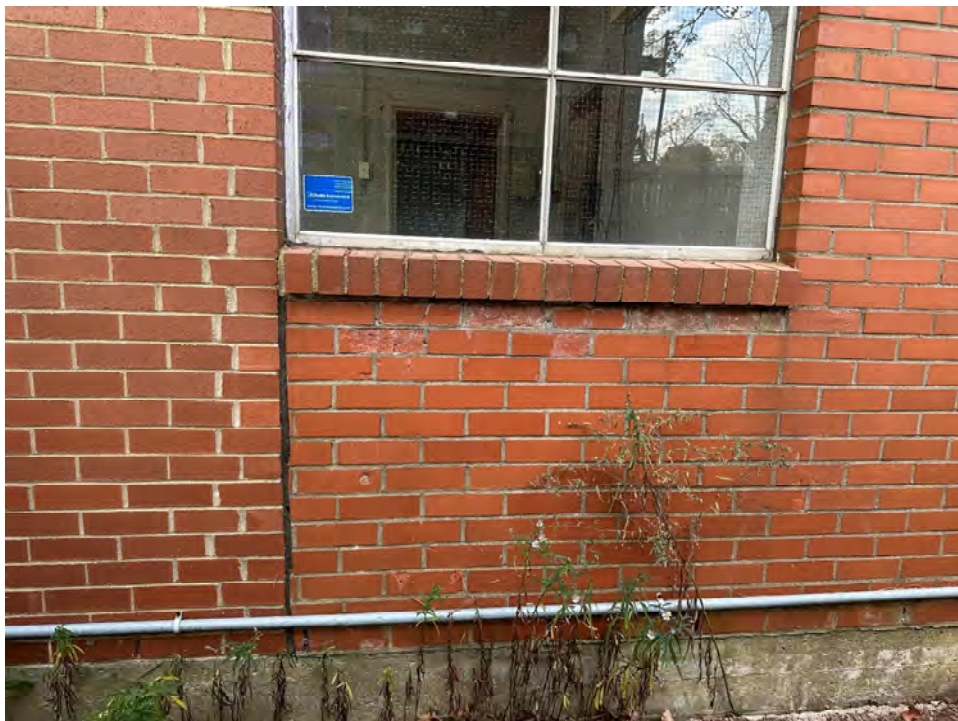
Photo 4: Brick deterioration on east elevation below brick sills

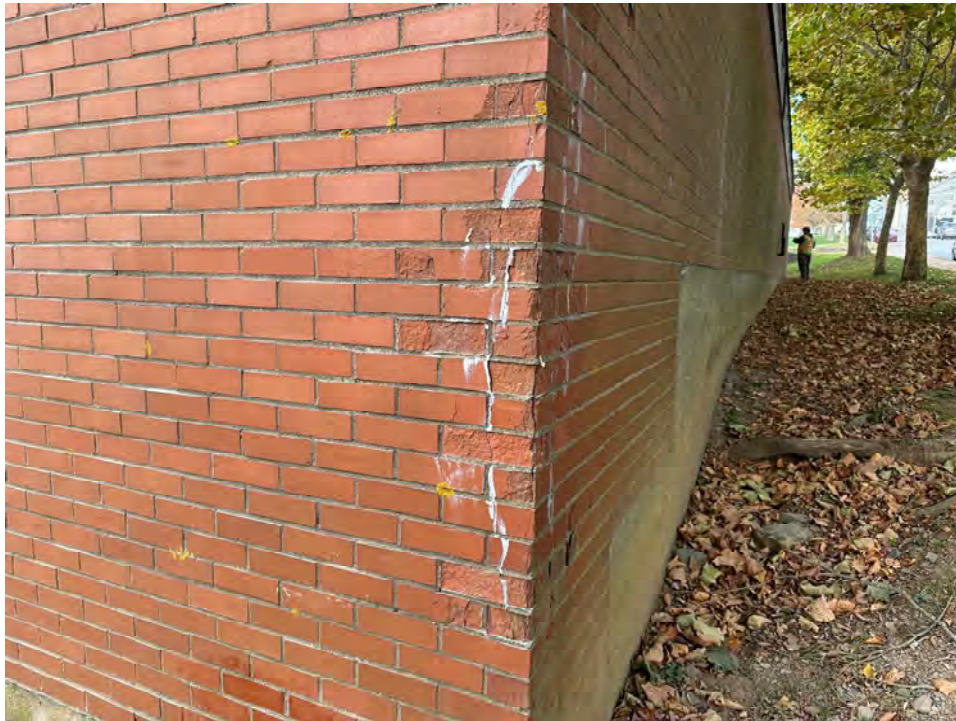
Photo 5: Brick deterioration at northeast corner

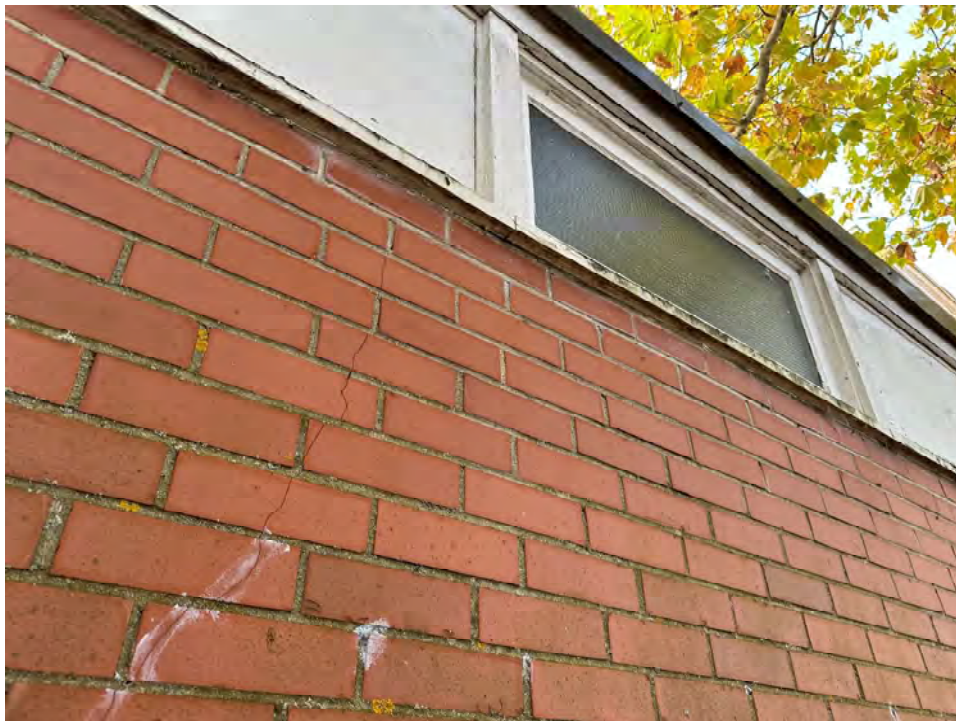
Photo 6: Brick cracking on north elevation

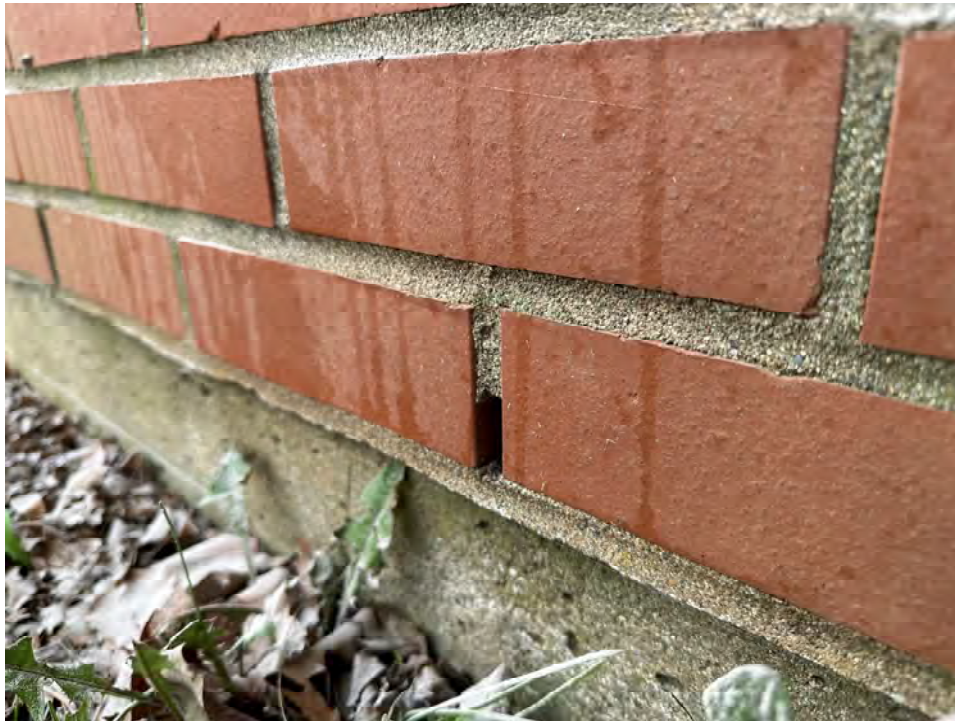
Photo 7: Close-up of weep hole at base of north elevation exterior brick

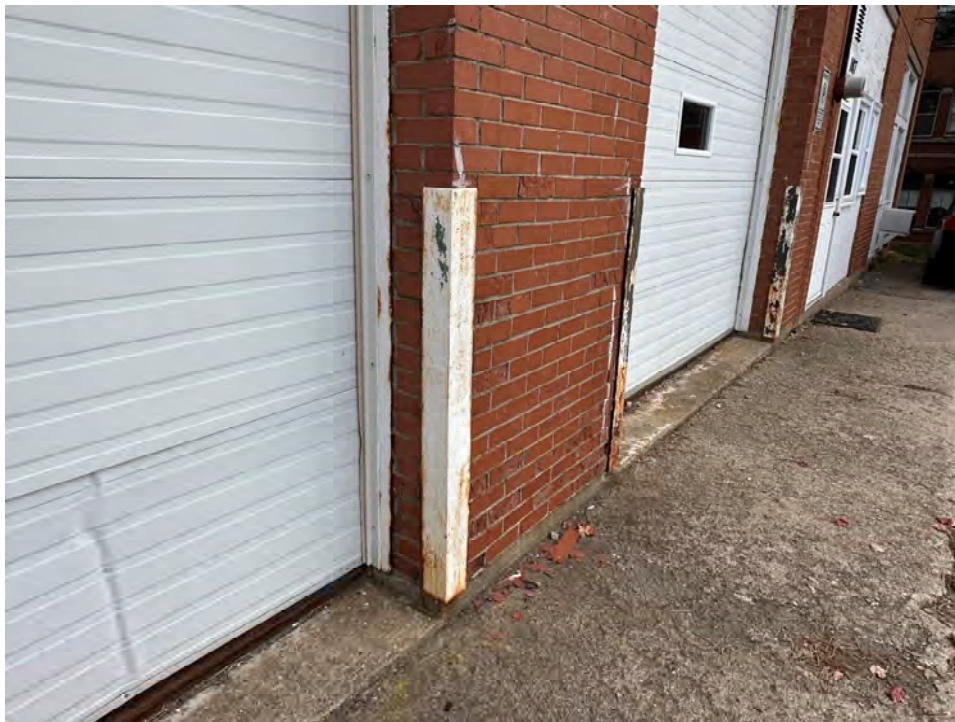
Photo 8: Brick deterioration on south elevation solid brick pier
