125 CUMBERLAND STREET

CIVIC SQUARE BANDSTAND STRUCTURAL CONDITION ASSESSMENT

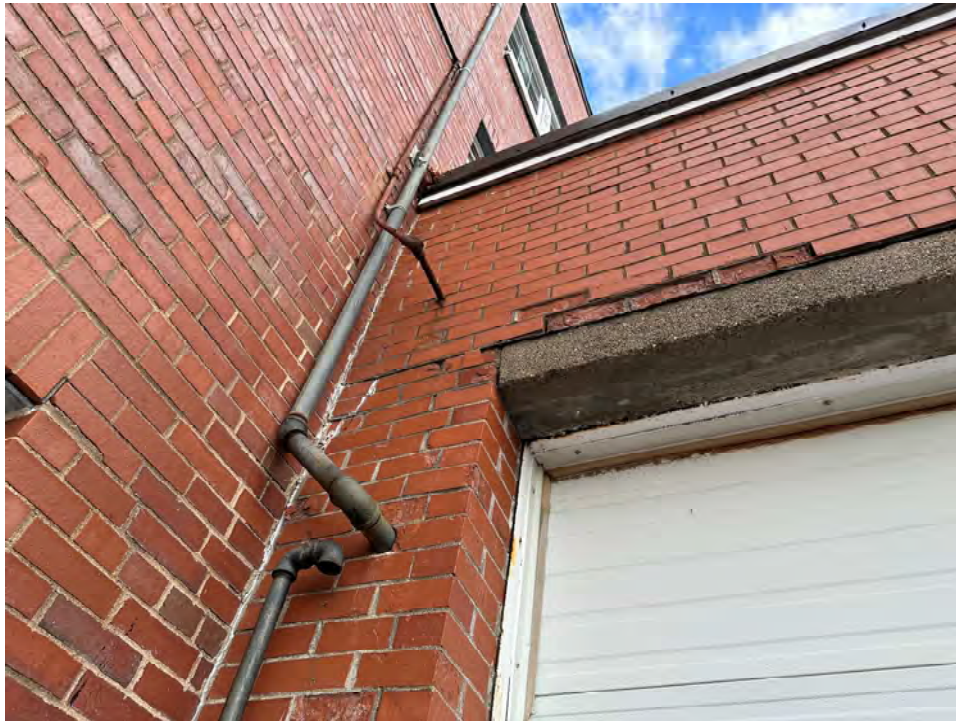
Photo 9: Brick deterioration on south elevation solid brick pier and above concrete projection/lintel from likely moisture accumulation and unsealed penetrations

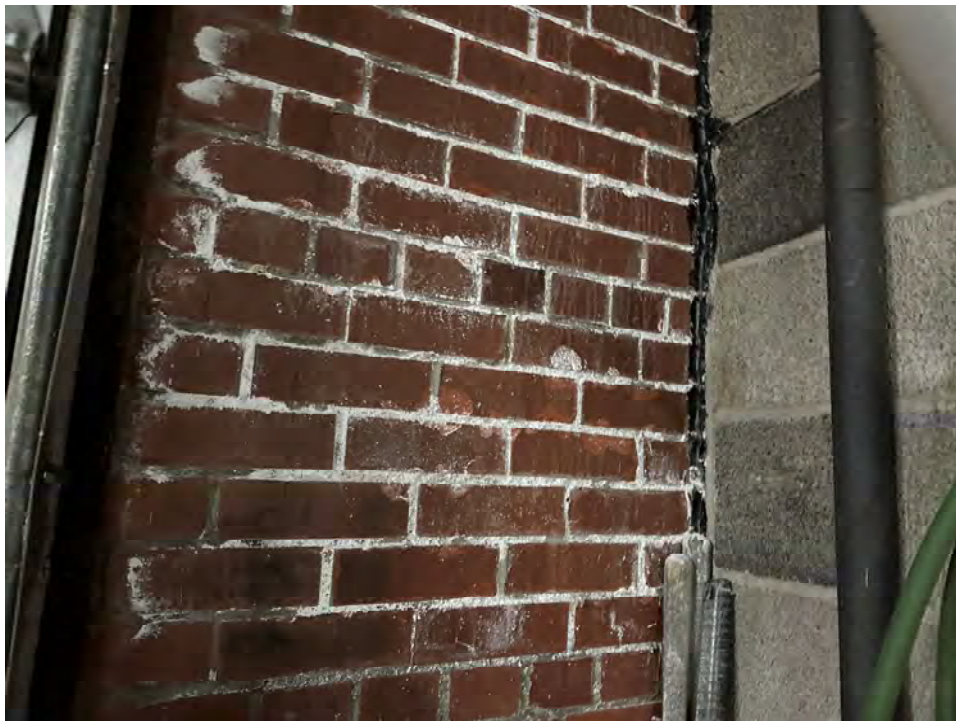
Photo 10: Efflorescence build up and staining on interior surface of solid brick pier (inside building at Photo 9 location)

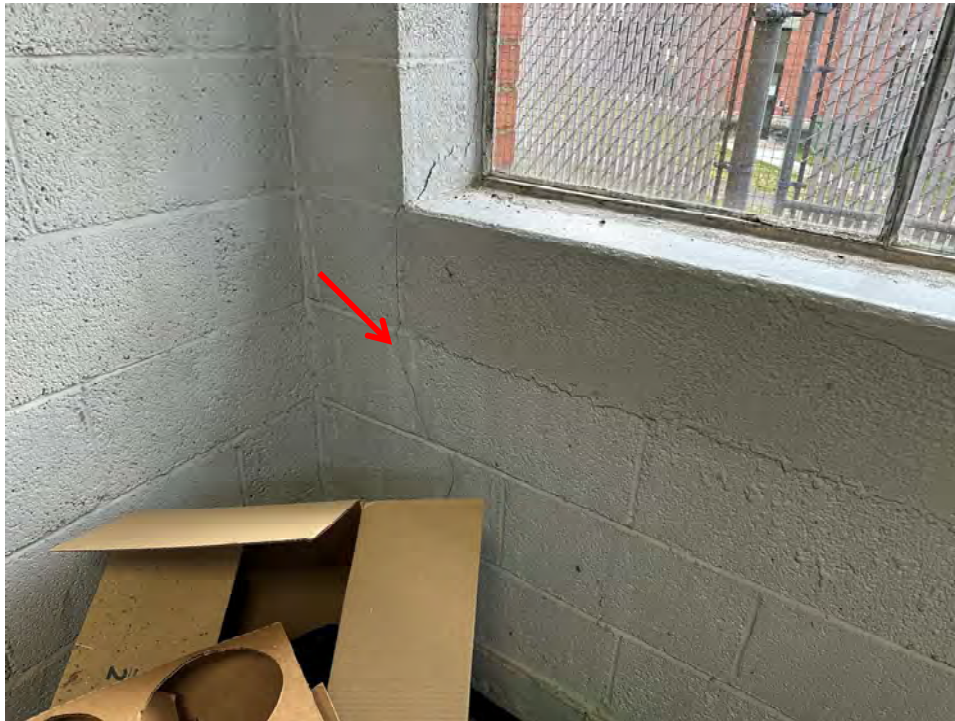
Photo 11: CMU cracking below window opening on east elevation wall

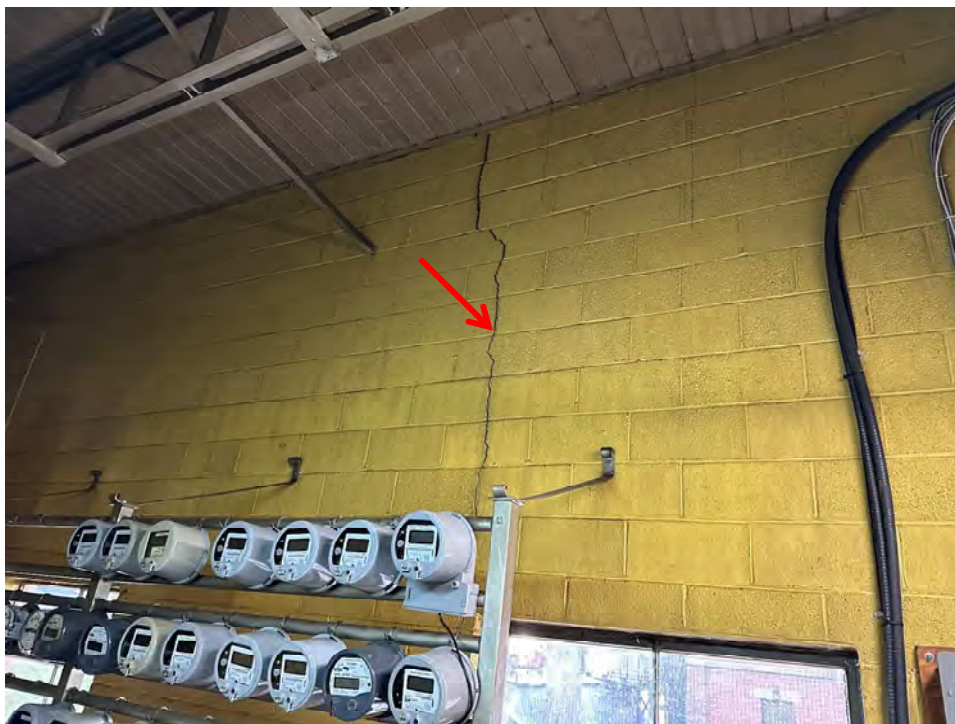
Photo 12: Full wall height CMU cracking adjacent to window opening on east elevation

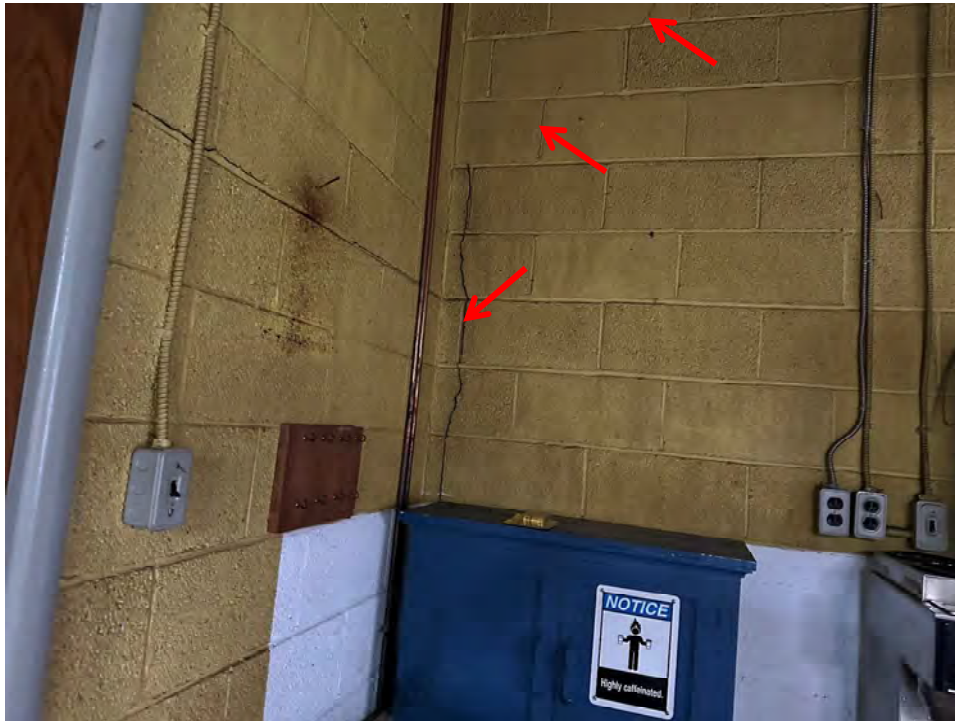
Photo 13: CMU cracking on north elevation wall

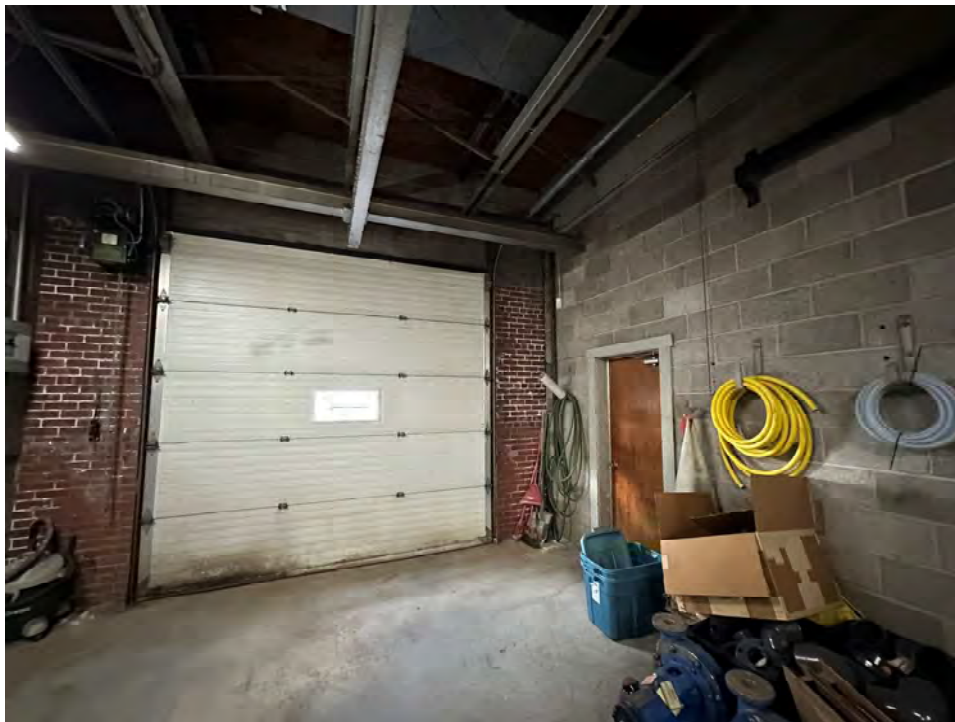
Photo 14: Bay door as visible from inside the building

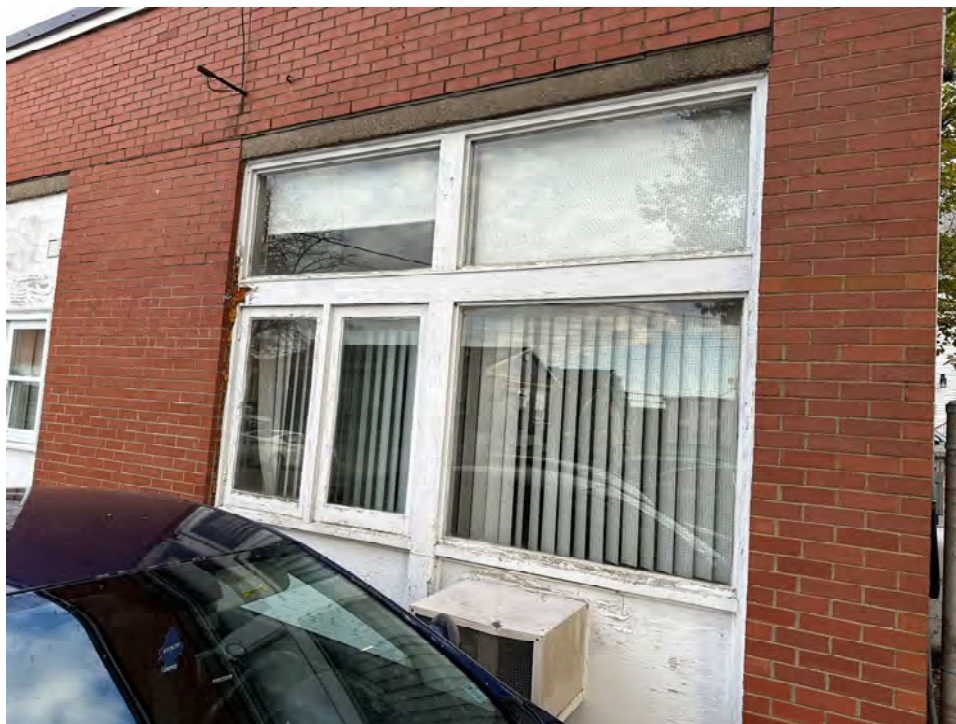
Photo 16: Deteriorated window unit on south elevation

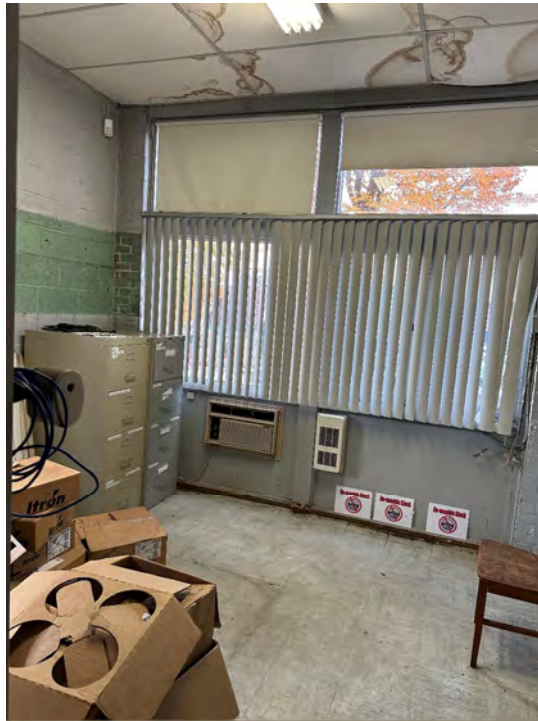
Photo 17: Deteriorated window unit as visible from building interior. Note, leakage staining on ceiling tiles above

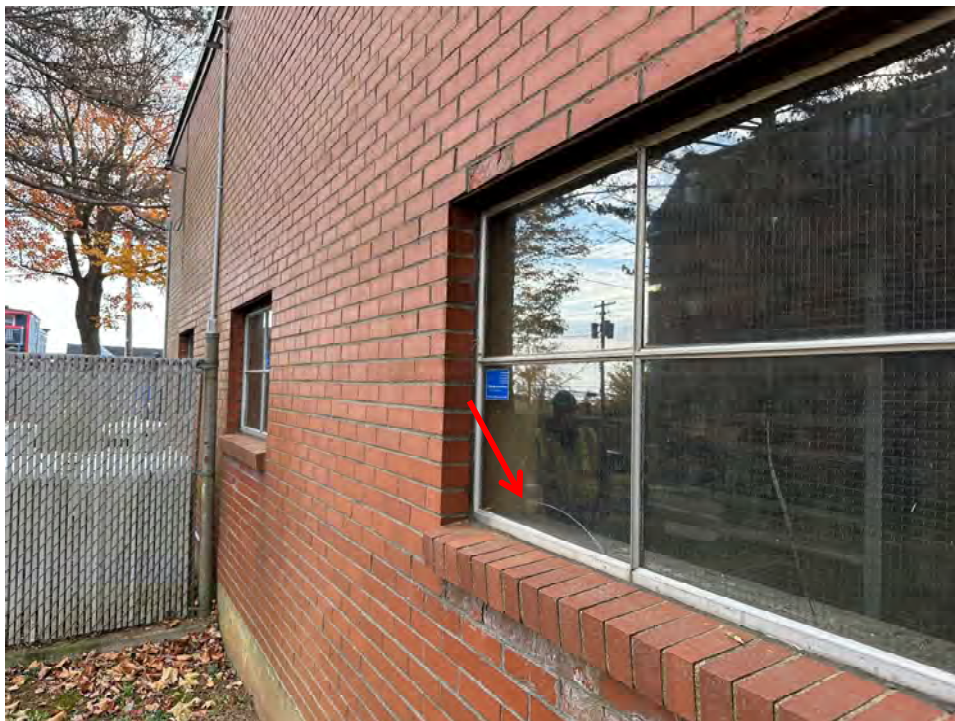
Photo 18: Cracked pane on east elevation aluminum-framed window with wired glass

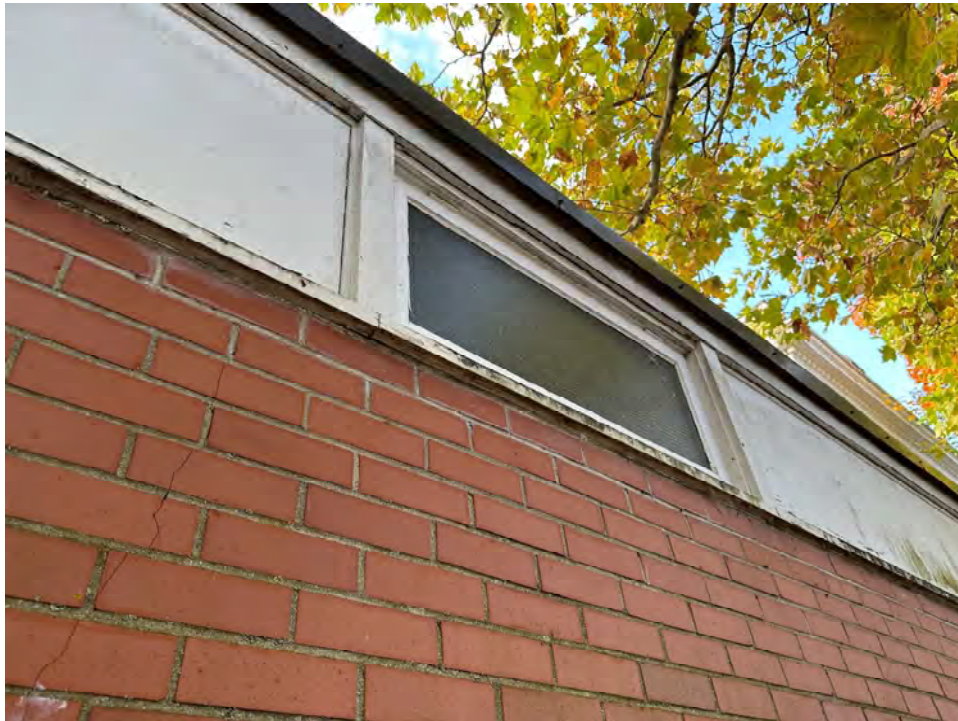
Photo 19: Wood-framed window and plywood coverings on north elevation wall

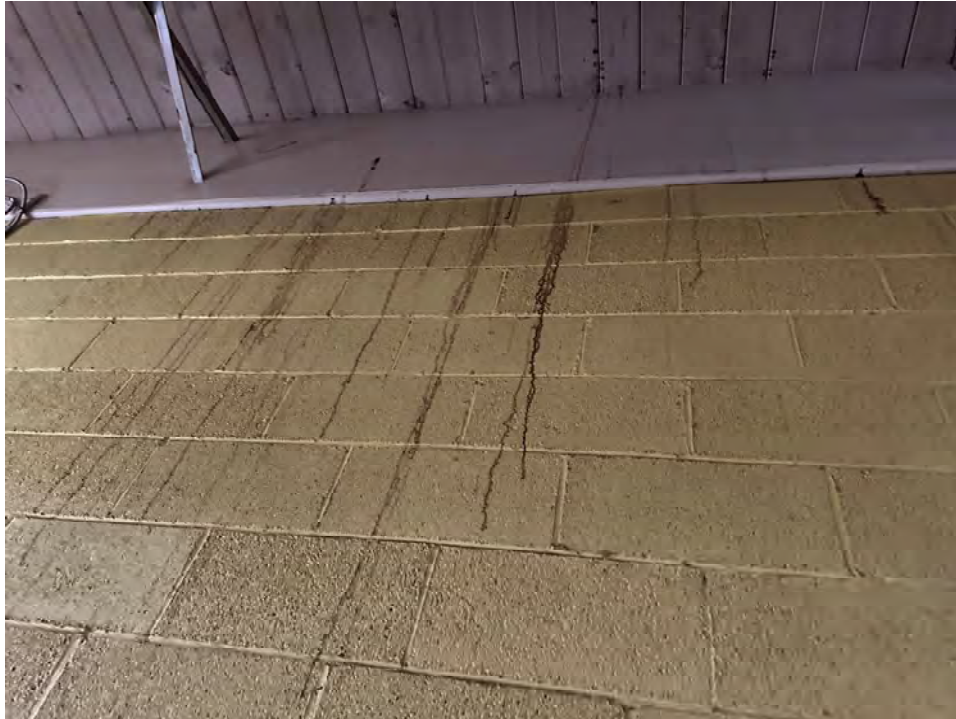
Photo 21: Indications of roof leakage on interior wall surface

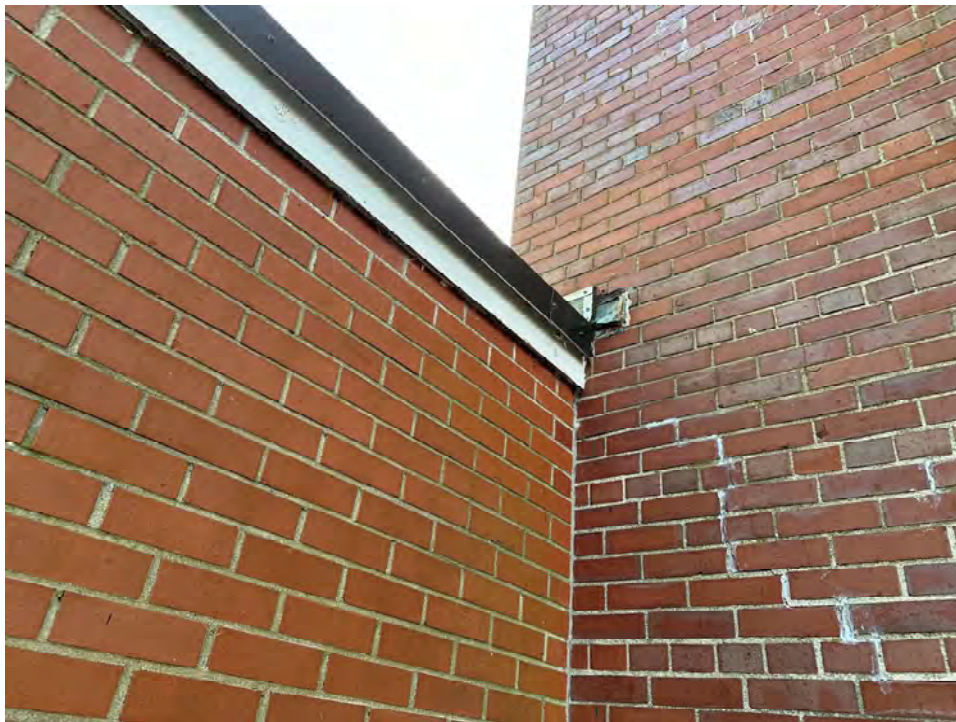
Photo 22: Newer roof flashing at top of west elevation wall at transition to Old Fire Hall building
