**TOWN OF LUNENBURG
RFP #TOL2024015**

REQUEST FOR PROPOSALS
Lunenburg Academy Roof Upgrades

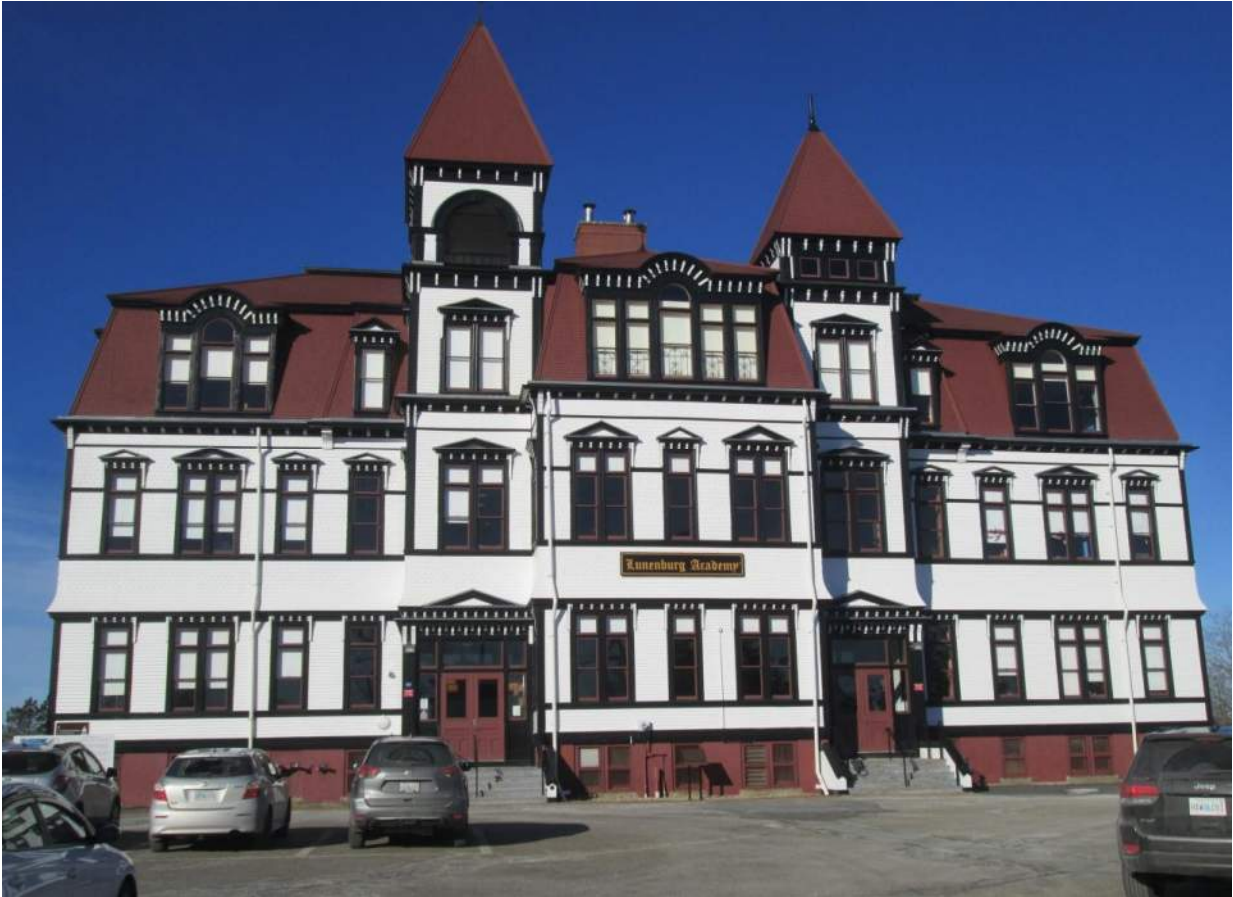
Figure 1 – East Elevation: Envelope restoration work completed in 2020. (does not include brick foundation wall)

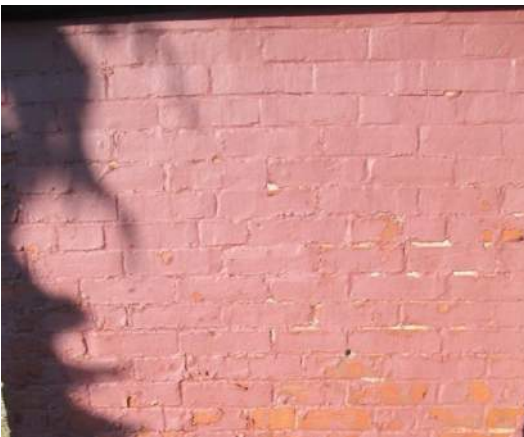
Figure 2 – Above grade brick foundation: far left-hand side (LHS) typical paint failures, peeled and cracked. Plug remains in wall from previous staging support, removal is recommended

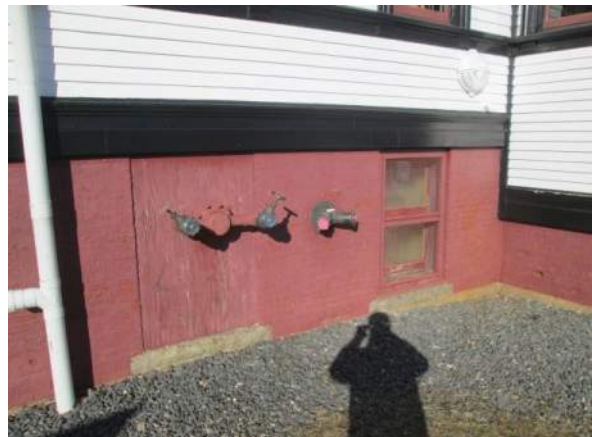
Figure 3 – Brick foundation wall with typical paint failures (peeled and cracked). Paint failure on plywood panel also.

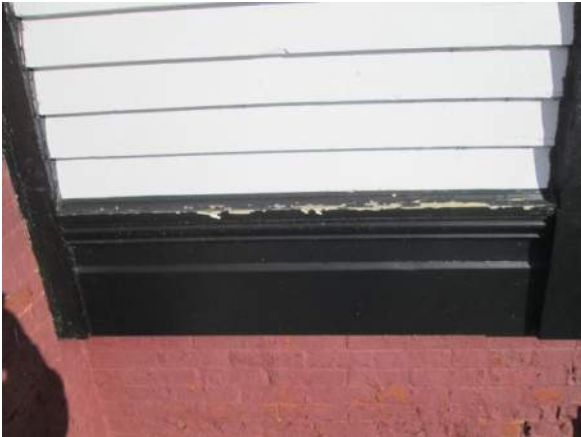
Figure 4 – Peeled paint on top of wood sill at LHS entry return.

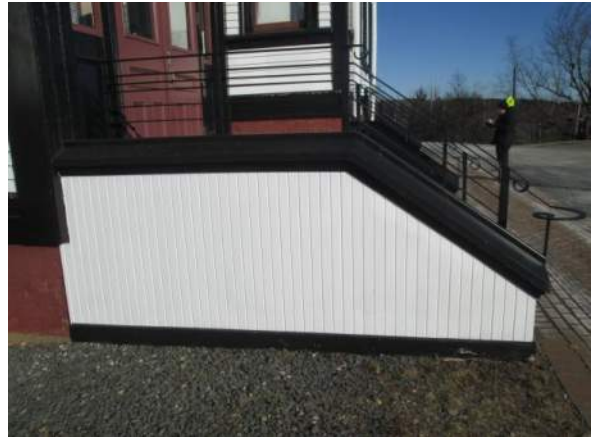
Figure 5 – LHS entry stair rebuilt in 2017 – good condition.

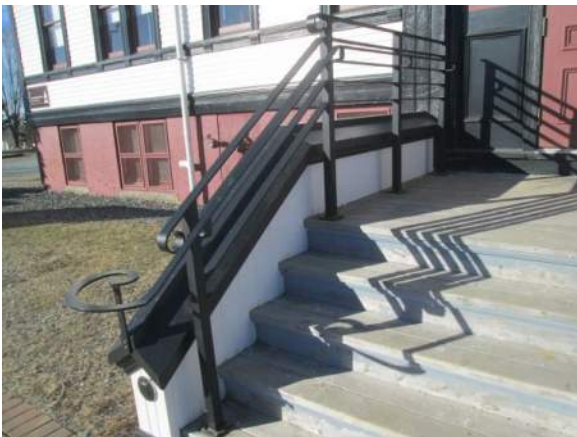
Figure 6 – Entry stair rebuilt in 2017, Guardrails installed in 2018 – good condition. Failed paint on steps and landing.

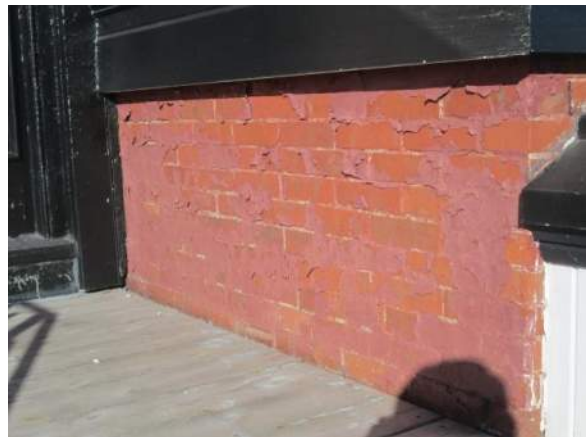
Figure 7 – Complete paint failure on brick foundation top of landing.

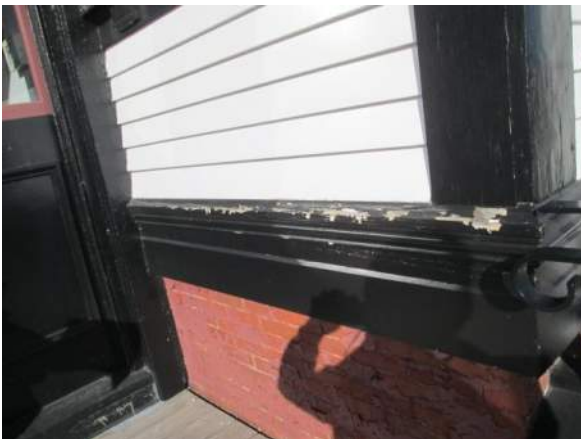
Figure 8 – Peeled paint on top of wood sill above brick foundation at LHS entry doors. This work completed in 2020.

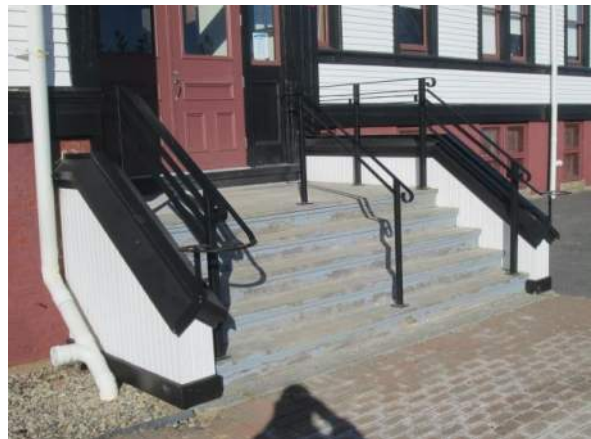
Figure 9 – RHS (right-hand side) Entry stair rebuilt in 2016, Guardrails installed in 2018 – good condition. Failed paint on steps and landing.

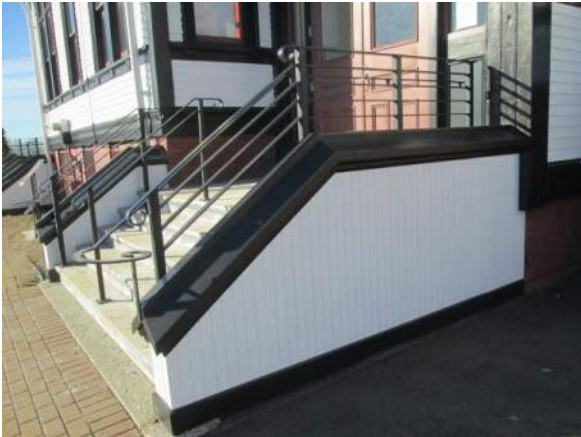
Figure 10 – RHS entry stair rebuilt in 2016 – good condition. Guardrails in 2018 – good condition.

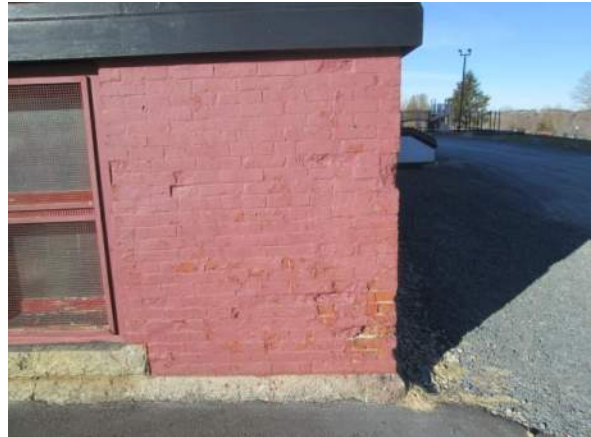
Figure 11 – Brick foundation at North-East corner, typical paint failure and heavy paint build up. Plug from staging support remains in brick and should be removed.

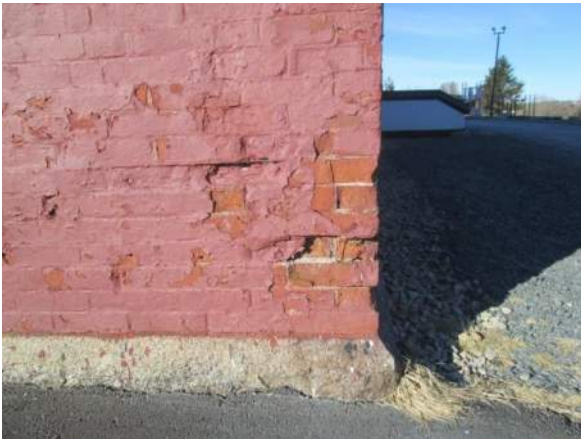
Figure 12 – North-East corner, broken & spalled brick. Typical heavy build up of paint and paint failure.

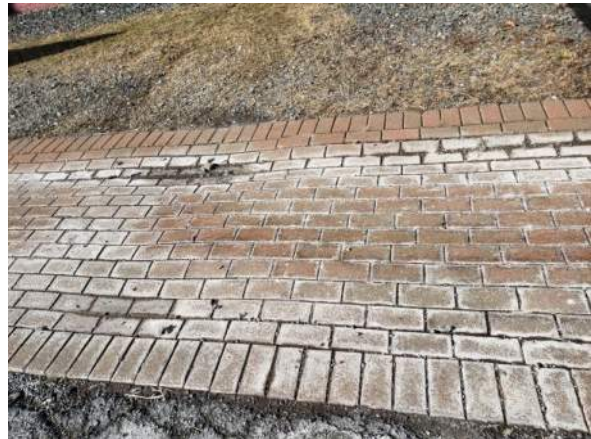
Figure 13 – Brick paver stone walkway. Sunken and “heaved” locations create an uneven walking surface, potential tripping hazard.

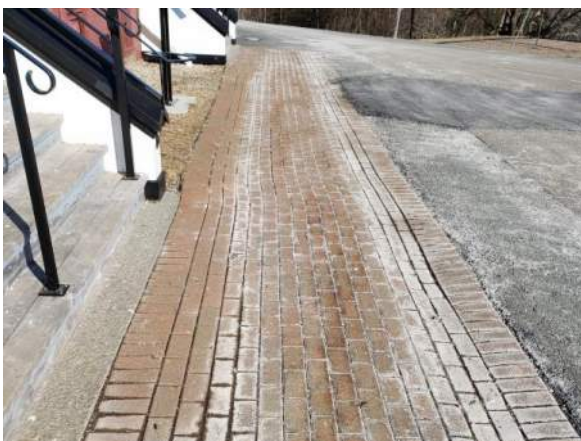
Figure 14 – Brick paver stone walkway. Sunken and “heaved” locations create an uneven walking surface, potential tripping hazard. Looking North.

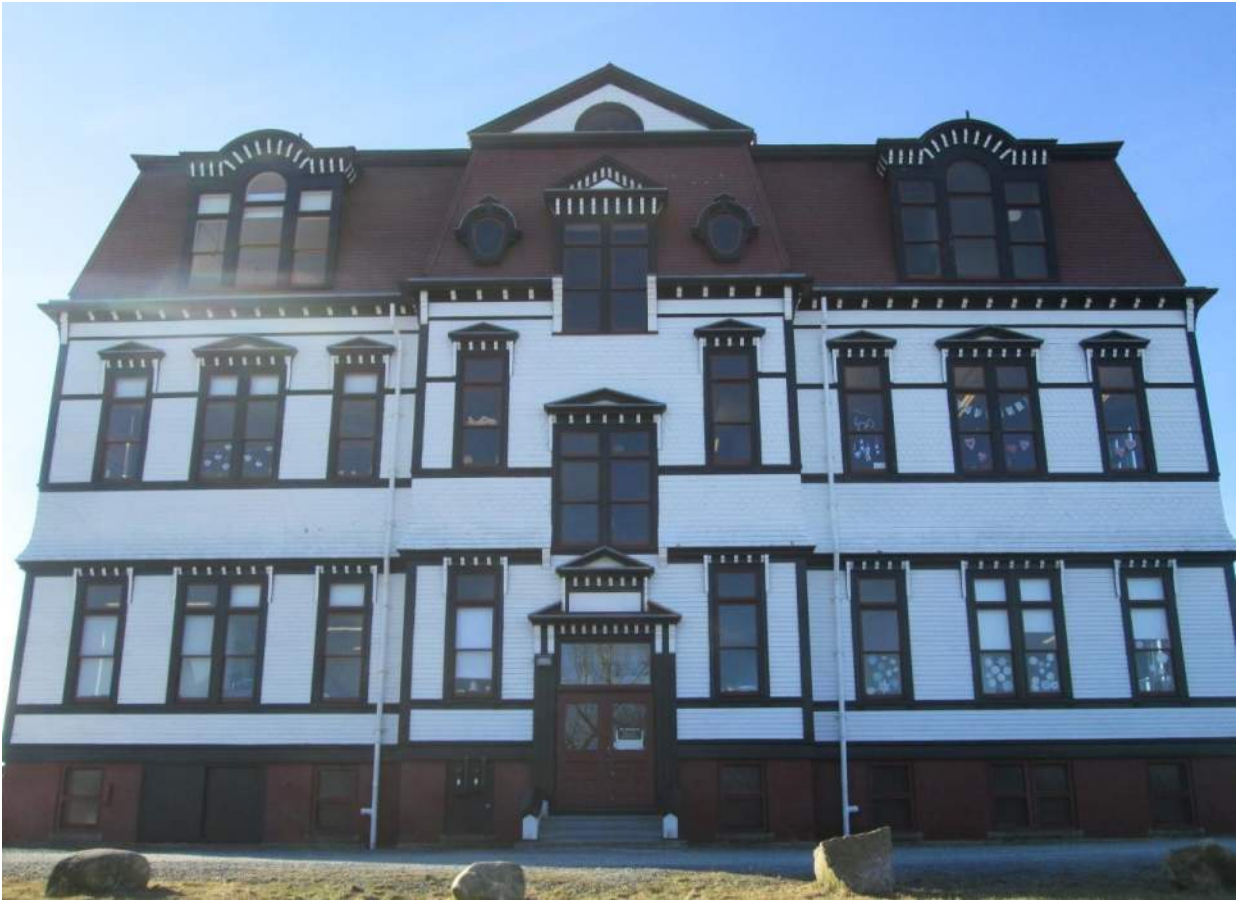
Figure 15 – North Elevation: Envelope restoration work completed in 2018. (does not include brick foundation wall)

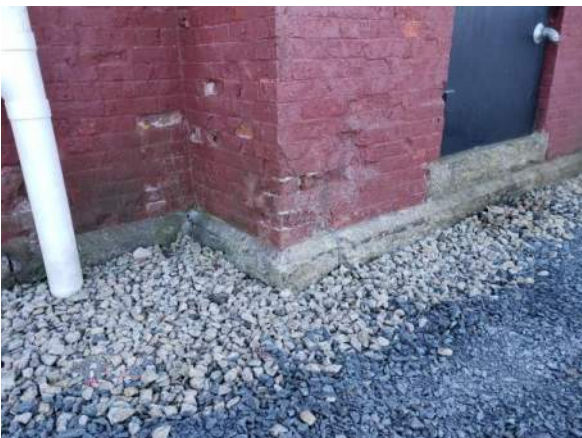
Figure 16 – Above grade brick foundation: brick is cracked, broken, and spalled. Typical paint failures include heavy build up plus peeling and cracking.

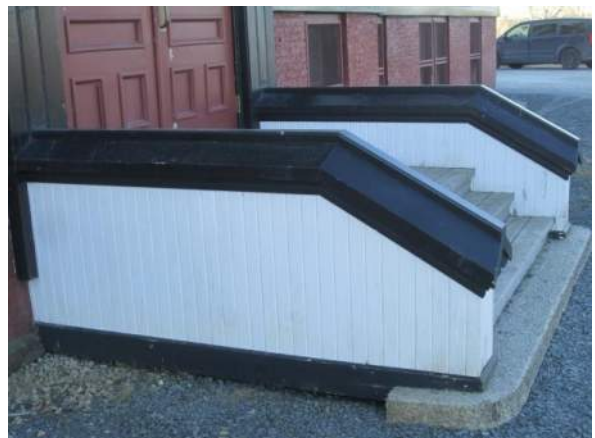
Figure 17 – Stairs to North doors rebuilt in 2016 - good condition.

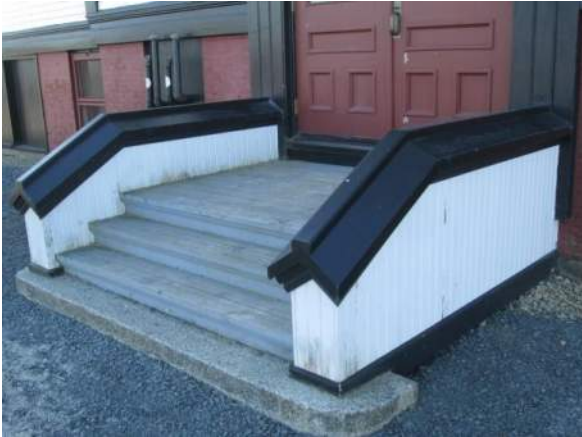
Figure 18 - Stairs to North doors rebuilt in 2016 - good condition. Steps and landing paint is worn off.

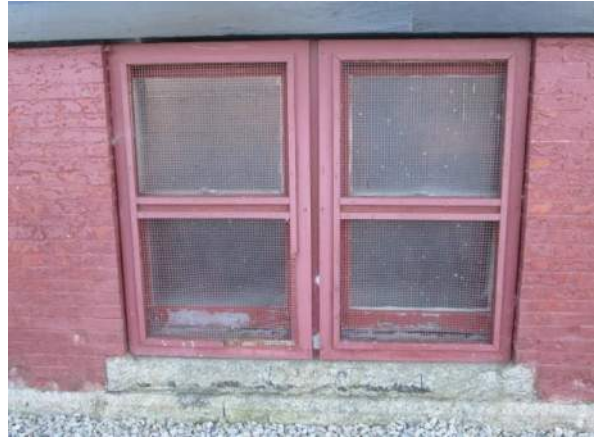
Figure 19 – Basement storm/security windows fairly poor condition. Typical at all locations on basement windows.

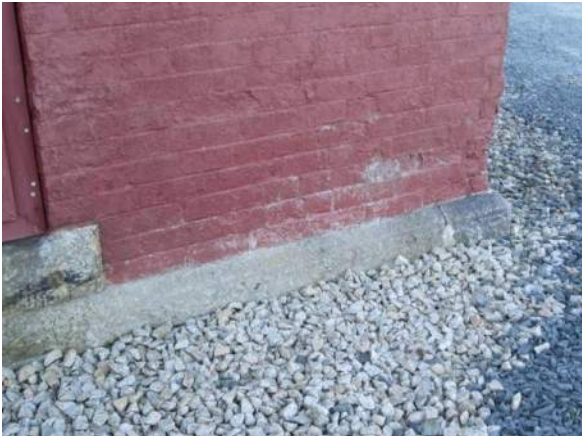
Figure 20 – Brick foundation, far RHS with spalled brick and failed paint finish – typical.

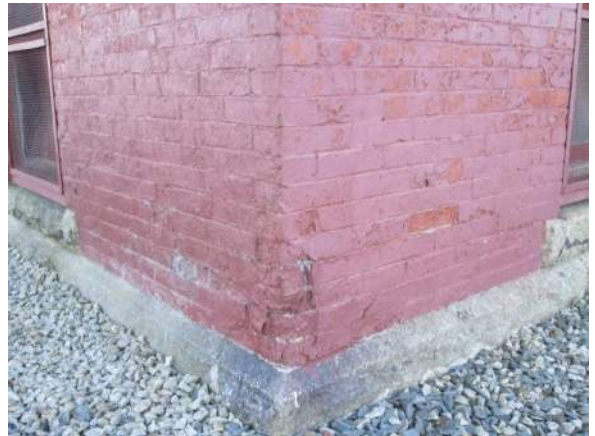
Figure 21 – North-West corner brick foundation: brick is broken, spalled and cracked. Typical paint conditions.

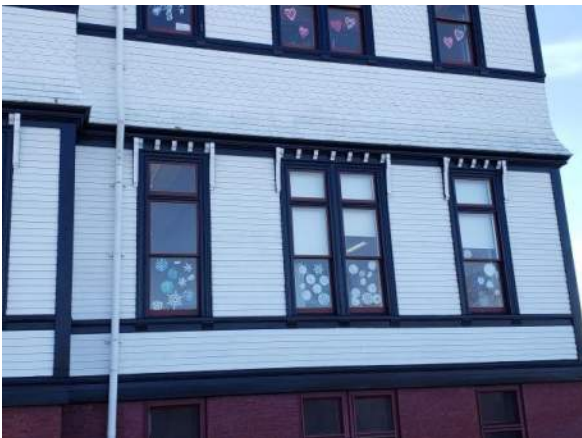
Figure 22 – Minor paint chipping and environmental staining on curved section of shingles above ground floor windows – typical across the North elevation.

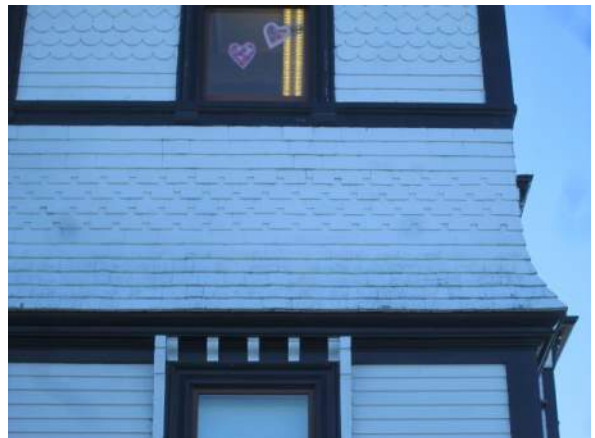
Figure 23 – Minor paint chips and environmental staining on curved section of shingles.

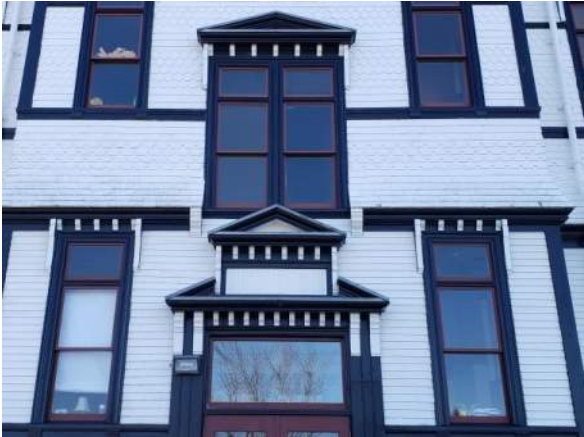
Figure 24 – Minor paint chips and environmental staining on curved section of shingles.

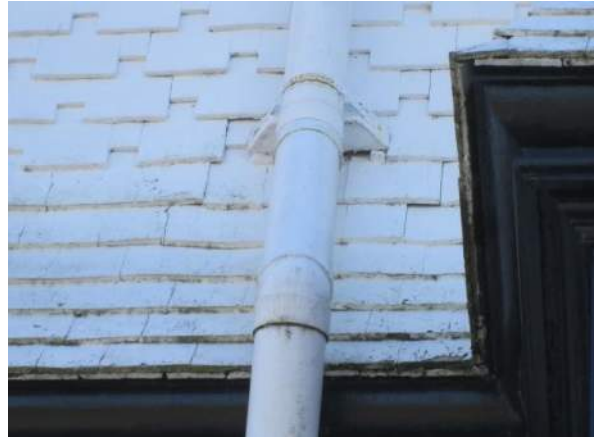
Figure 25 – Environmental staining.

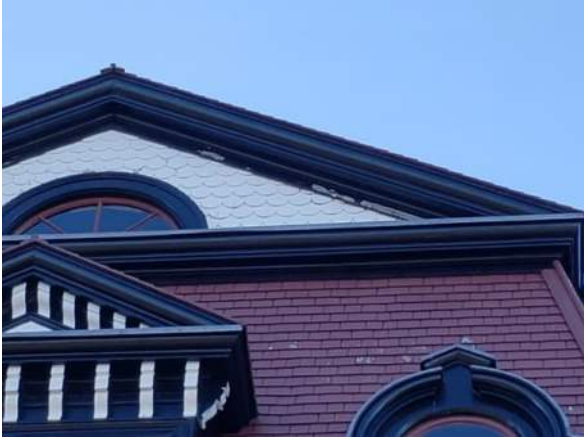
Figure 26 – Paint peeled at gable trim and some locations of stain failures on red roof shingles.

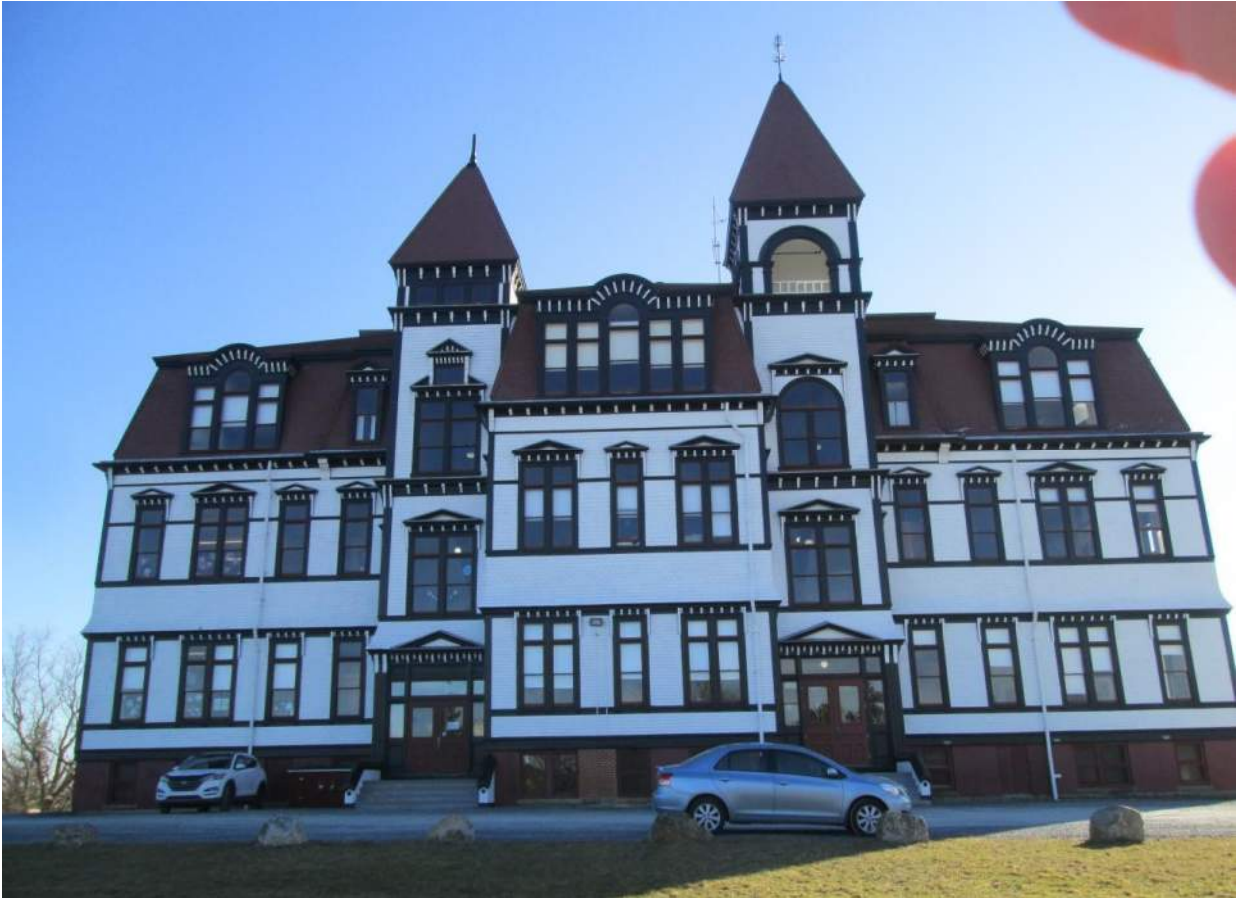
Figure 27 – West Elevation: Envelope restoration work completed in 2018. (does not include brick foundation wall)

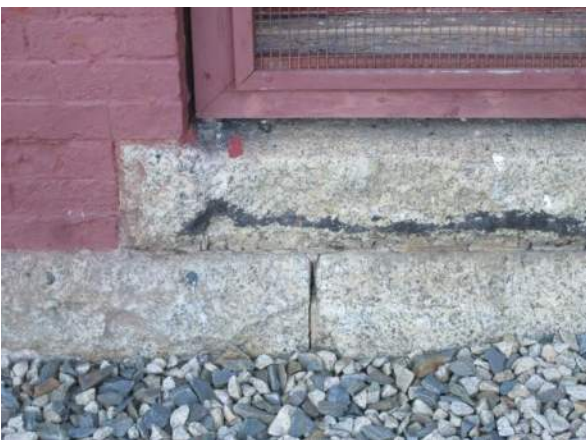
Figure 28 – Open joint in stone band below stone sill on far LHS basement window.

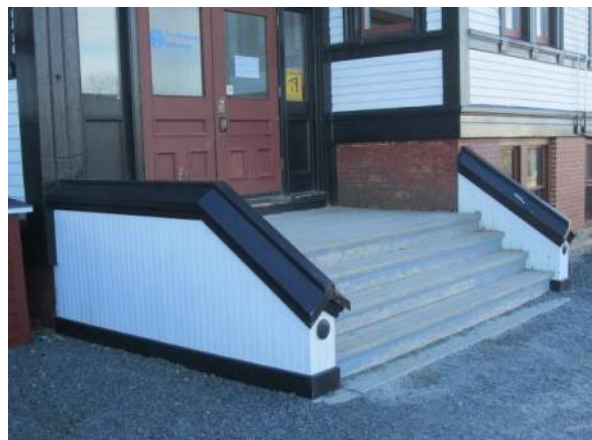
Figure 29 – Entry stair LHS rebuilt in 2016 – good condition. Paint on steps and landing is worn.

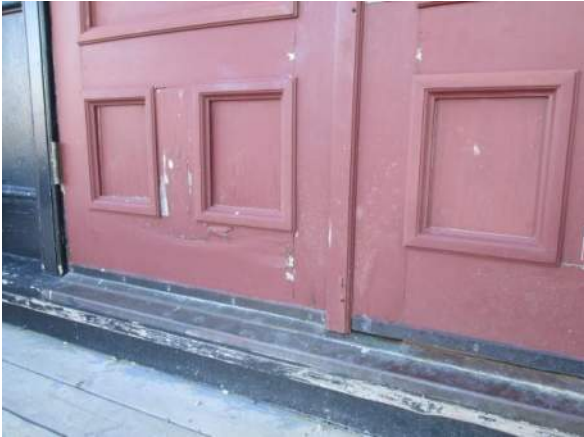
Figure 30 – Doors refinished in 2018. Gaps at threshold and between doors. Paint failure on doors and wood sill.

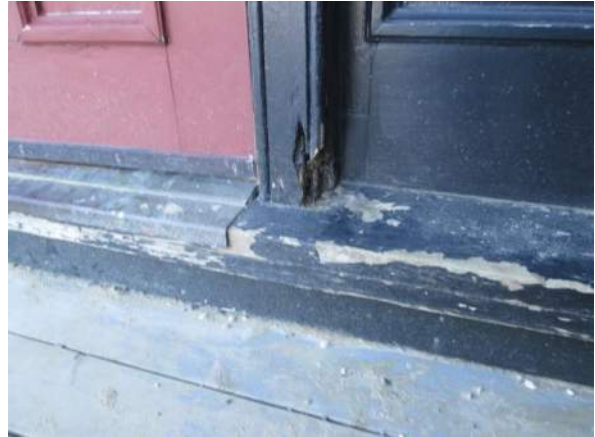
Figure 31 – Location of rot not repaired in 2018. Peeling paint on wood sill.

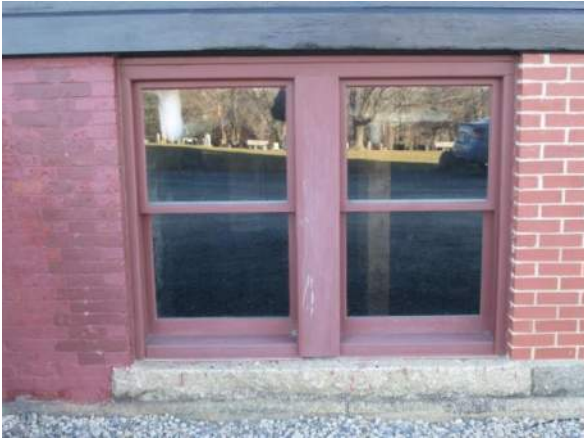
Figure 32 – New windows installed in 2018 – faded paint.

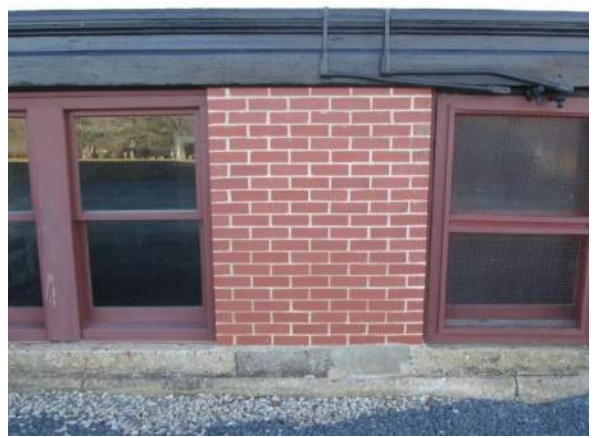
Figure 33 – New brick foundation wall section re-installed in 2018 when old access doors used to be.

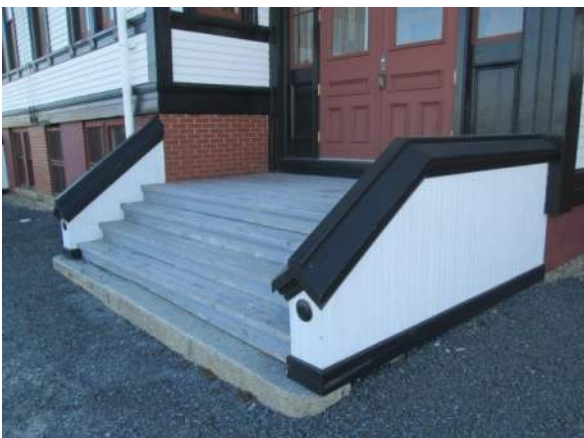
Figure 34 – Entry stair RHS rebuilt in 2016 – good condition. Paint on steps and landing is worn.

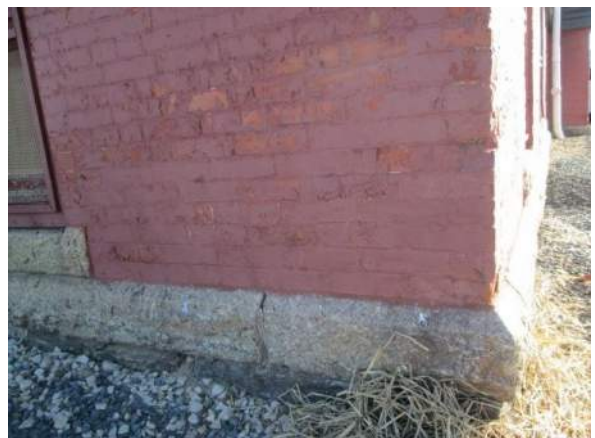
Figure 35 – Small open joint in stone band. Spalled brick and typical paint failure on brick foundation: South-West corner.

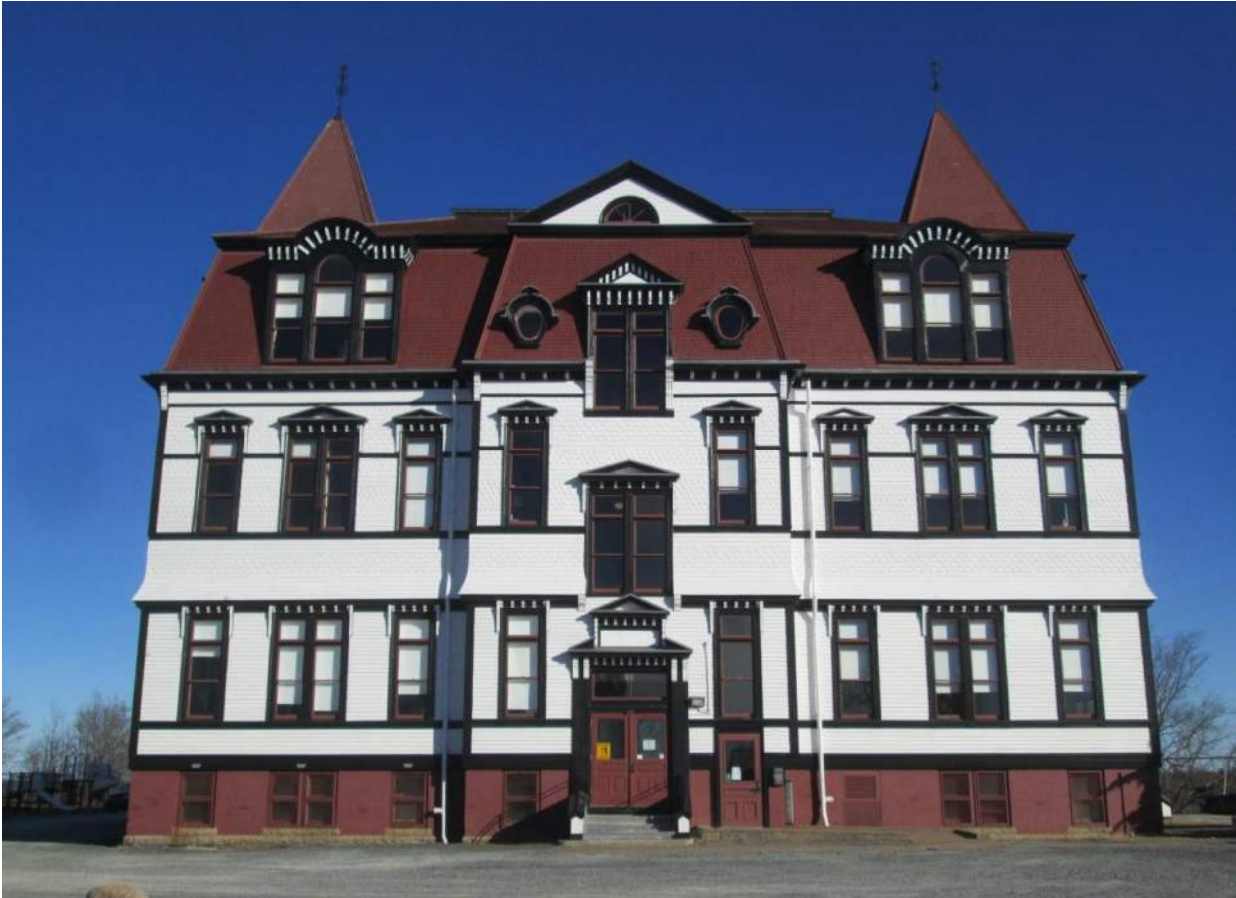
Figure 36 – South Elevation: Envelope restoration work completed in 2018. (does not include brick foundation wall)

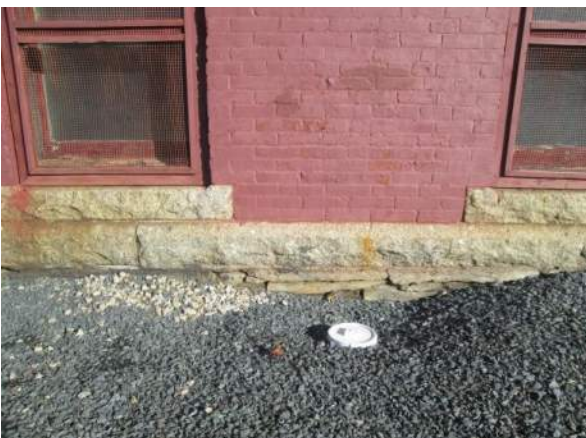
Figure 37 – Open joint in stone band below stone sill and large open joints in exposed foundation stones below band. Typical paint conditions on brick foundation wall.

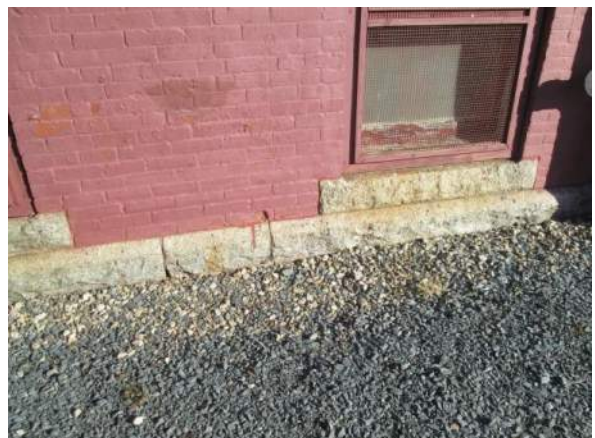
Figure 38 – Spalled brick and typical paint failures. Open joint in stone band below brick.

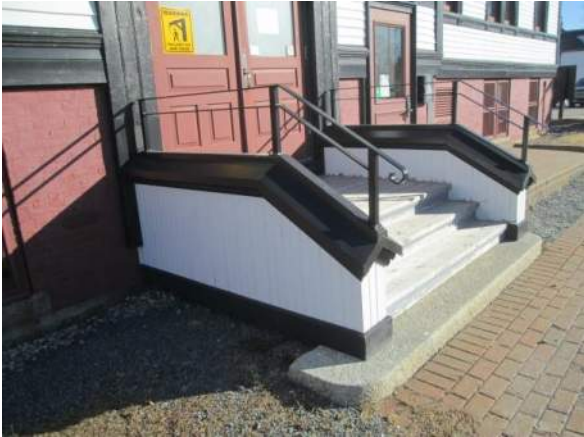
Figure 39 – Stair rebuilt in 2016 and guardrails installed in 2018 – good condition.

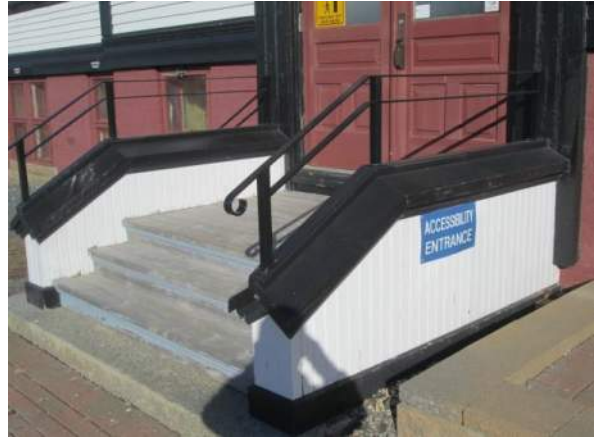
Figure 40 Stair rebuilt in 2016 and guardrails installed in 2018 – good condition.

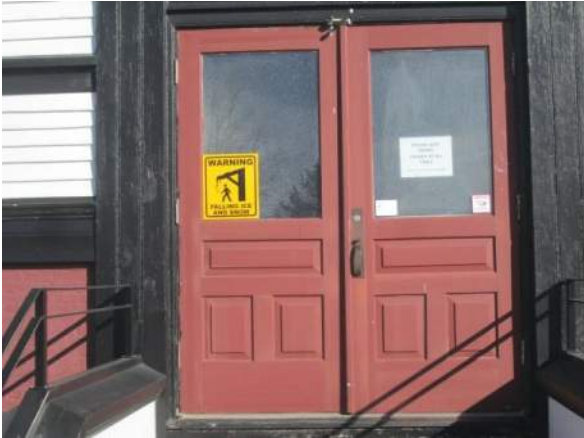
Figure 41 – Doors re-finished in 2018.

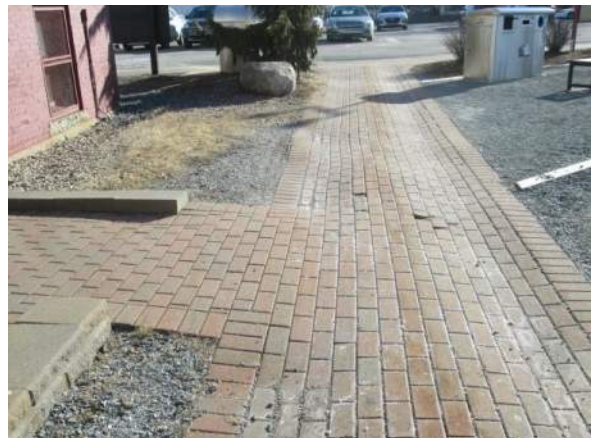
Figure 44 – Brick paver sidewalk from South “accessible” entrance: Heaving and sunken areas. Potential tripping hazard.

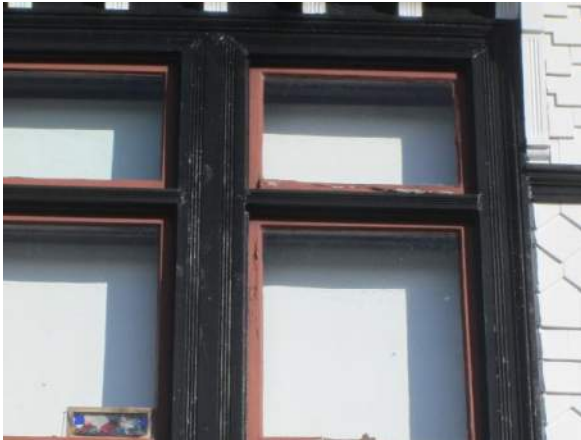
Figure 45 – Paint failure on upper transom sash.

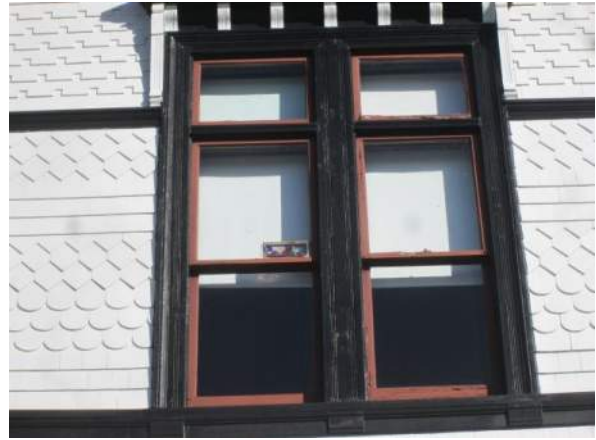
Figure 46 – Paint failure on transom, upper and lower sash on right hand side.

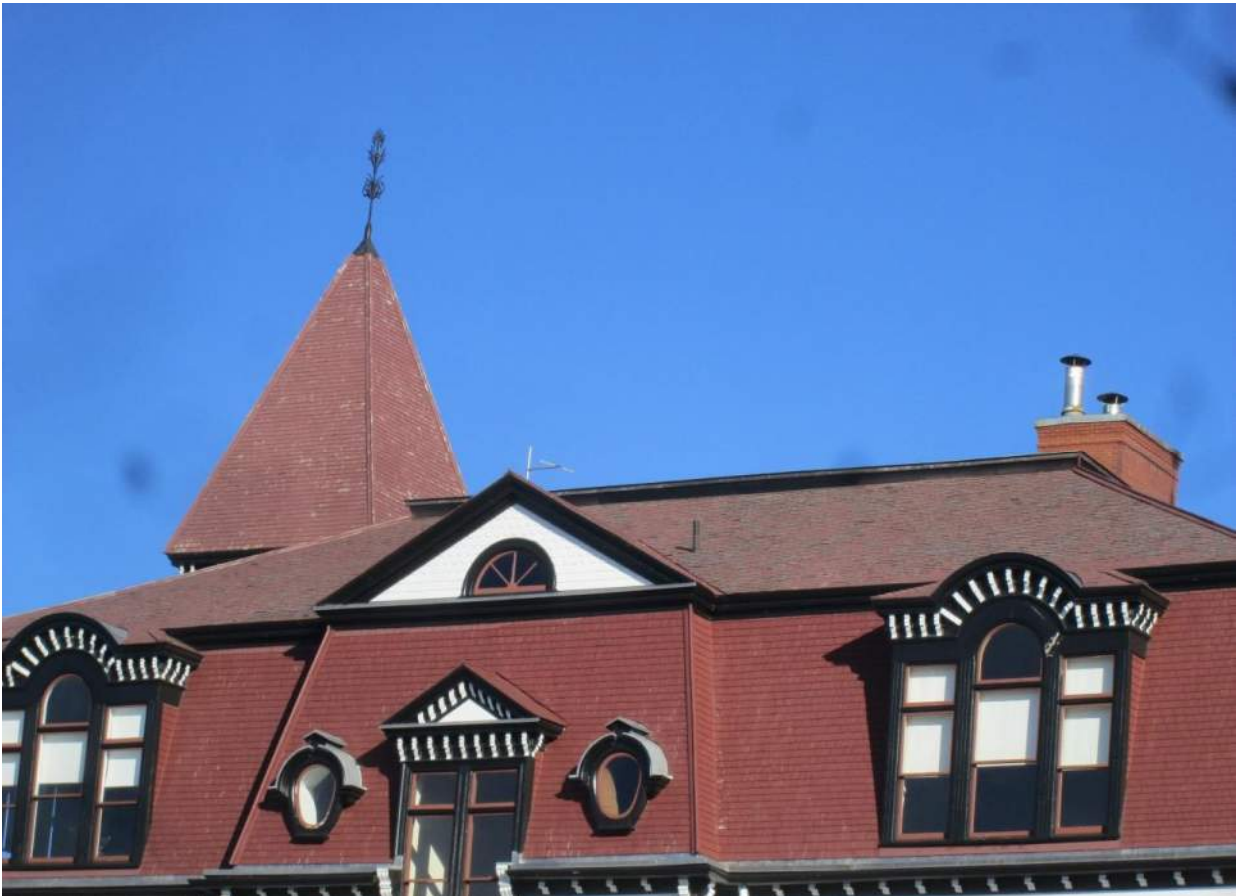
Figure 47 – South Elevation: Mansard Roof. Upper section of mansard roof replaced in 2018. Appears that stain is failing. Tower roof beyond also exhibits signs of faded and worn finish stain.

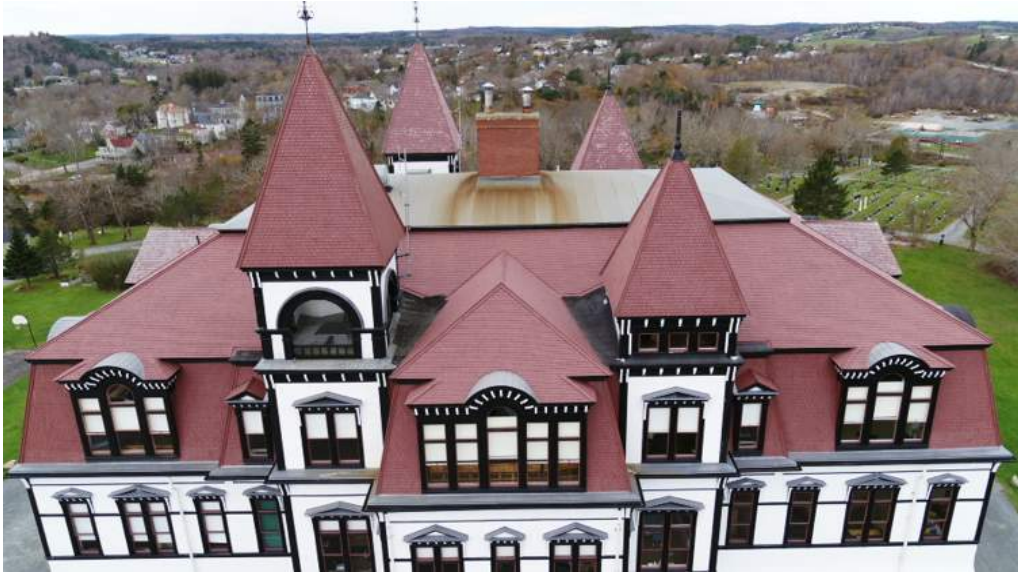
Figure 48 – East Elevation. Overall view

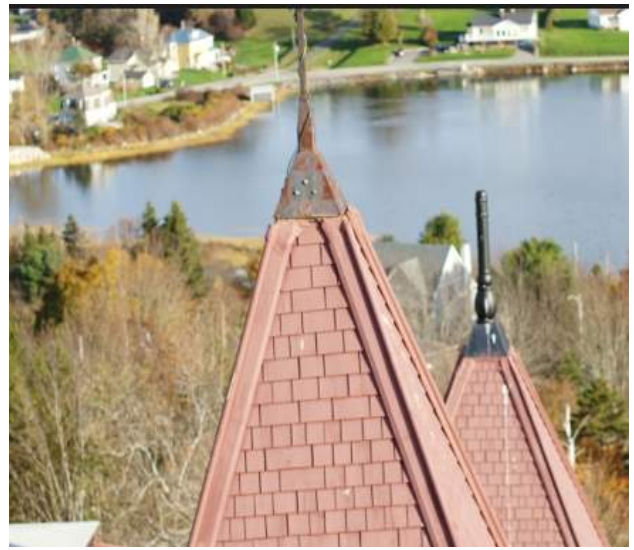
Figure 54 – Tower 3. The top metal element has significant rust on the surface

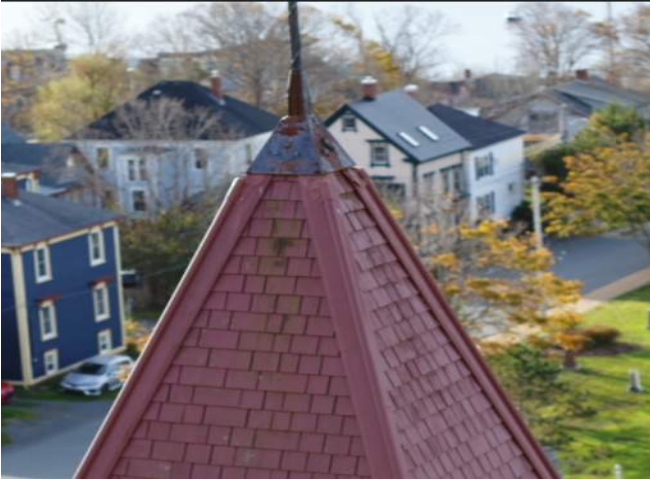
Figure 55 – Tower 3. North Elevation. Shingles at the top areas of the Tower roof are covered with mold

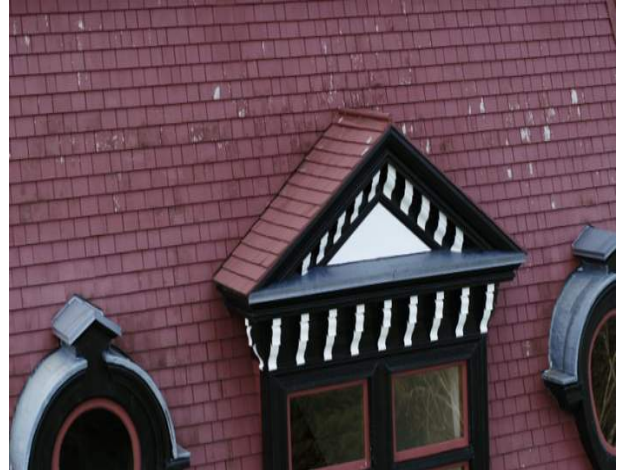
Figure 56 – South elevation. Areas with mold and peeled and faded Red Stain

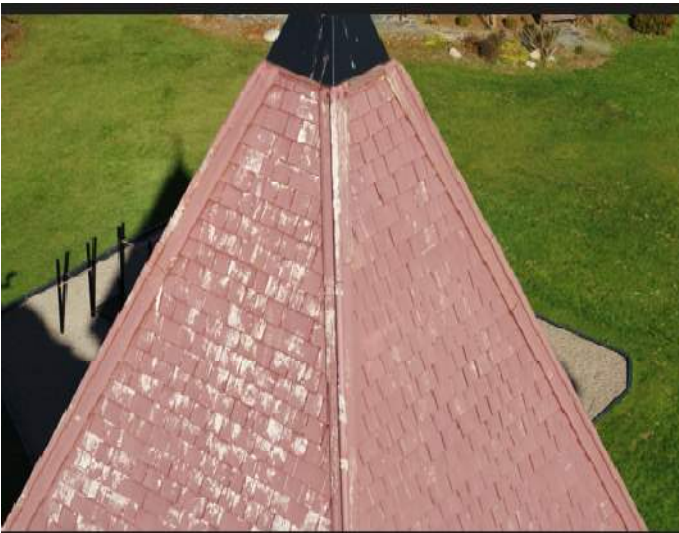
Figure 57 – Tower 2. South Elevation. A significant area of peeling and faded Red Stain

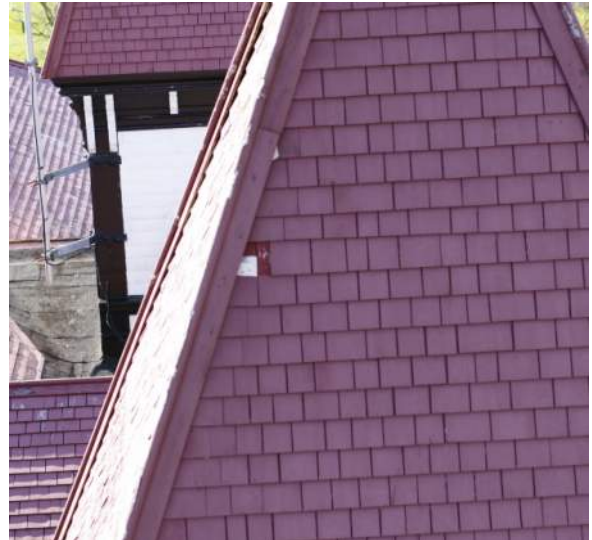
Figure 58 – Tower 2. North Elevation. Area with the missing shingles, which can be a possible cause of rainwater penetration.

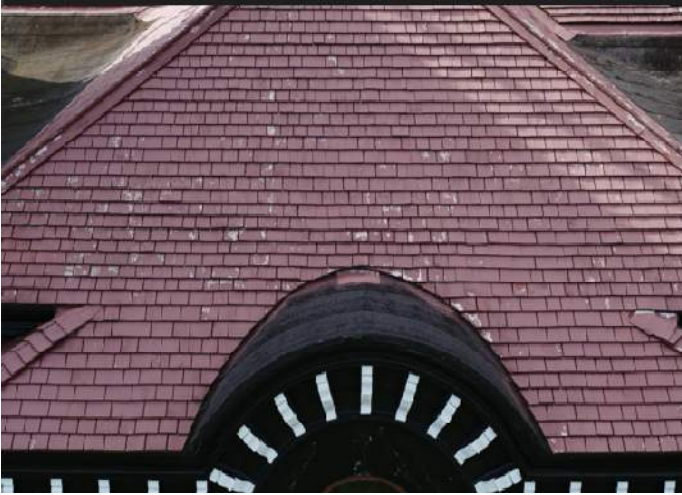
Figure 59 – West elevation. Areas with peeled and faded Red Stain

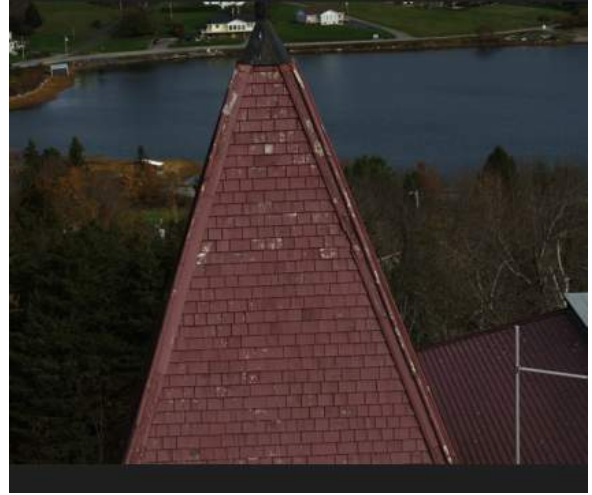
Figure 60 – Tower 1. South elevation. A significant areas of peeled and faded Red Stain

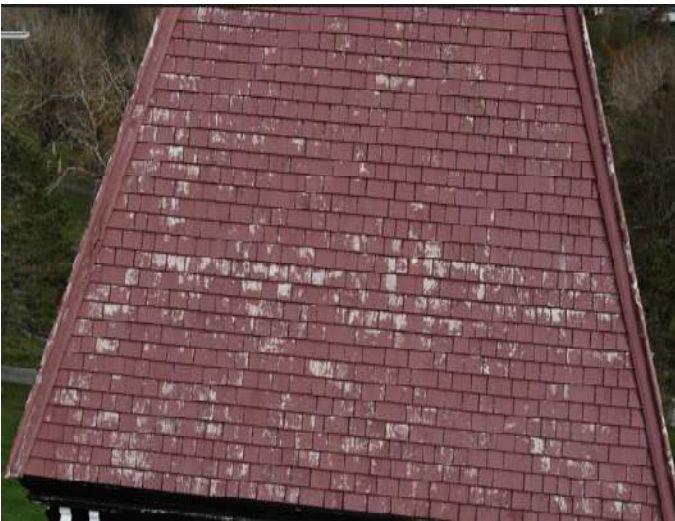
Figure 61 – Tower 1. East elevation. A significant areas of peeled and faded Red Stain

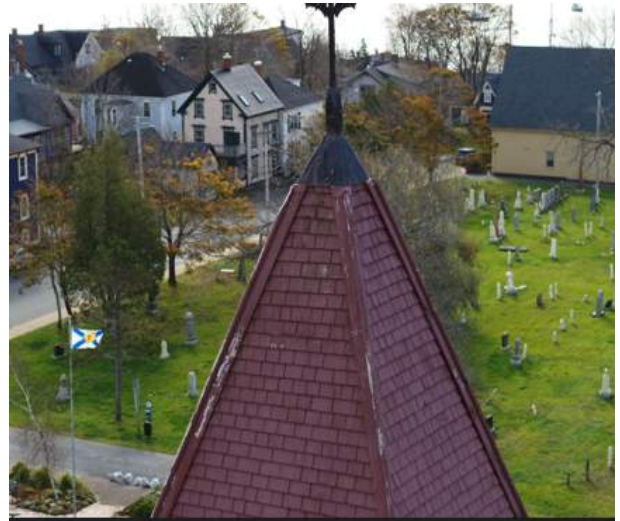
Figure 62 – Tower 1. North Elevation. Shingles at the top areas of the Tower roof are covered with mold. Some areas of peeled and faded Red Stain

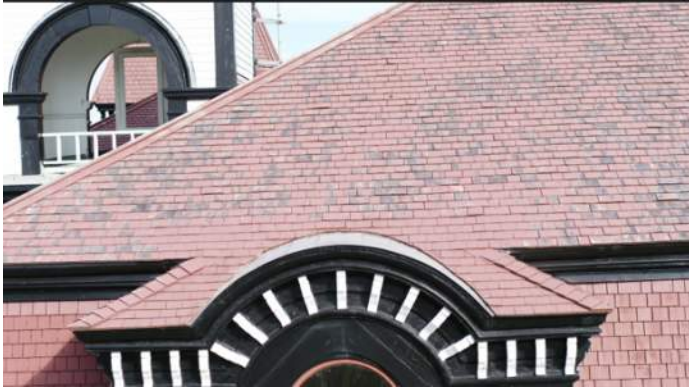
Figure 63 – South Elevation (left side). A significant areas of peeled and faded Red Stain

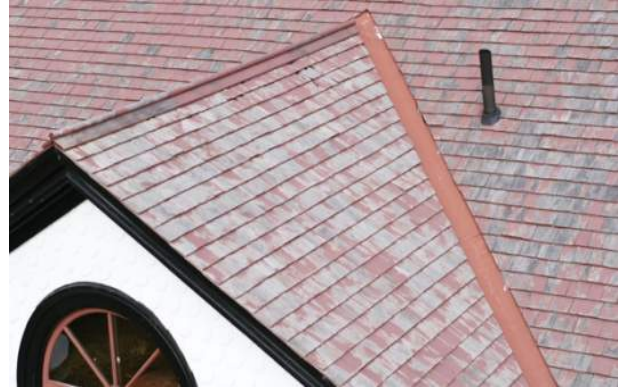
Figure 64 – South Elevation (center). A significant areas of peeled and faded Red Stain

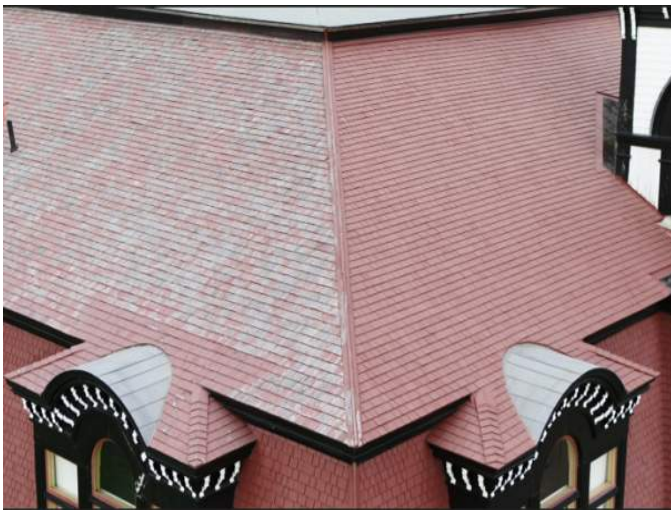
Figure 65 – South Elevation (right side). A significant area of peeled and faded Red Stain

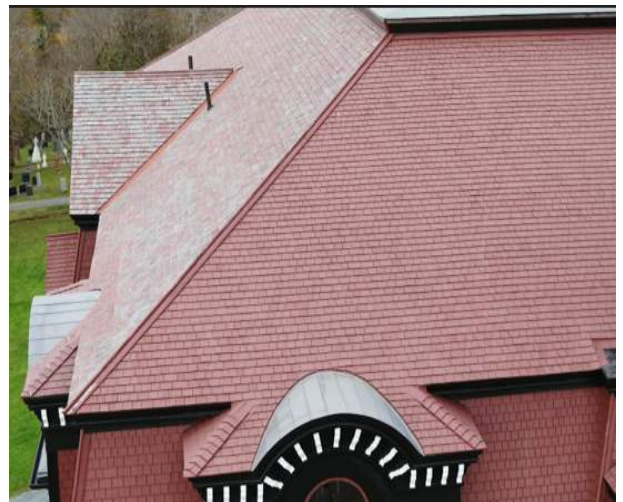
Figure 66 – East Elevation (left side). The Roof condition is satisfactory."

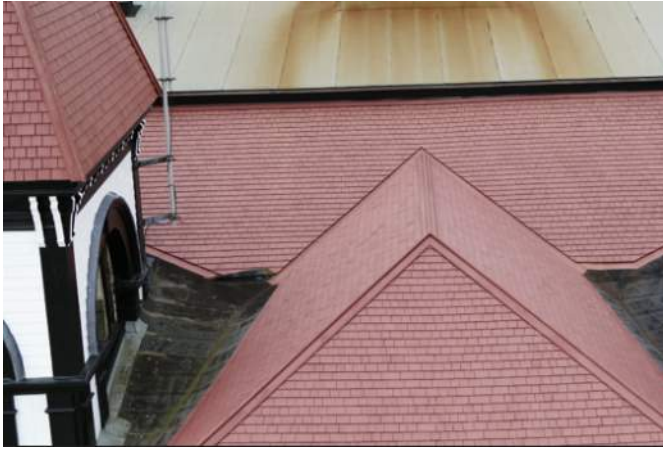
Figure 67 – East Elevation (center). The Roof condition is satisfactory.

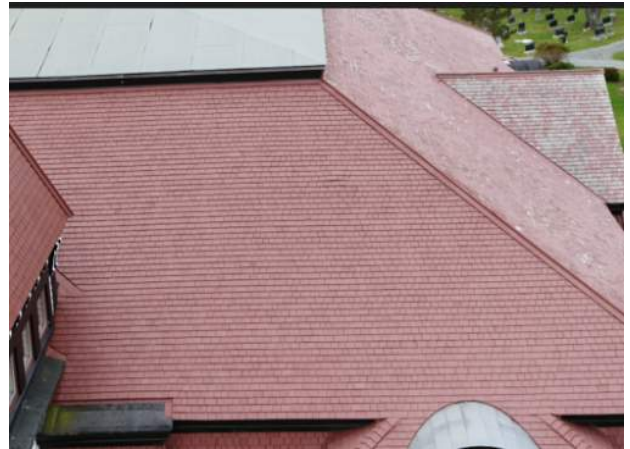
Figure 68 – East Elevation (left side). The Roof condition is satisfactory.

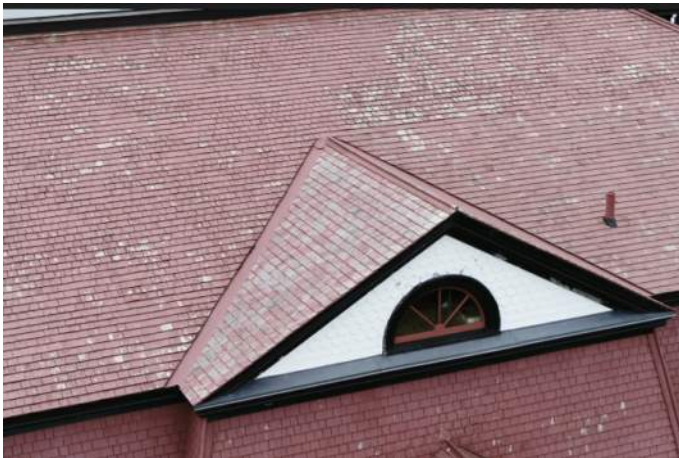
Figure 69 – North Elevation (Center-view1). A significant areas of peeled and faded Red Stain
