**TOWN OF LUNENBURG
RFP #TOL2024015**

REQUEST FOR PROPOSALS
Lunenburg Academy Roof Upgrades

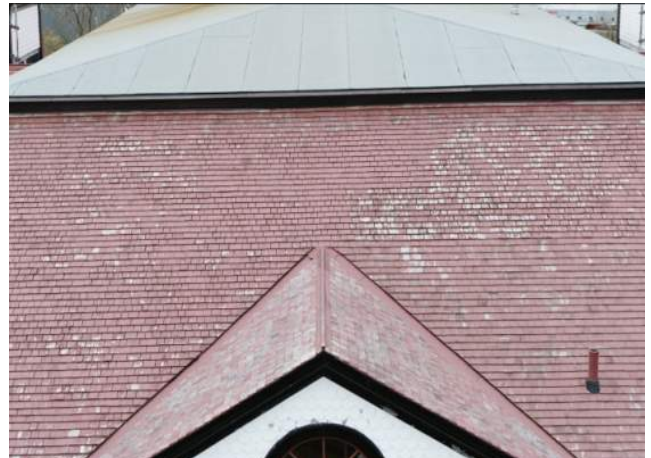
Figure 70 – North Elevation (Center-view2). A significant areas of peeled and faded Red Stain

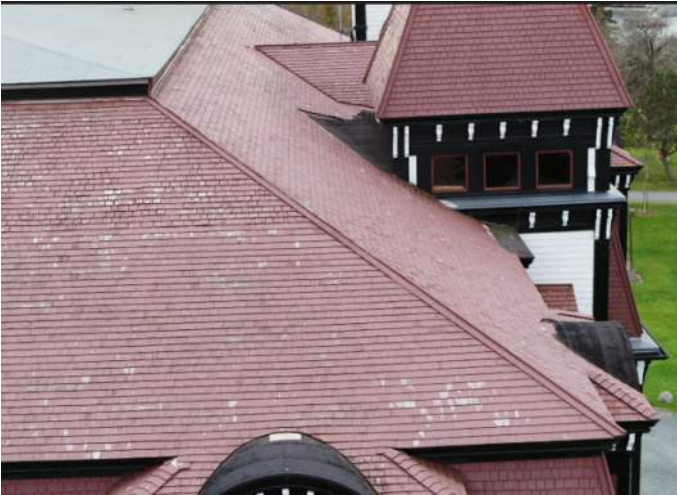
Figure 71 – North Elevation (Right side). A significant areas of peeled and faded Red Stain

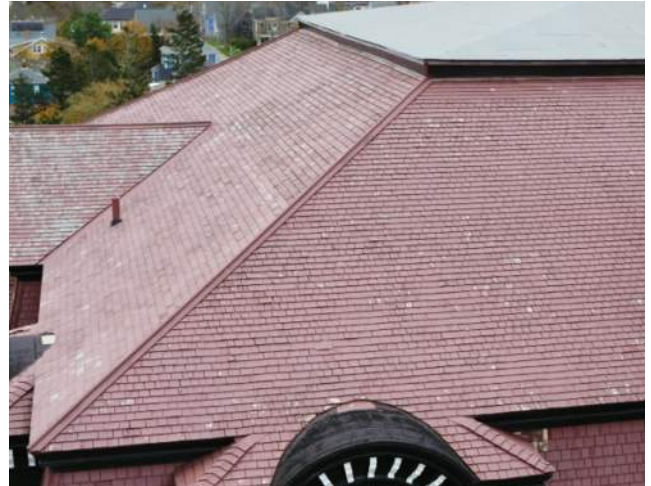
Figure 72 – West Elevation (Left side). Some areas of peeled and faded Red Stain

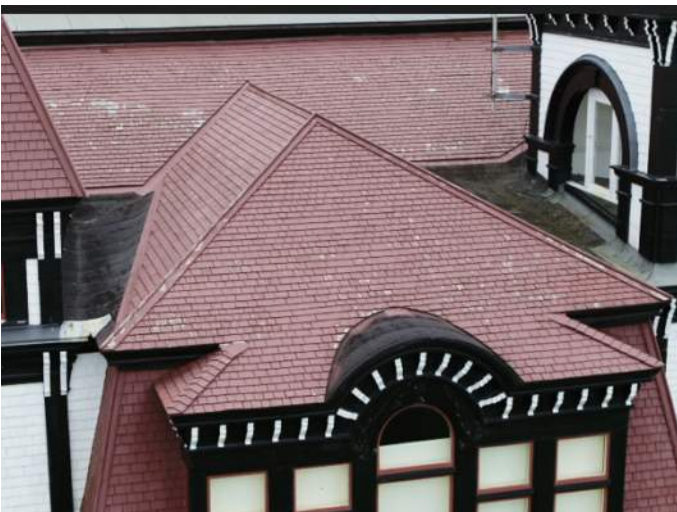
Figure 73 – West Elevation (Center). Some areas of peeled and faded Red Stain

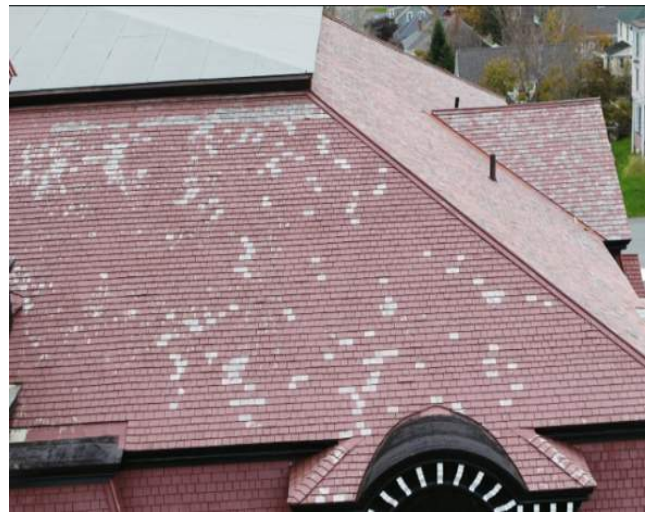
Figure 74 – West Elevation (Right side). Significant areas of peeled and faded Red Stain

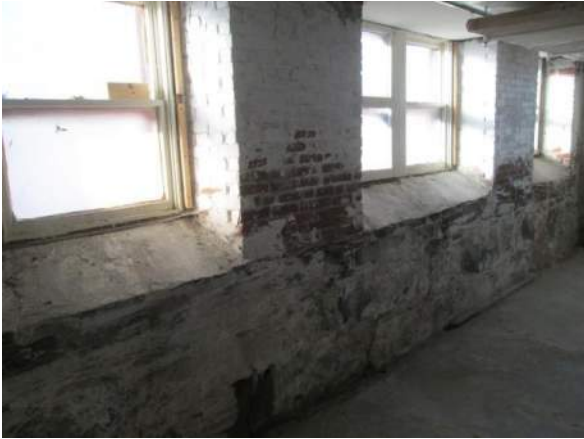
Figure 75 – Paint failure in brick section of foundation wall. Paint failure on lower stone section of wall also locations of efflorescence.

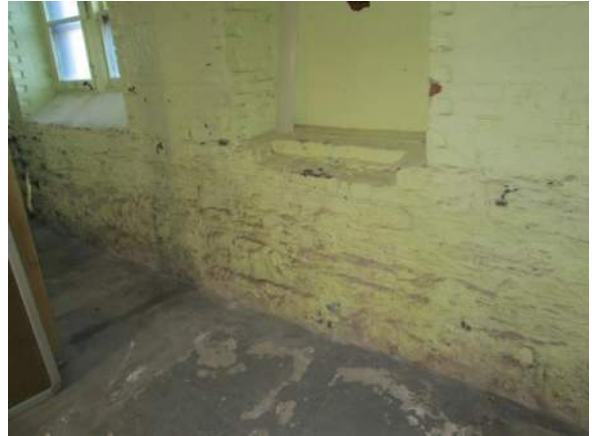
Figure 76 – Typical new heavy timber post(s) found throughout basement. Installed prior to renovations for new library above.

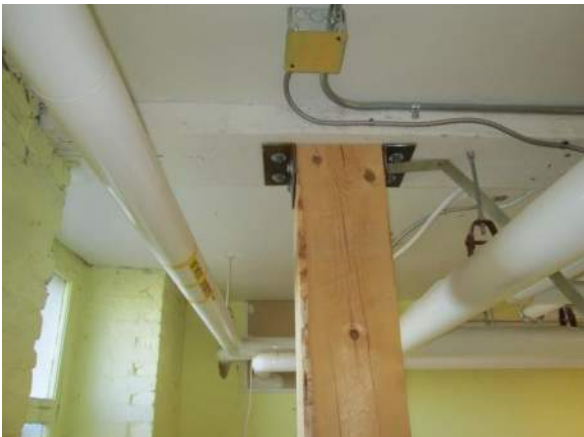
Figure 77 – New door in 2020 and new door operator panel. Painted brick and foundation wall. Appears to be in good condition, no wet locations

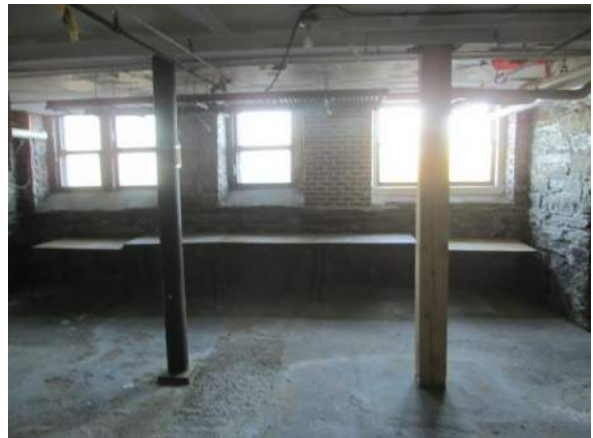
Figure 78 – Room B24: looking West.

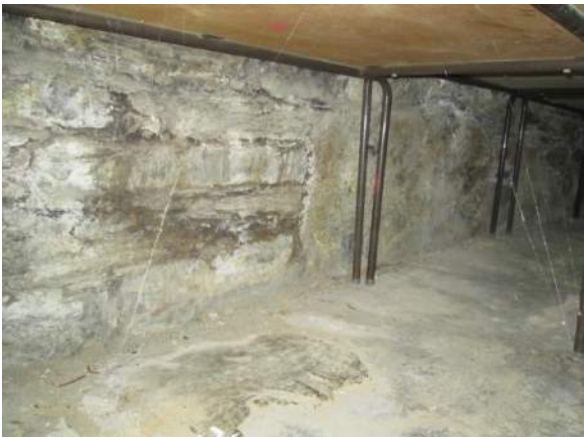
Figure 79 – Stone foundation wall below windows show some locations of efflorescence.

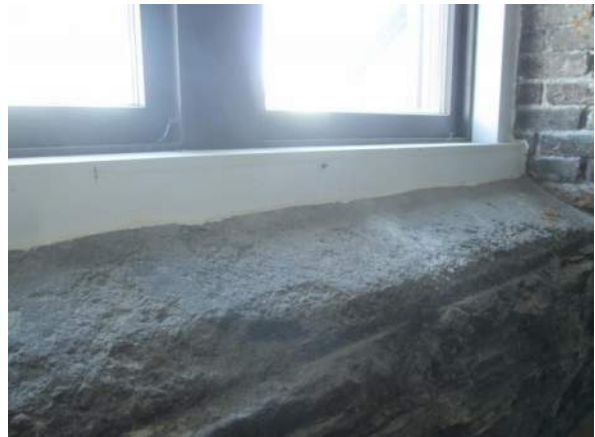
Figure 80 Stone sill with new windows installed in 2018. Also see photo 32.

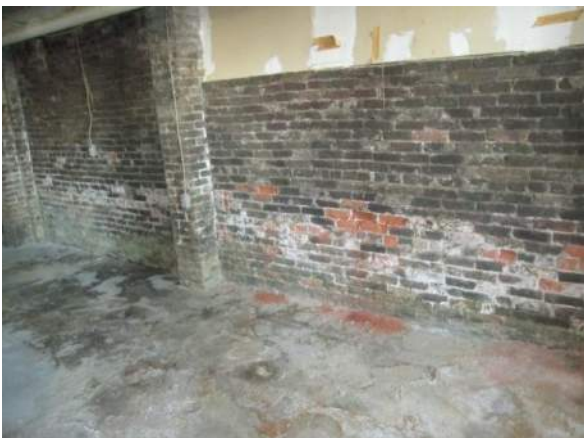
Figure 83 – Interior brick wall in room B24, rising damp at base bricks and deteriorating/crumbling brick above.

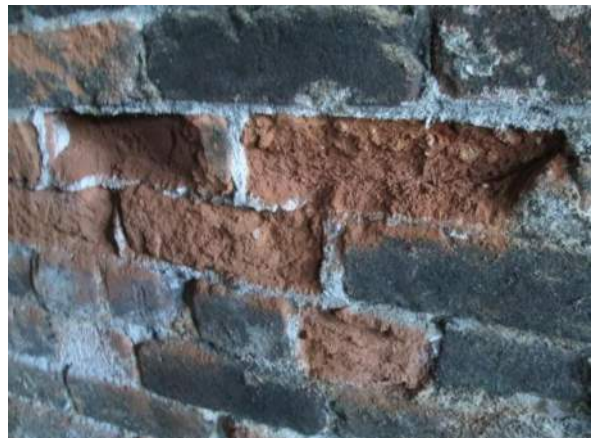
Figure 84 – Deteriorating / crumbling brick.

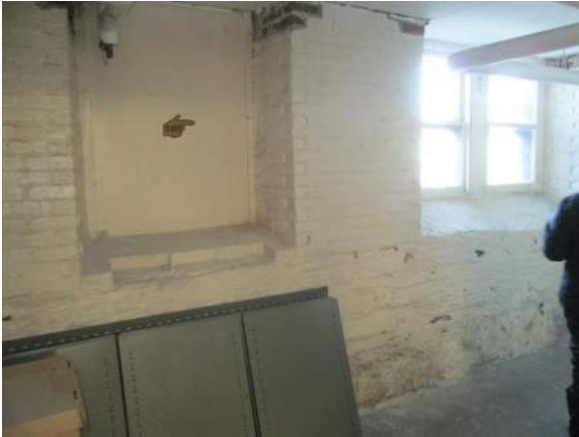
Figure 85 – Foundation wall outside former boys washroom: No wet or damp locations noted

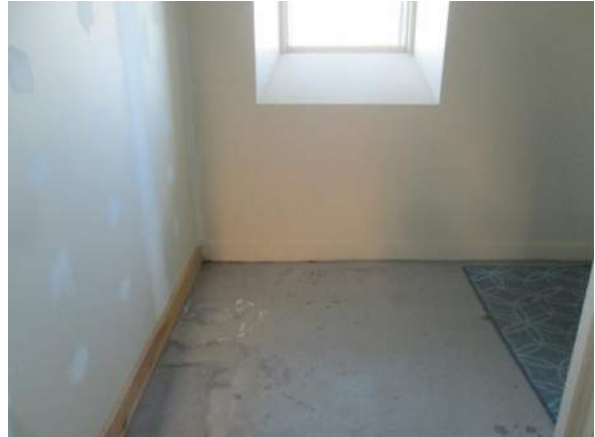
Figure 86 – Inside former washroom space: room is dry with no damp / wet locations noted .

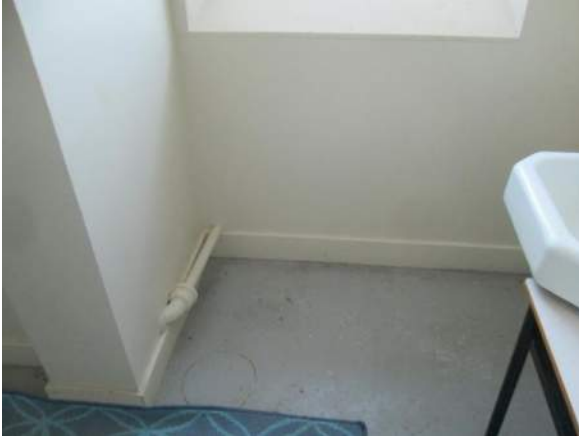
Figure 87 – Inside former washroom space: room is dry with no damp / wet locations noted.

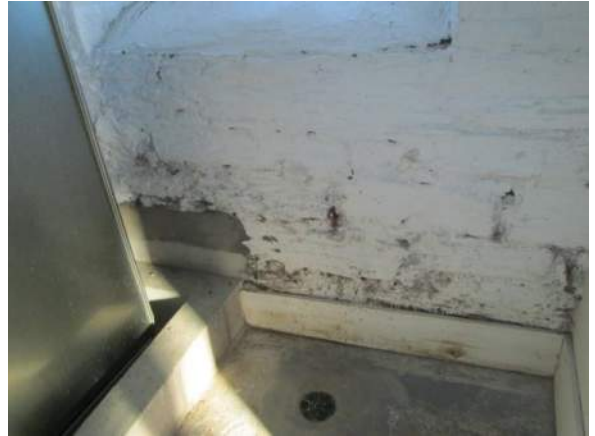
Figure 88 – Oil tank storage room: Newer drain installed to keep water from sitting. Section of wall beyond in wet.

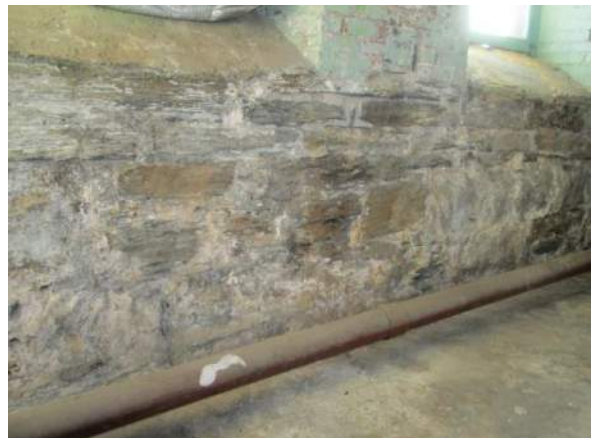
Figure 90 – Room B27 wall is dry and appears to be in good condition.

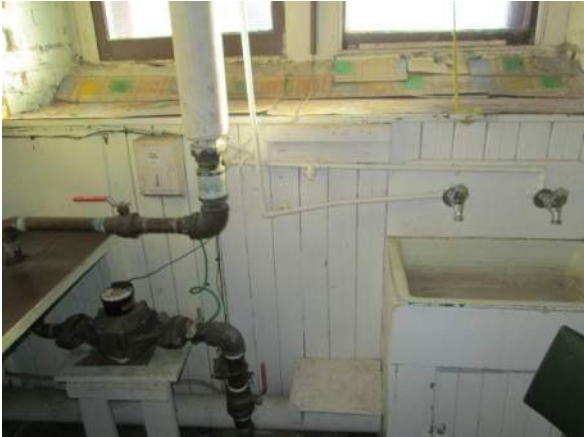
Figure 91 – Room B26 wood sill and knee-wall built over stone foundation wall.

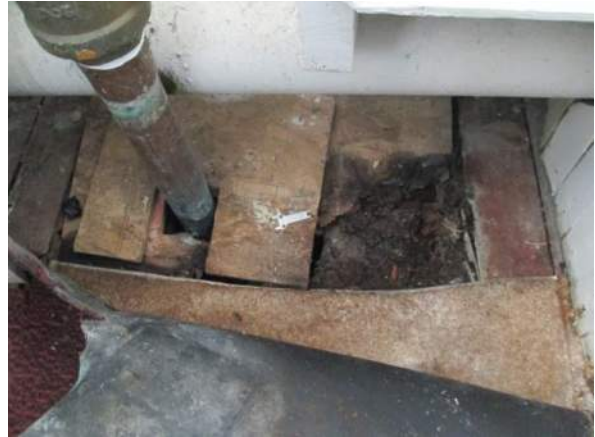
Figure 92 – Hole in floor at base of knee-wall – wet wood is soft.

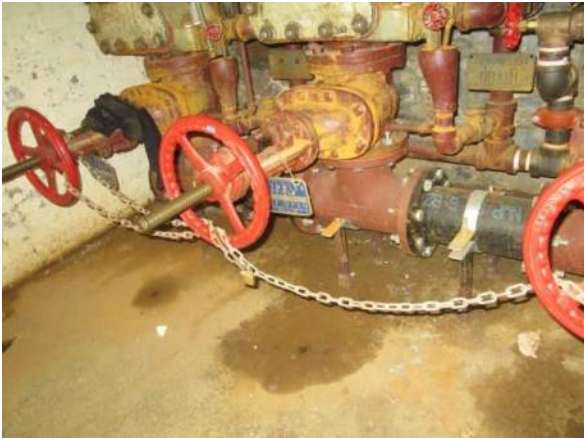
Figure 93 – Room B25: water on floor against foundation wall.

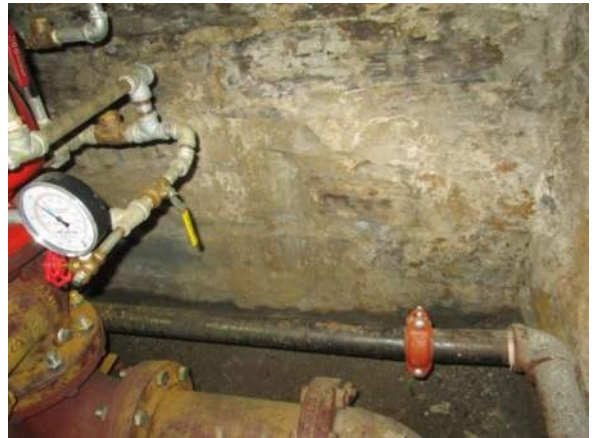
Figure 94 – Room B25: damp section on floor against foundation wall.

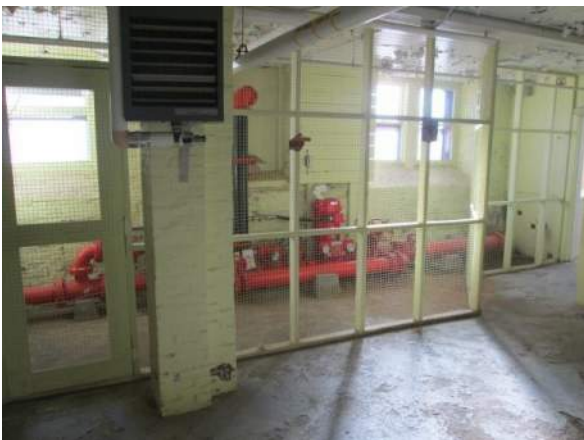
Figure 95 – Sprinkler pump against west wall.

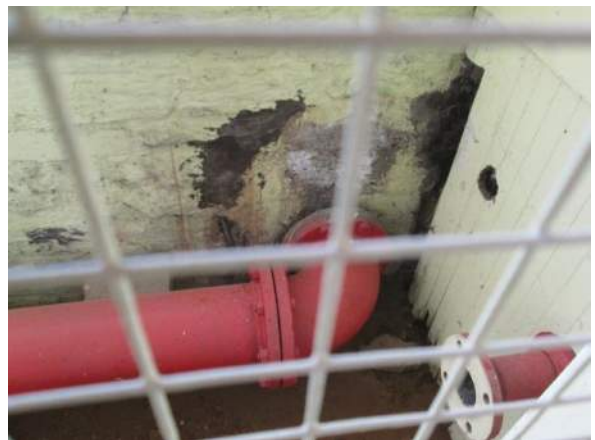
Figure 96 – Sprinkler pump line through stone foundation wall. Wall and floor appear to be damp.

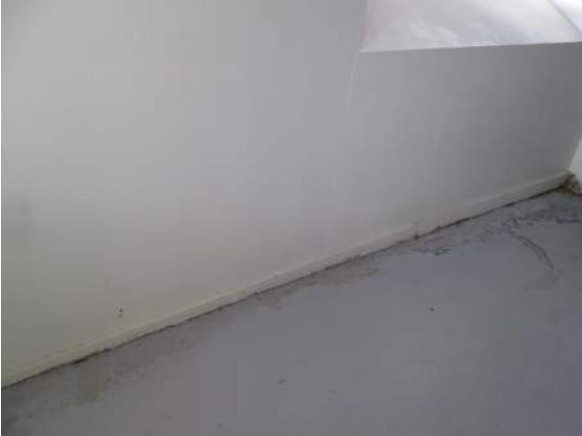
Figure 97 – Room at South-west corner of basement: floor is wet under baseboard.

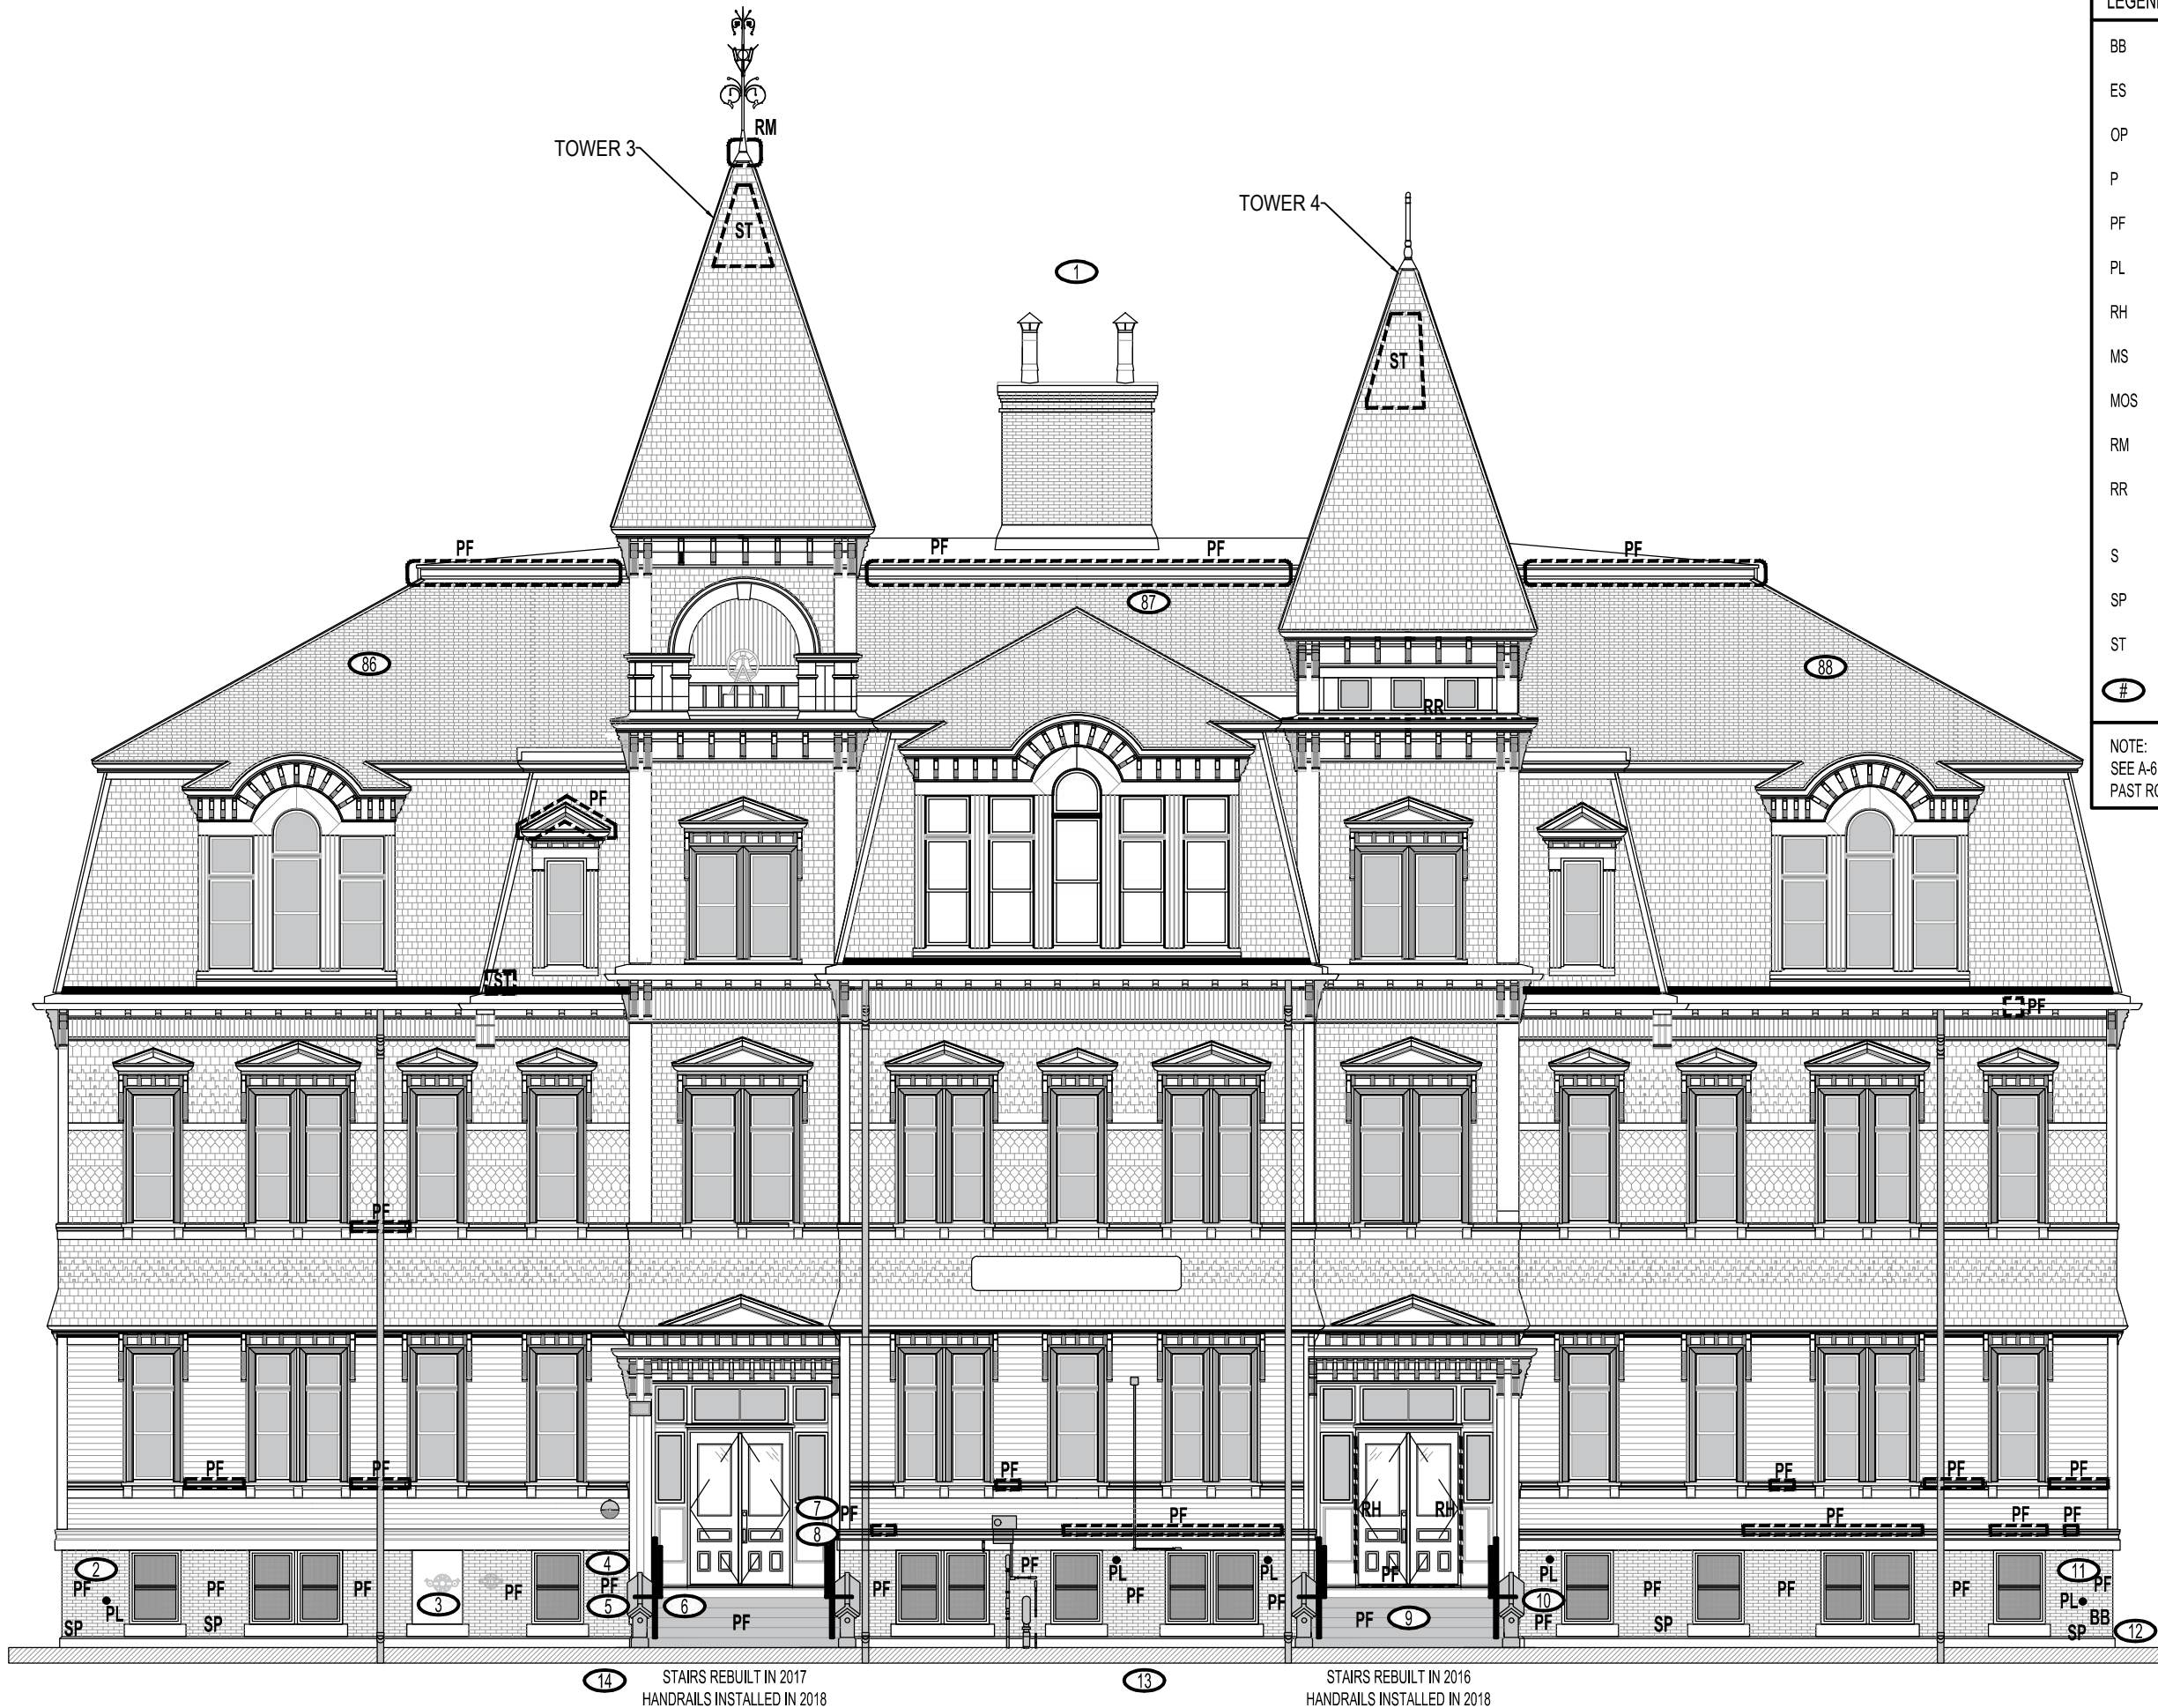
**LUNENBURG
ACADEMY**
BUILDING CONDITION
ASSESSMENT

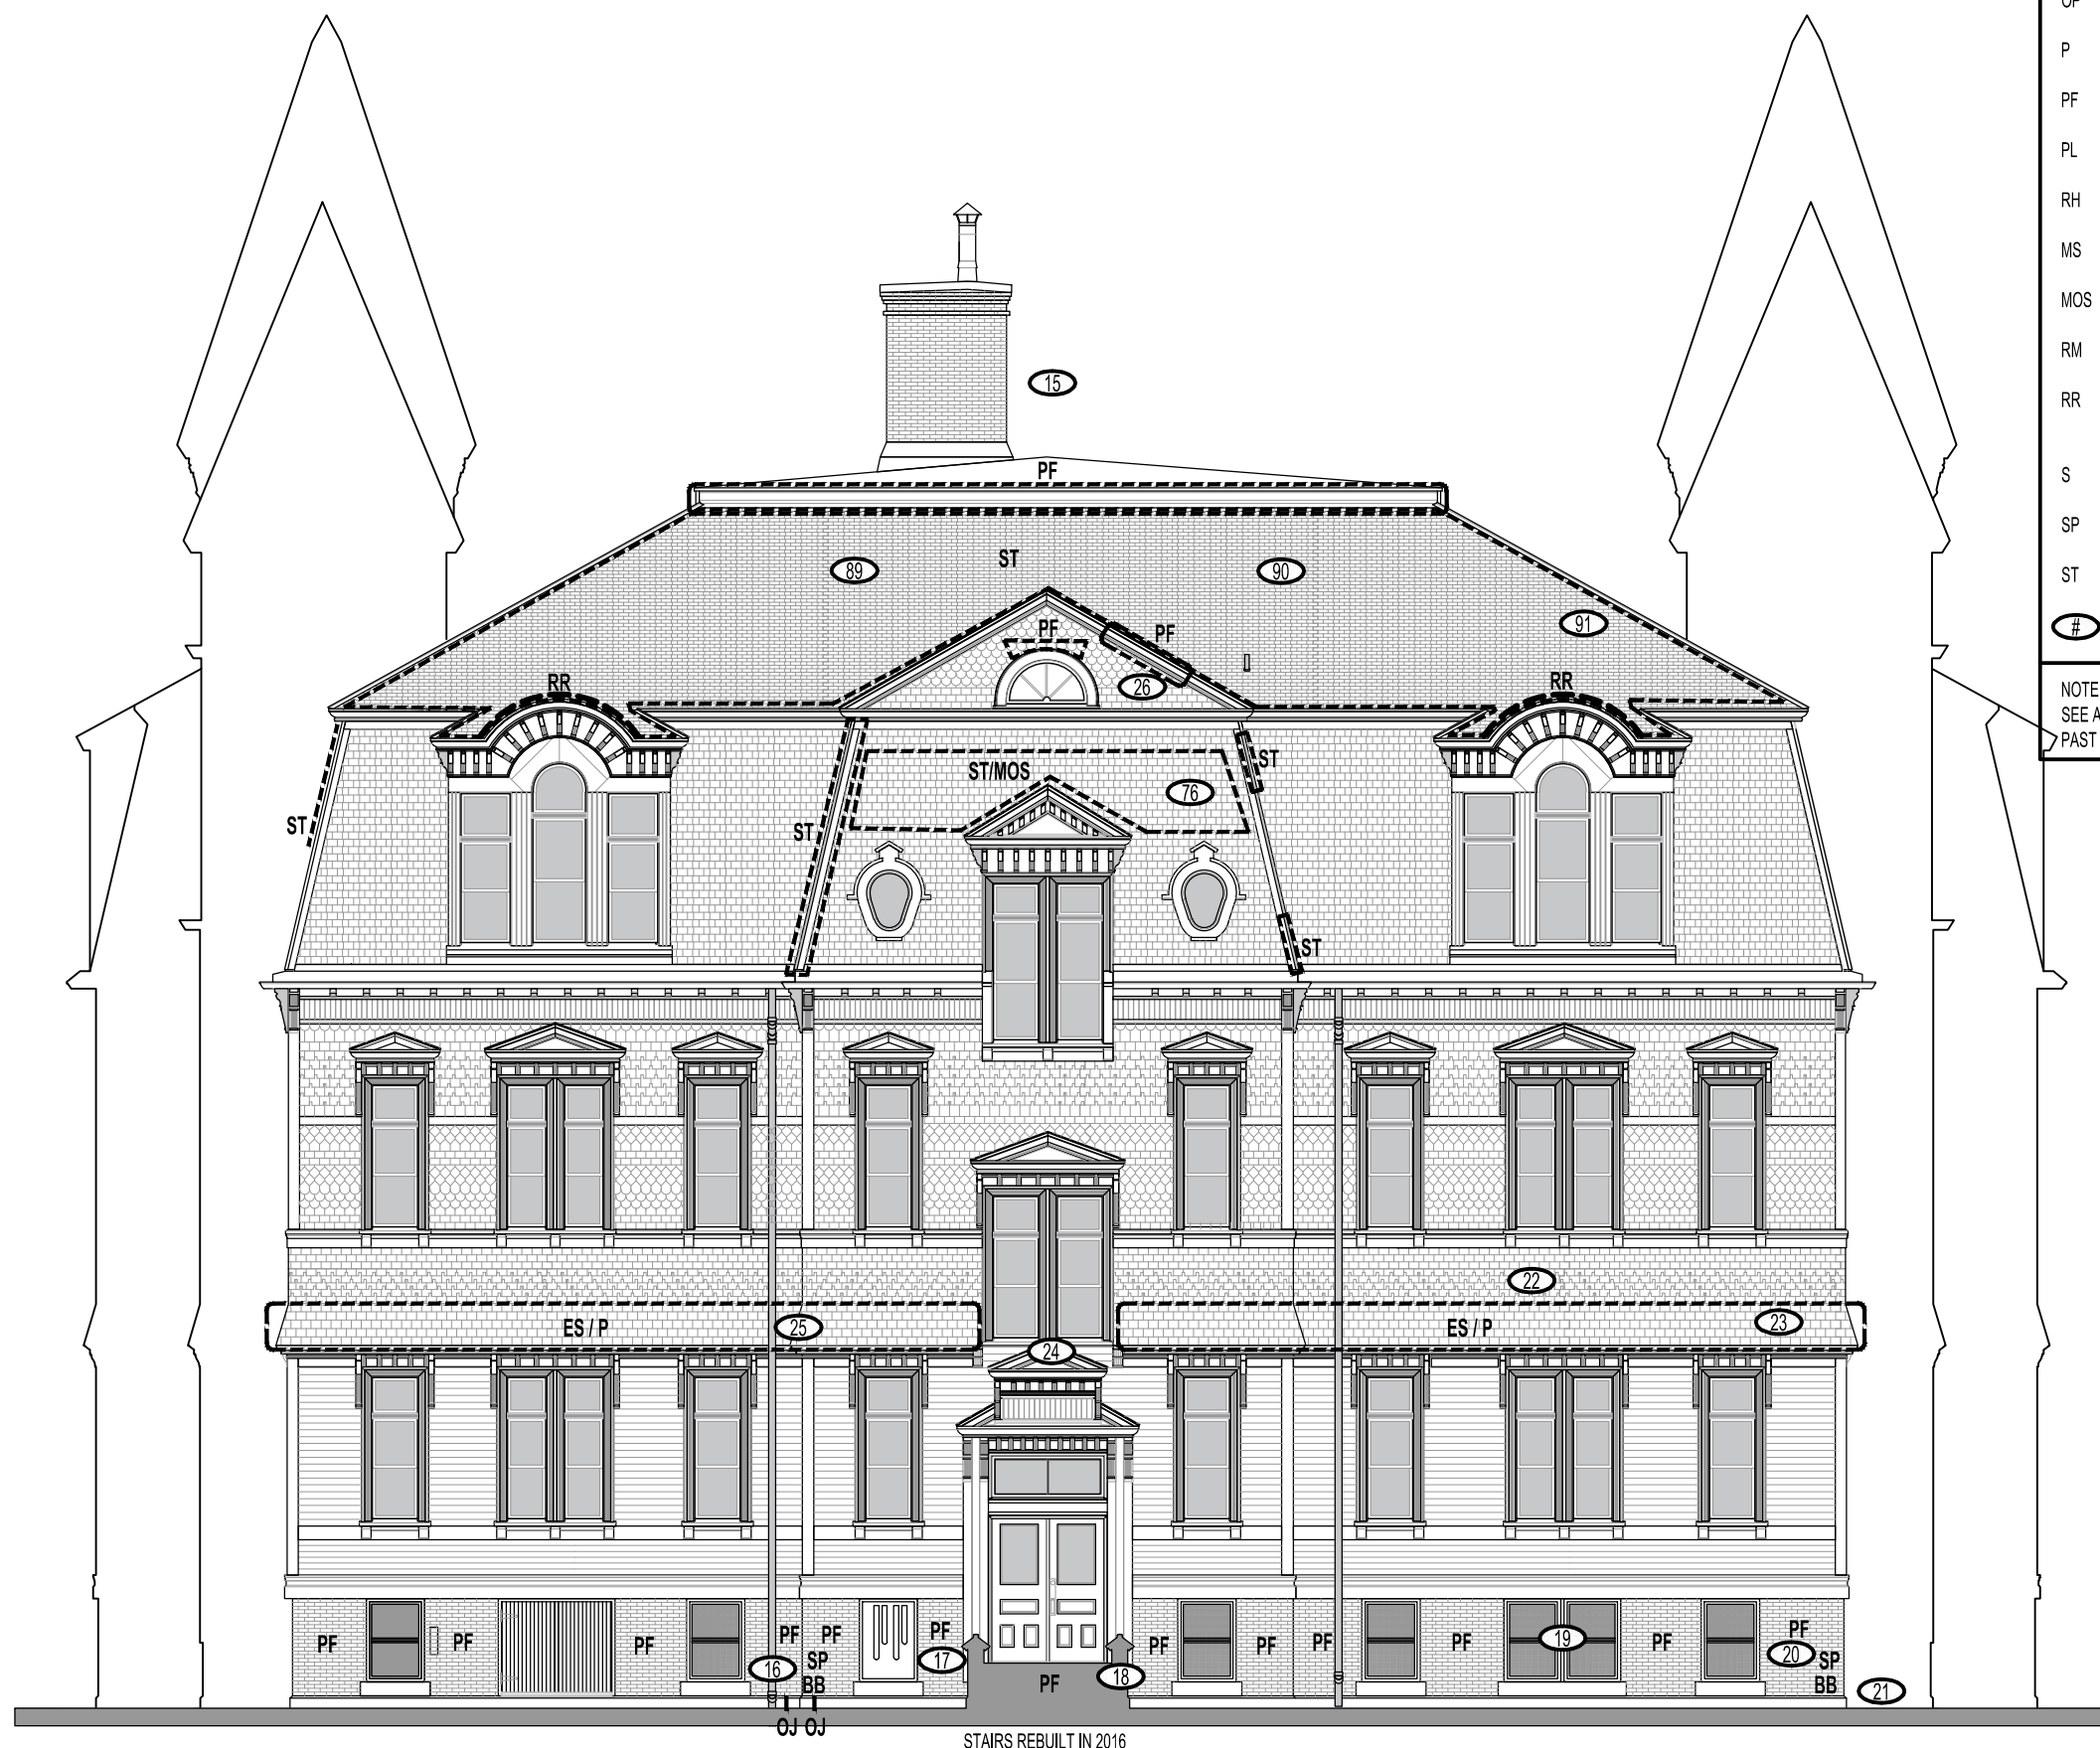
**LUNENBURG
ACADEMY**
BUILDING CONDITION
ASSESSMENT

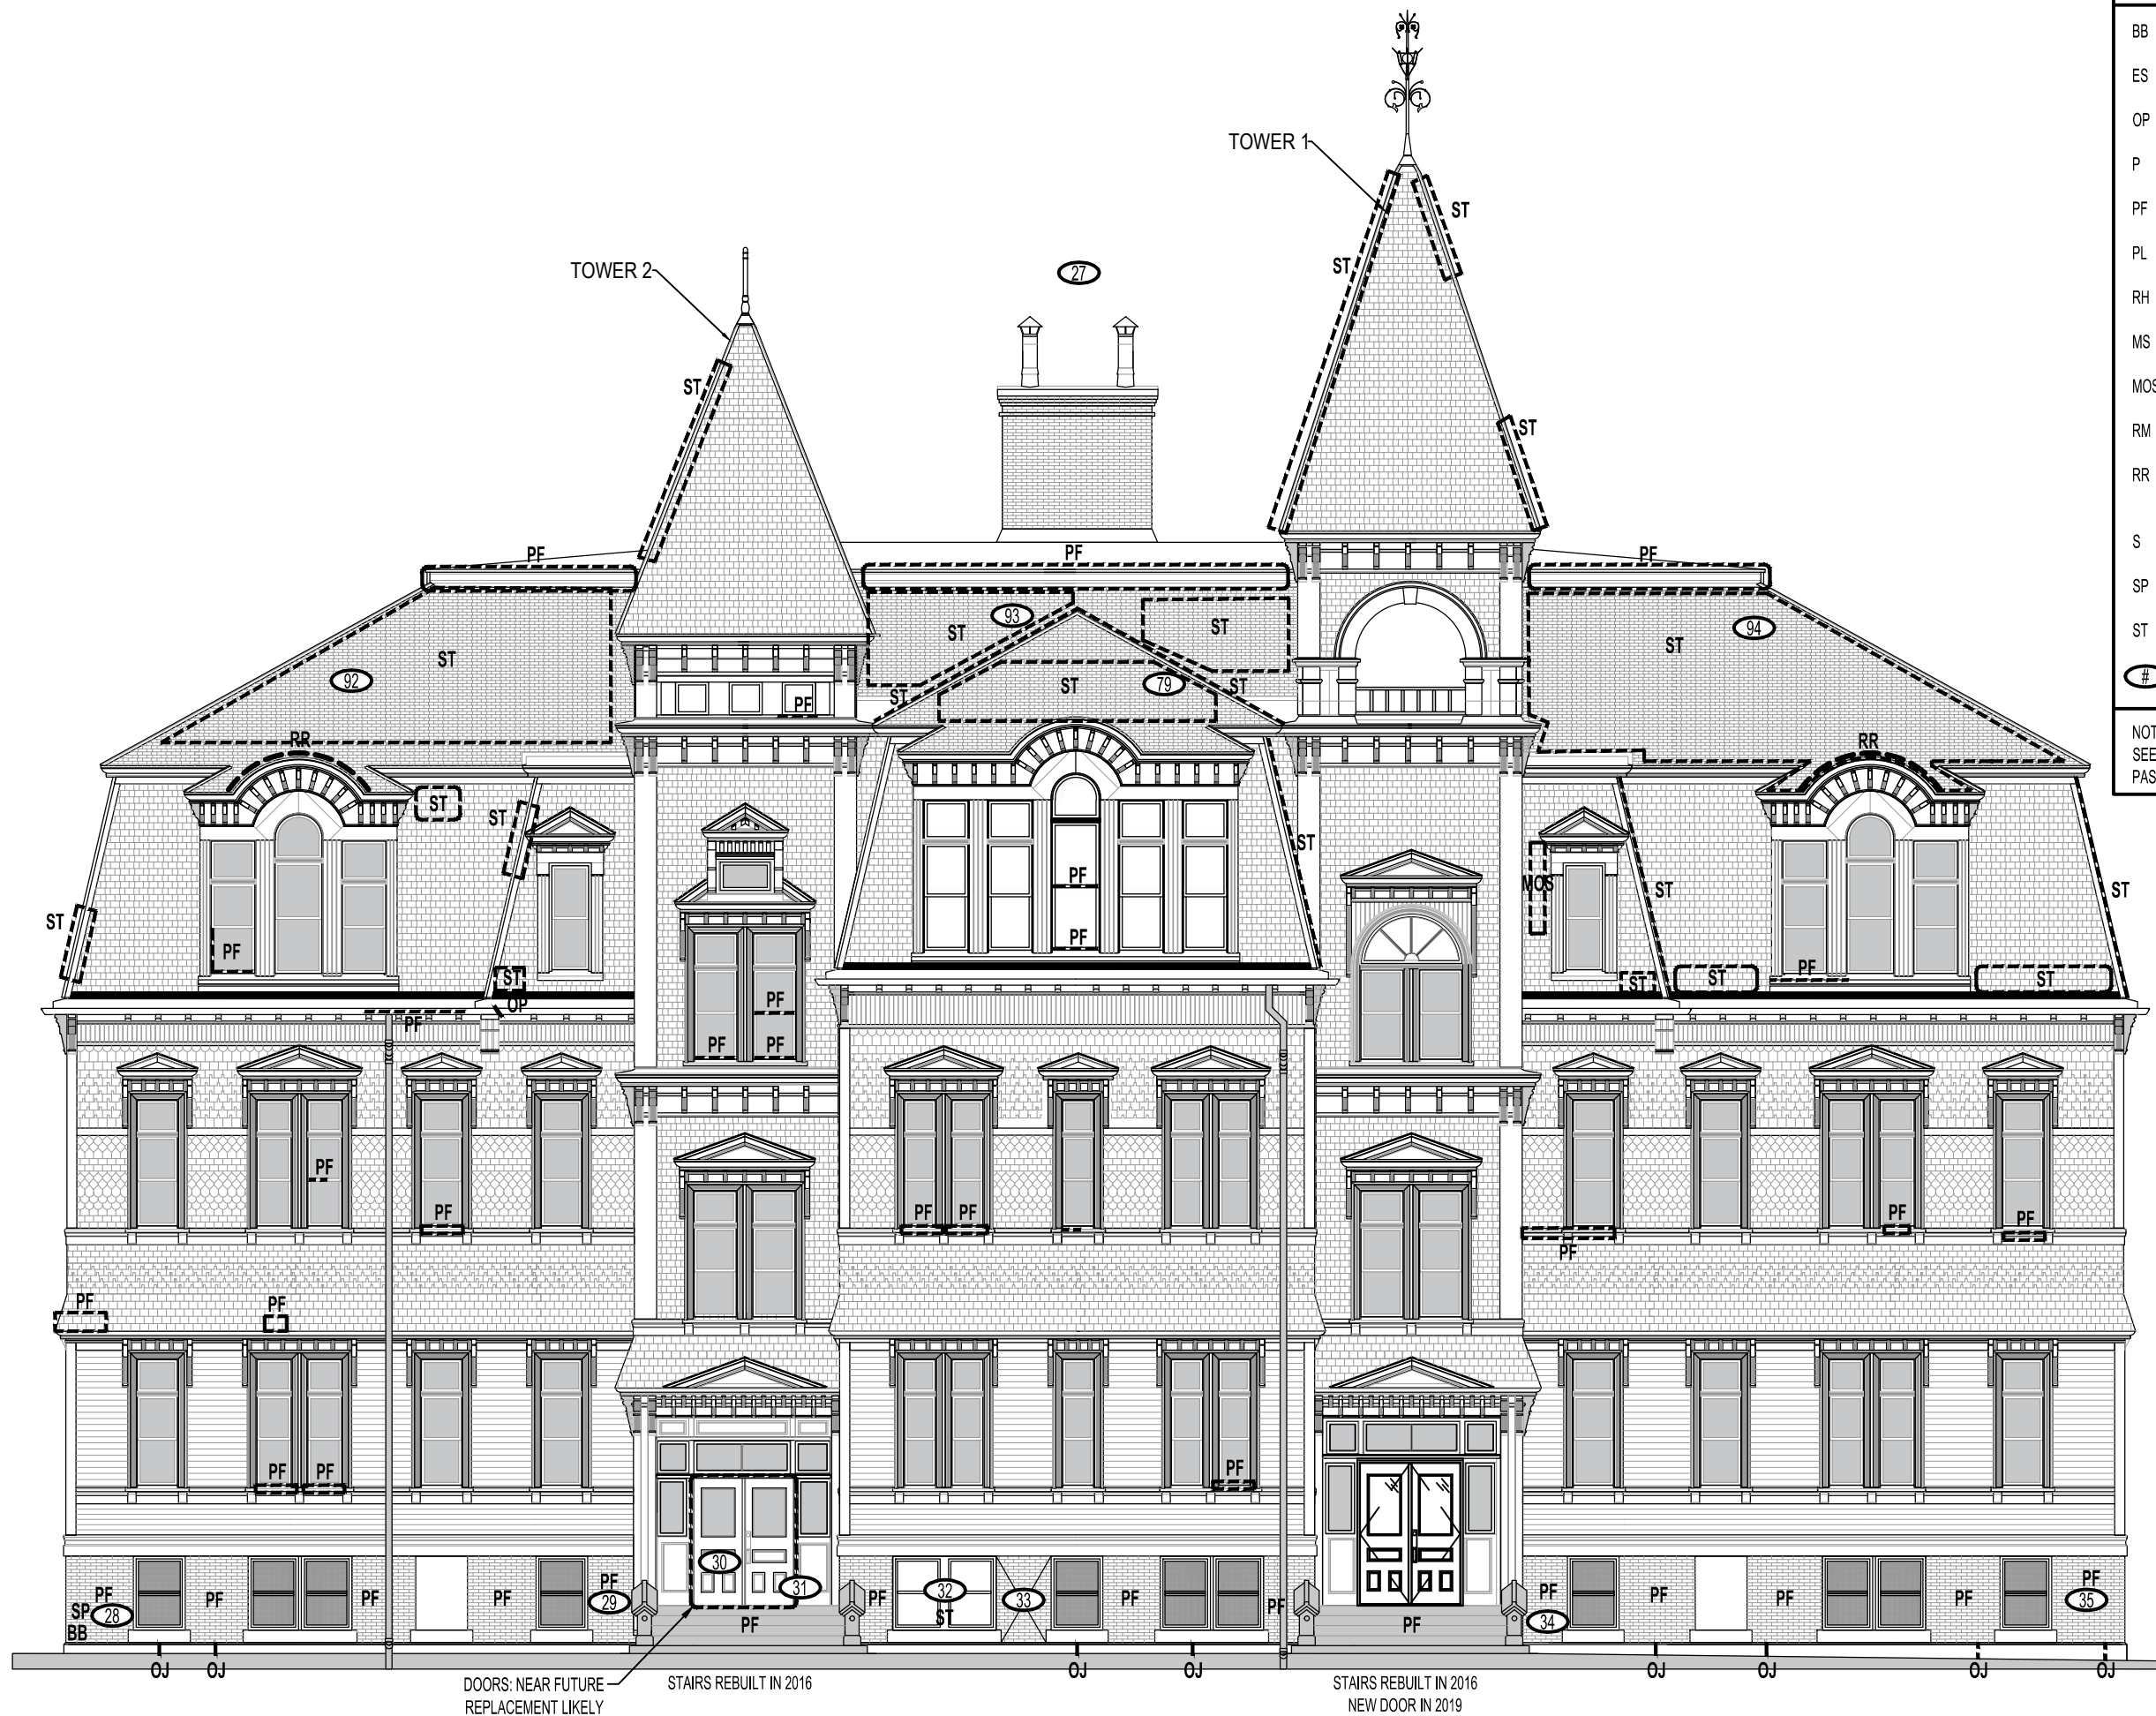
**LUNENBURG
ACADEMY**
BUILDING CONDITION
ASSESSMENT

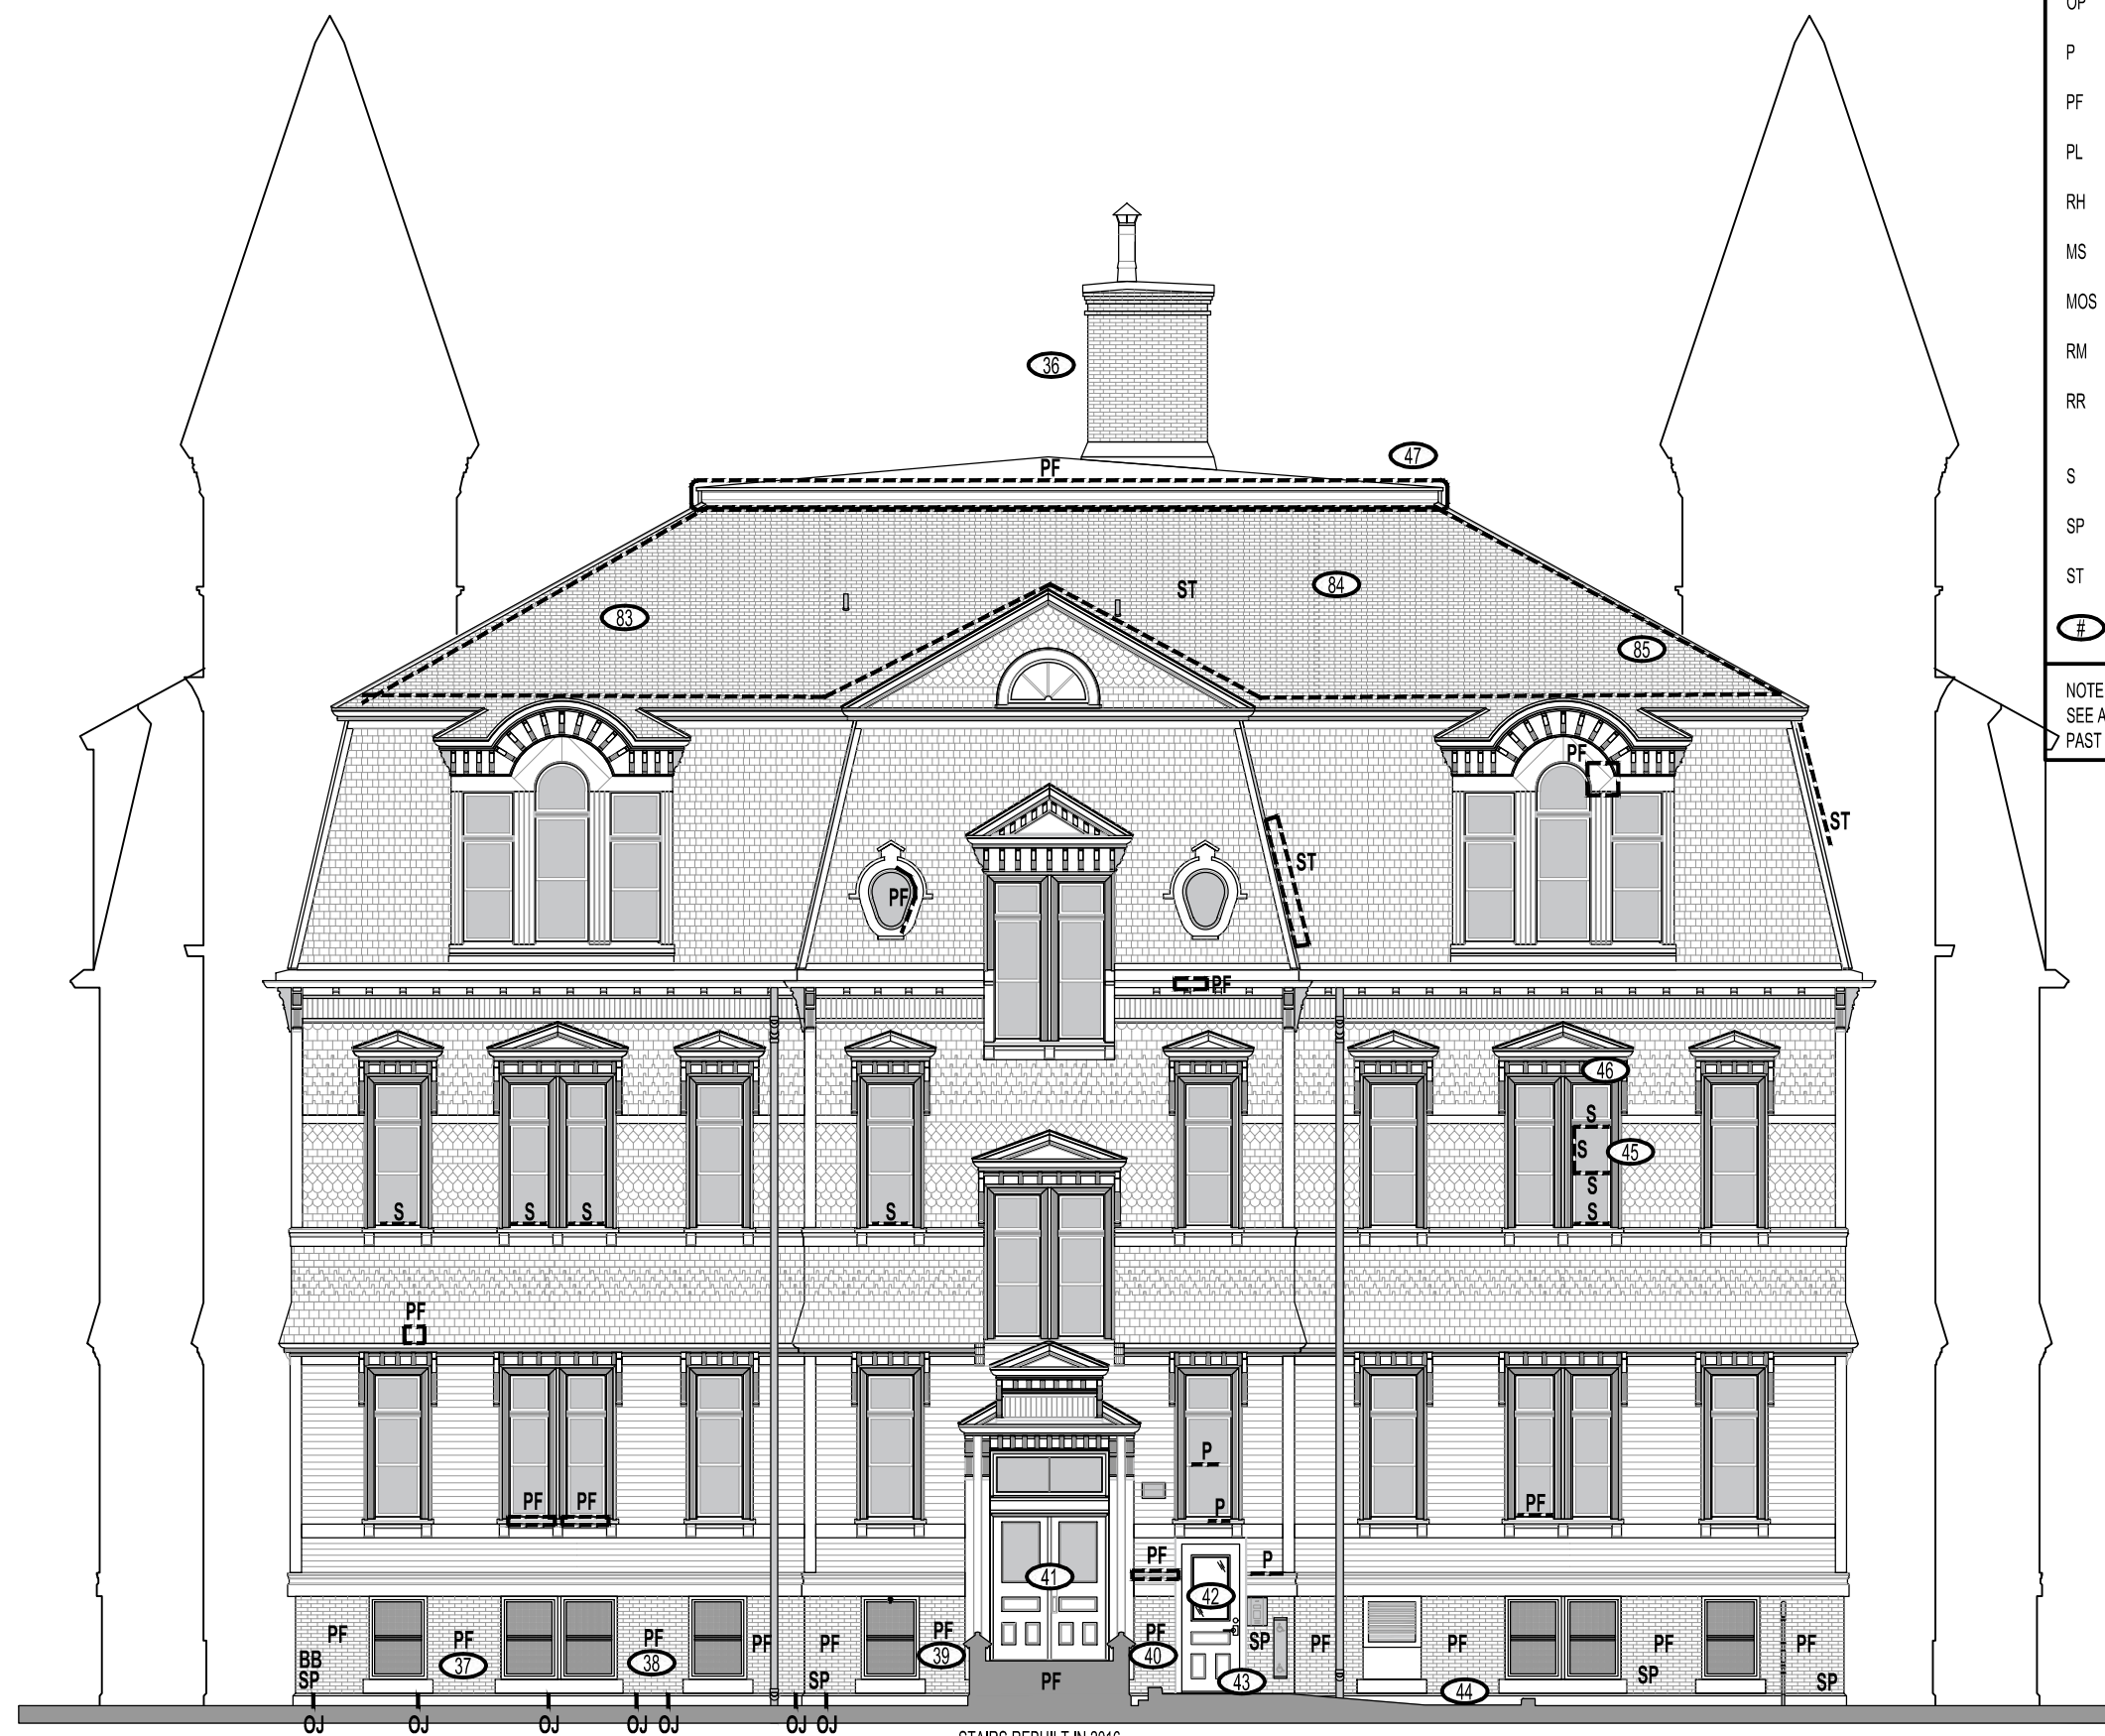
**LUNENBURG
ACADEMY**
BUILDING CONDITION
ASSESSMENT

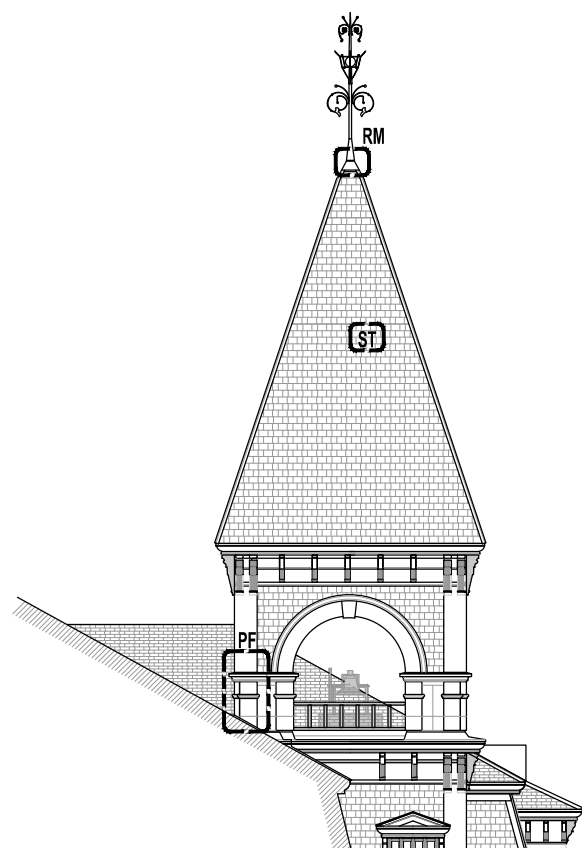
TOWER 3 SOUTH ELEVATION

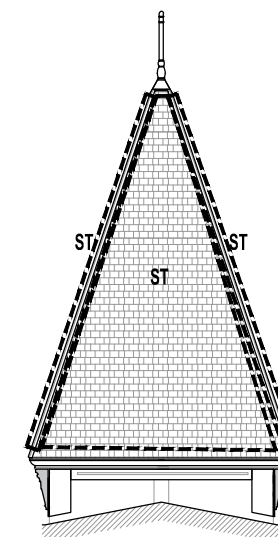
TOWER 2 EAST ELEVATION
