**TOWN OF LUNENBURG
RFP #TOL2024015**

REQUEST FOR PROPOSALS
Lunenburg Academy Roof Upgrades

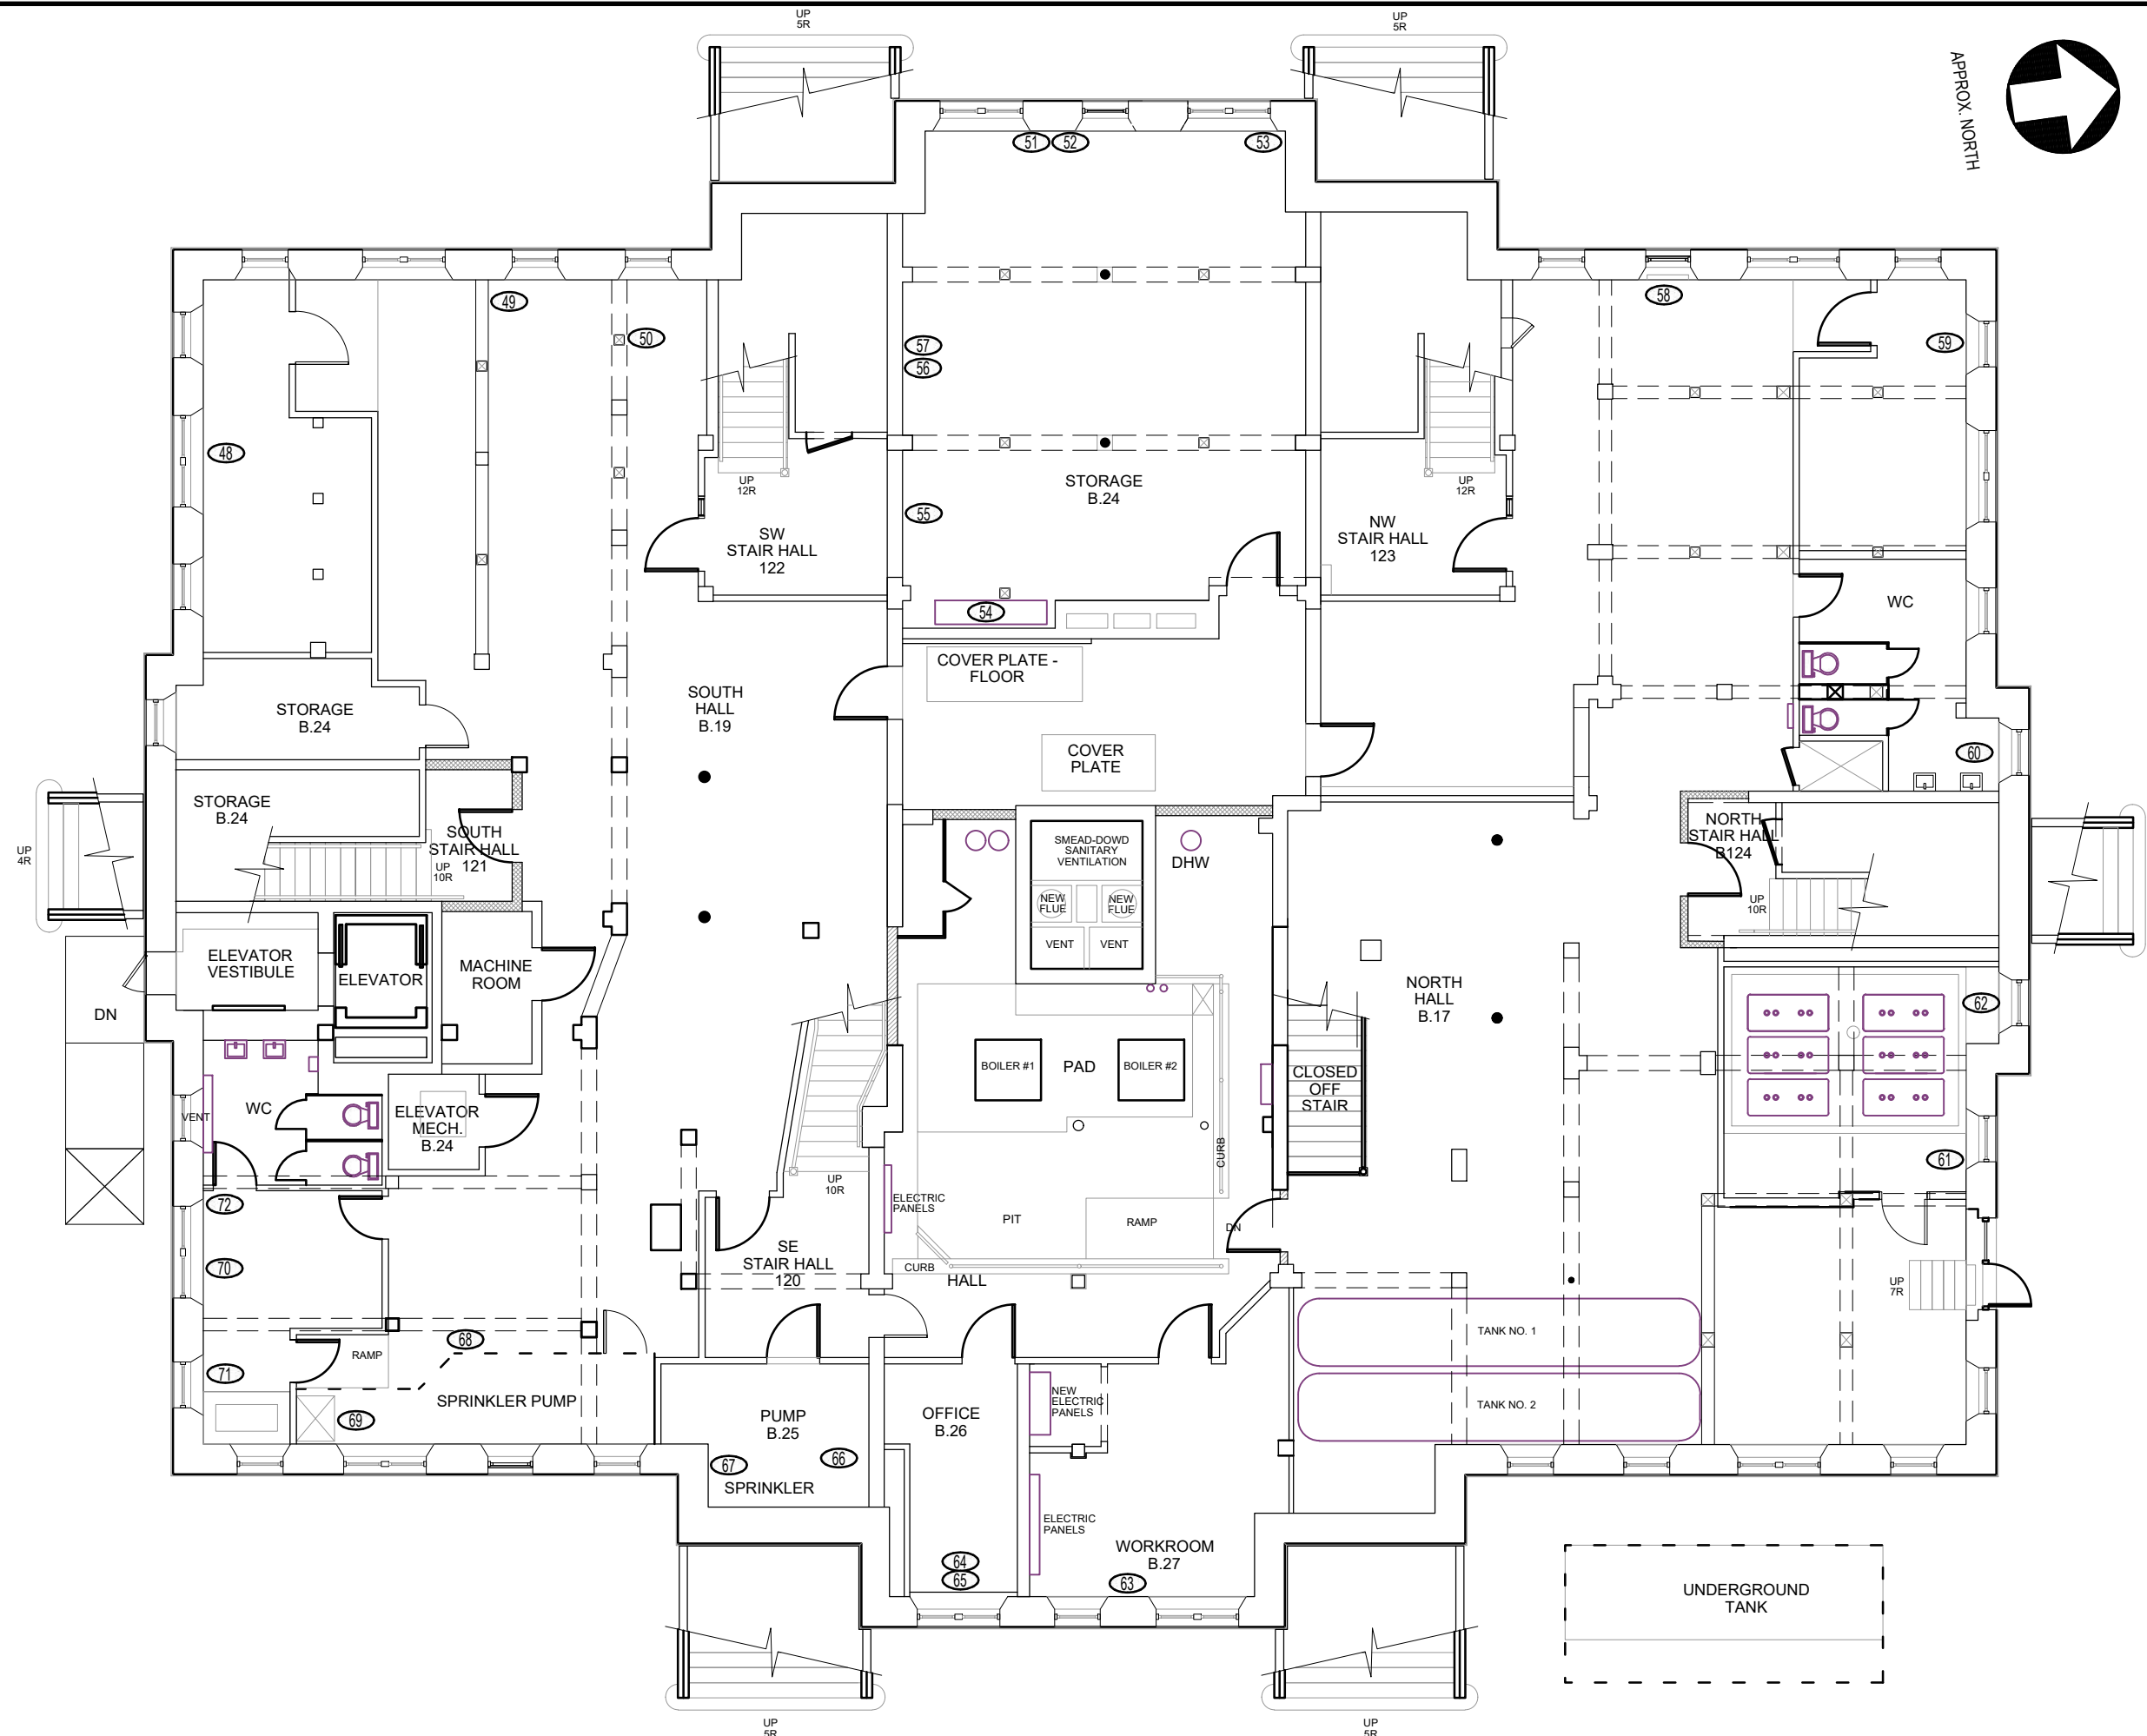
**LUNENBURG
ACADEMY**
BUILDING CONDITION
ASSESSMENT

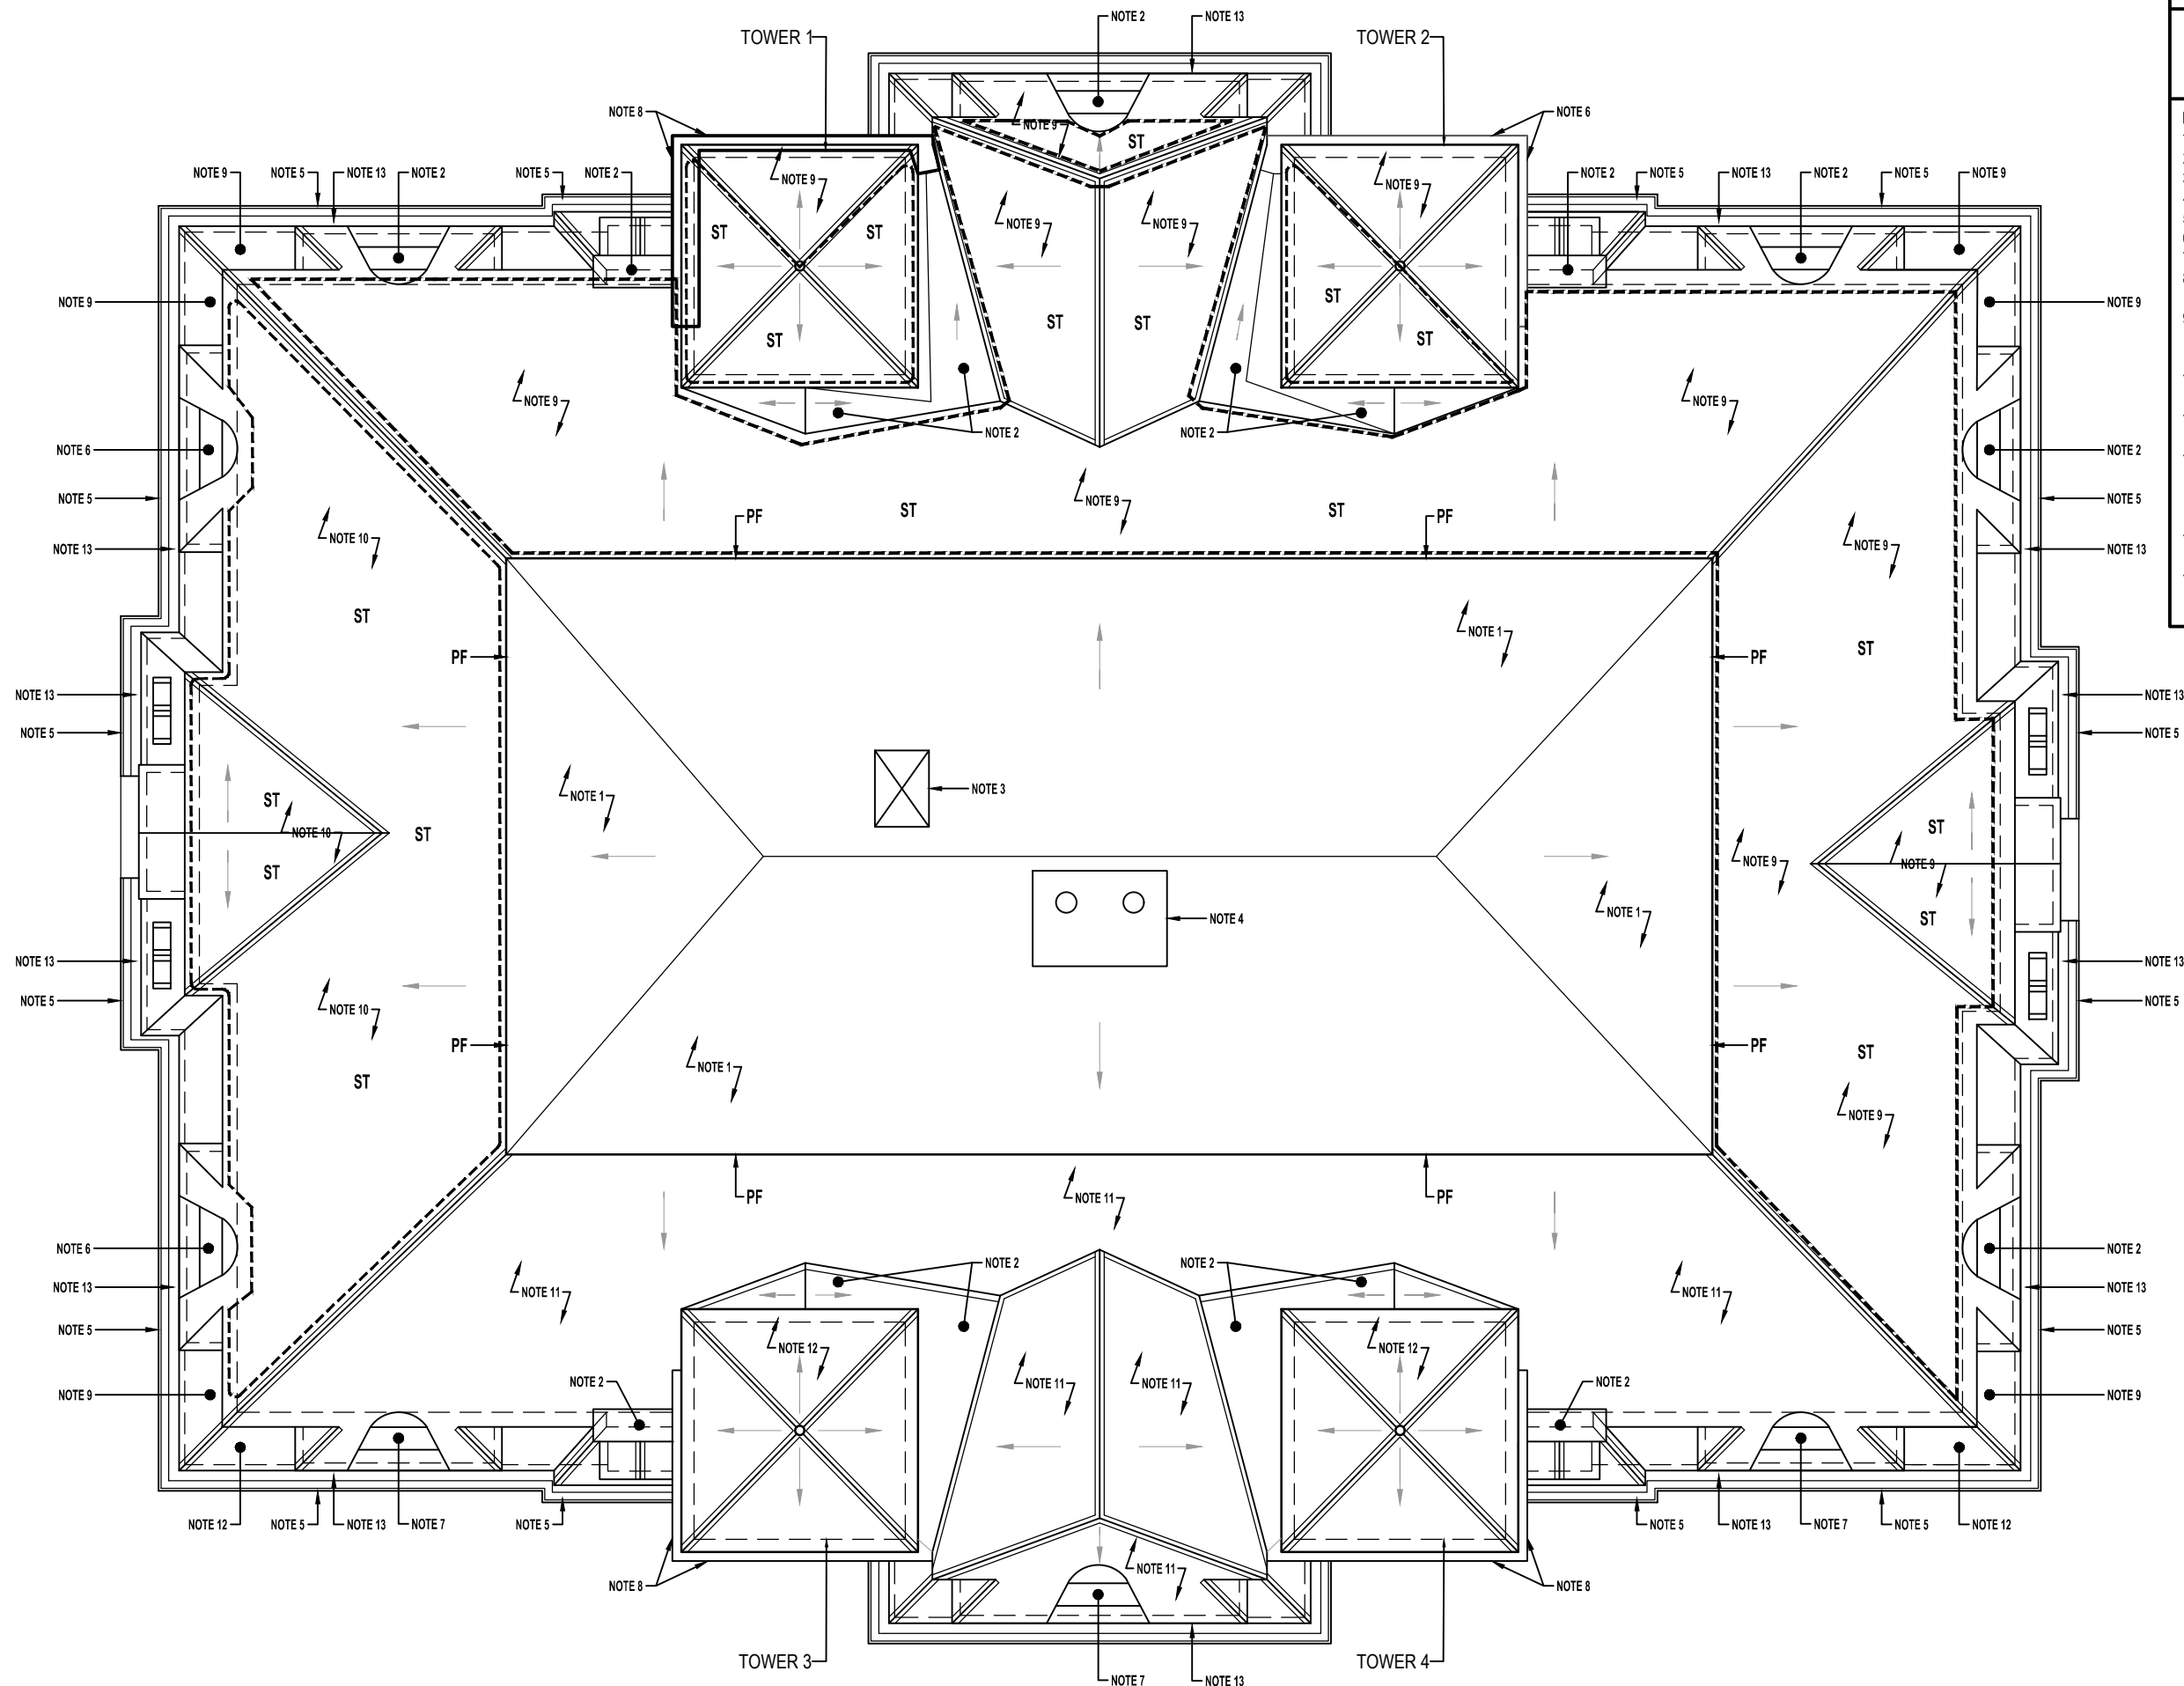
**LUNENBURG
ACADEMY**
BUILDING CONDITION
ASSESSMENT
