Building Condition Assessment

Lunenburg Townhall
119 Cumberland Street
Lunenburg, Nova Scotia

FSA Project No.: 22057DA
2022-09-23

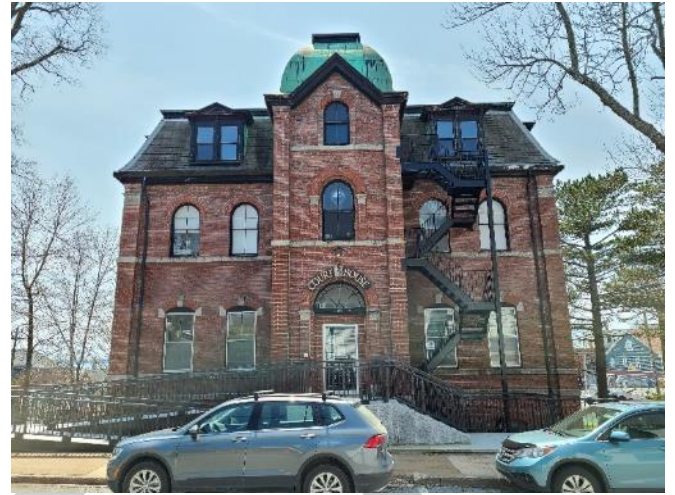
North Elevation

- General image of north elevation.
- Substantial crazing of masonry units was observed at multiple locations.

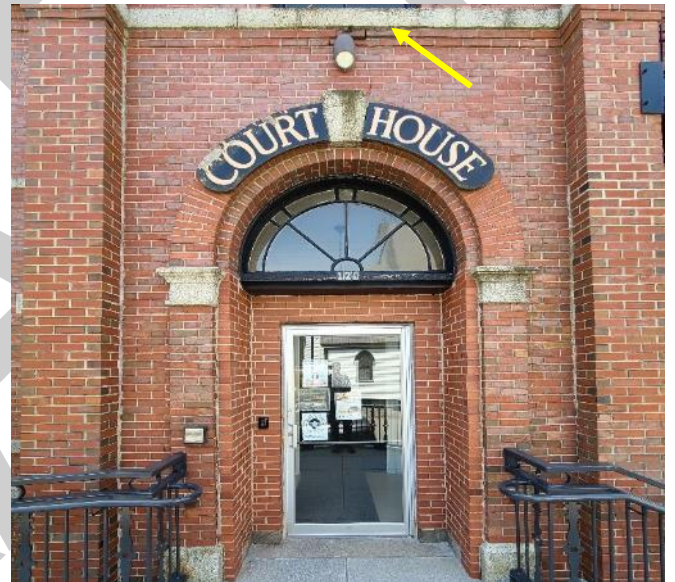
North Elevation

- General image of north elevation.
- Deteriorated mortar was observed below the first granite ribbon.
- Staining was observed at the granite keystone above the entrance and a granite ribbons.

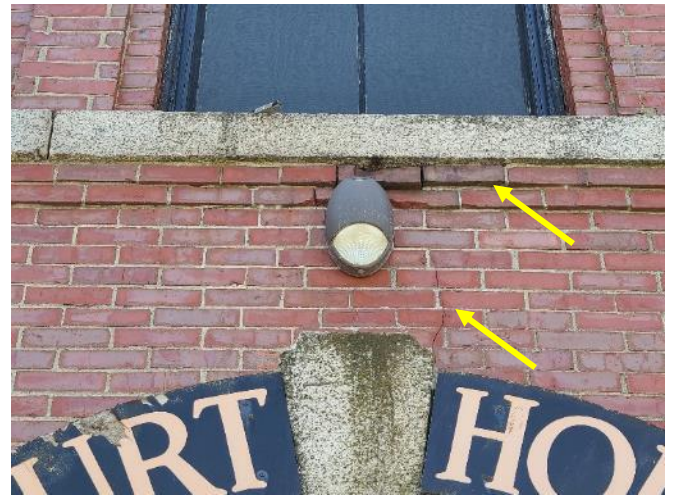
North Elevation

- Deteriorated mortar was observed below the granite ribbon.
- A crack was observed through the masonry originating above the granite keystone, traveling vertically towards the horizontal granite ribbon.
- Staining of the granite was observed in multiple locations.

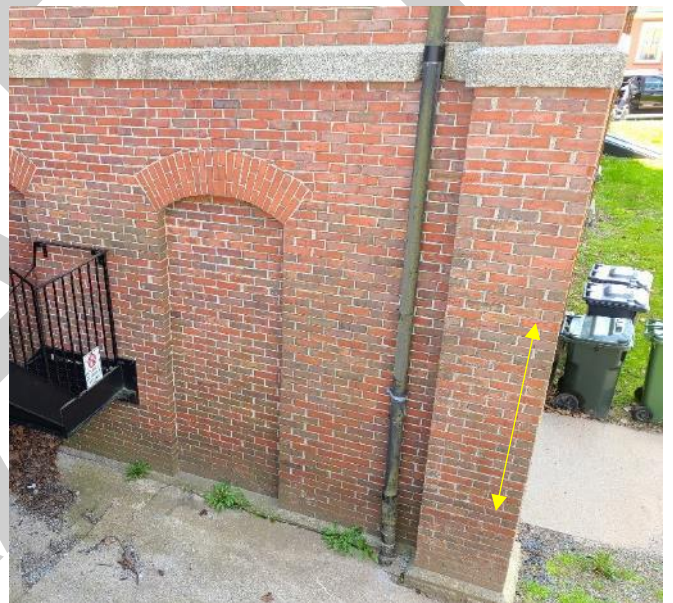
North Elevation

- Cracking through the masonry was observed at the base of the pilaster (yellow arrow).
- The original copper downspout has been replaced with plastic and is observed to drain beneath grade level.

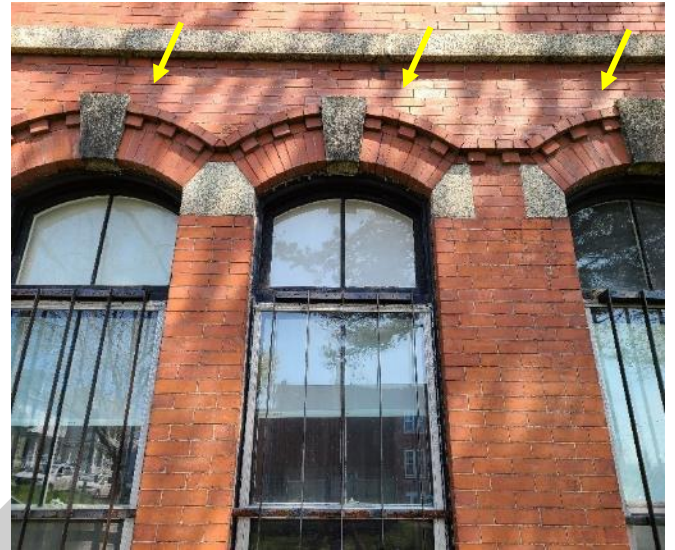
West Elevation

- Typical masonry arch detail above first floor windows.
- Deterioration of mortar joints between the cap bricks of the masonry eyebrow was observed (yellow arrows).
- Spalled masonry faces were observed at this location.
- Previous repairs were observed at the head of windows.
- Deteriorated sealant was observed.
- Staining of the granite keystones was observed.

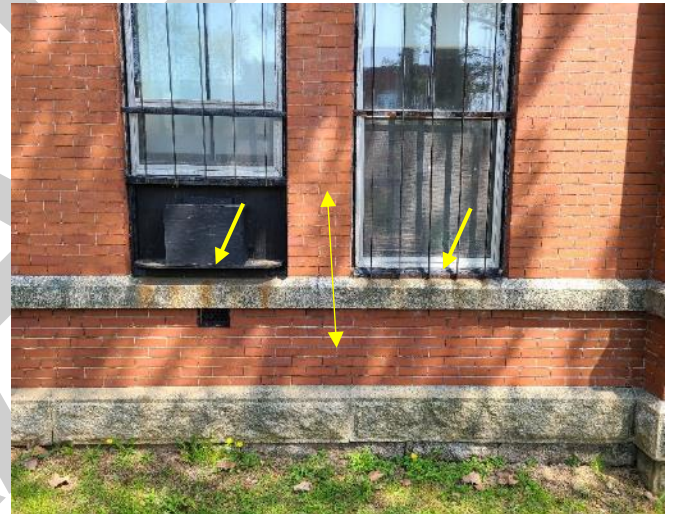
West Elevation

- Staining was observed at the granite ribbon below the first-floor windows. This is likely caused by the deteriorated, metal security bars at windows.
- Deteriorated mortar joints were observed below the granite ribbon.
- A masonry crack originating at the foundation was observed to travel vertically between windows.
- Efflorescence and crazing of the masonry units was observed at window level.

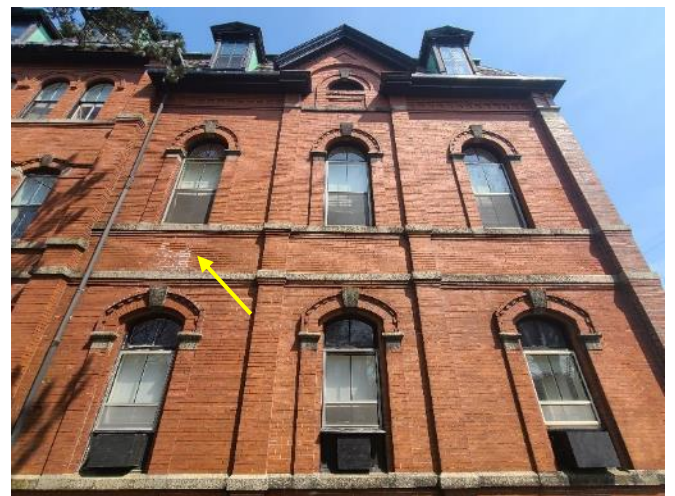
West Elevation

- Typical example of masonry arches common to the west and east elevation.
- A previous repair and repointing effort was observed (yellow arrow). Repair work does not blend with the surrounding masonry.
- Spalling masonry was observed near the downspout (see following observation).

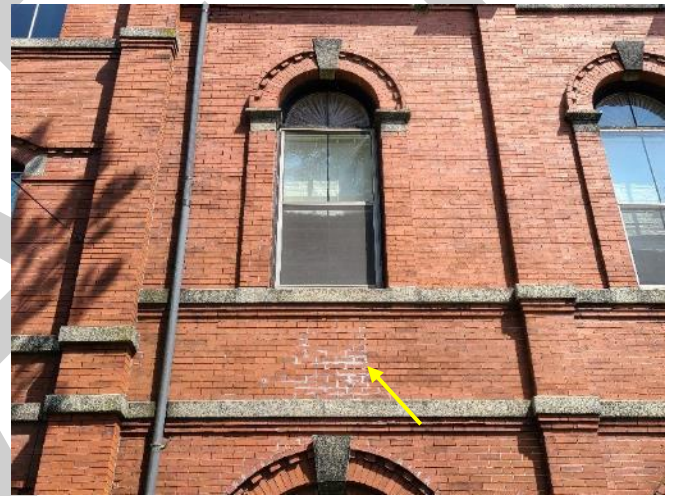
West Elevation

- A previous repair and repointing effort was observed (yellow arrow). Repair work does not blend with the surrounding masonry.
- Staining of granite keystones and springers were observed at most windows.

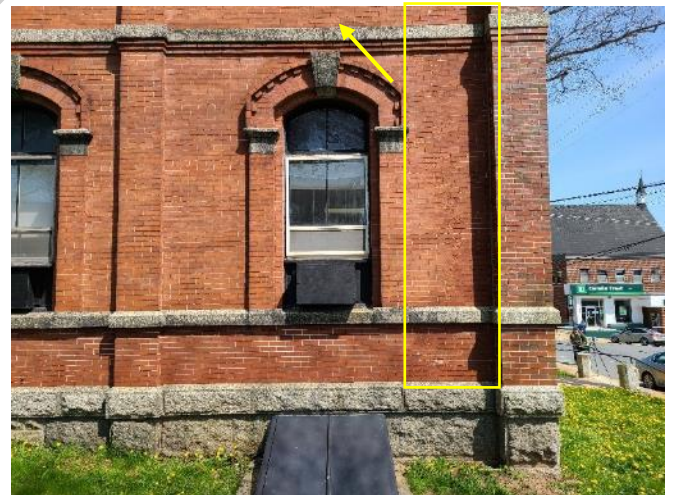
West Elevation

- Spalling of masonry was observed to the left of the pilaster (yellow box).
- A masonry crack was observed above the window (yellow arrow).
- Staining of granite ribbons was observed.

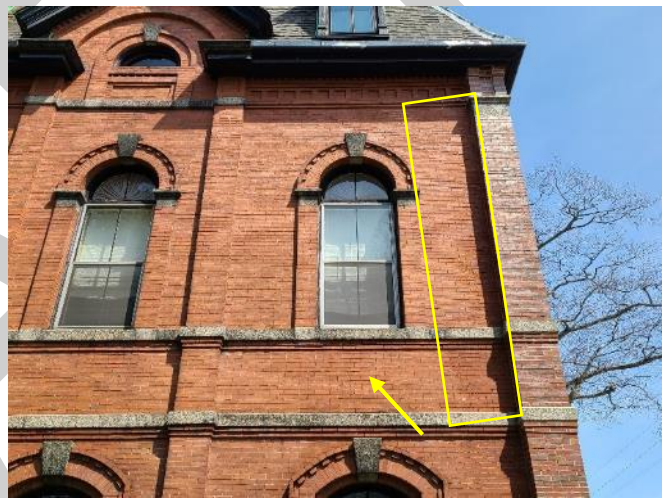
West Elevation

- Spalling of masonry was observed two the left of the pilaster (yellow box).
- A masonry crack was observed (yellow arrow).
- See following observation.

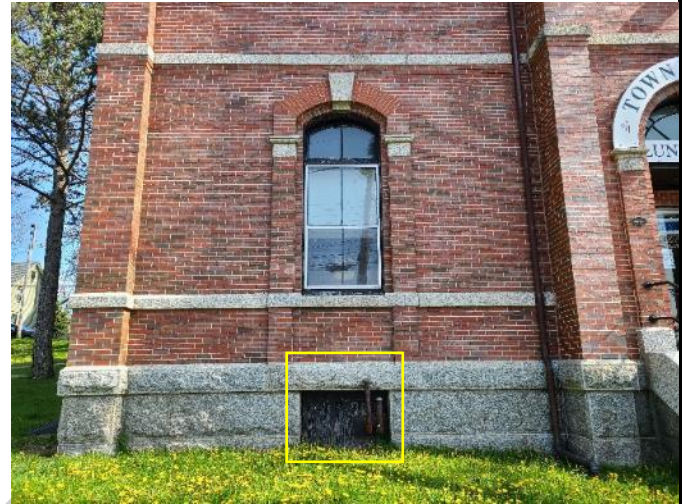
South Elevation

- Window frames were generally observed to be sound; however, paint was observed to be deteriorated.
- Sealant was observed to be deteriorated.
- The basement window is infilled with painted plywood. An oil fill and vent pipe were observed to penetrate the window area. Paint was observed to be deteriorated.

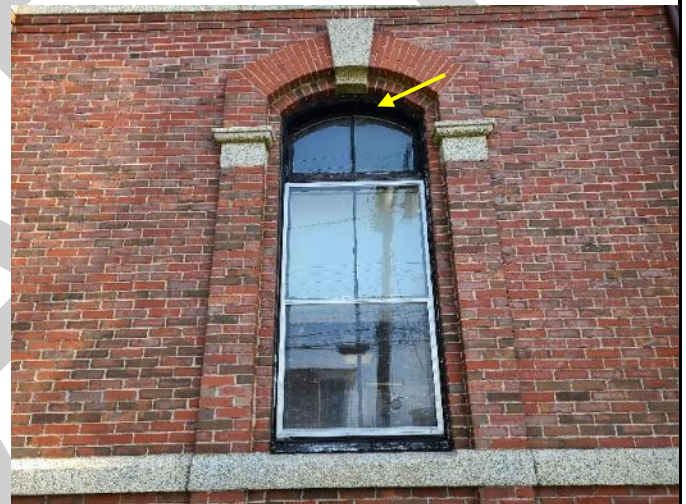
South Elevation

- Window frames were generally observed to be sound; however, paint was observed to be deteriorated.
- Sealant was observed to be deteriorated.
- A crack glazing unit was observed in the upper left arched window (yellow arrow).

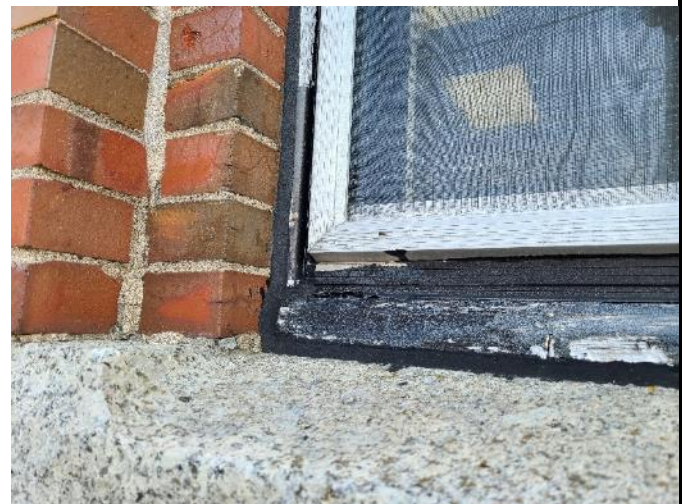
South Elevation

- In many instances, sealant has been replaced between window frames and masonry; however, the sealant used and its application is inconsistent and was often observed to be deteriorated.
- Paint/stain was generally observed to be deteriorated at wooded window frames and sills.

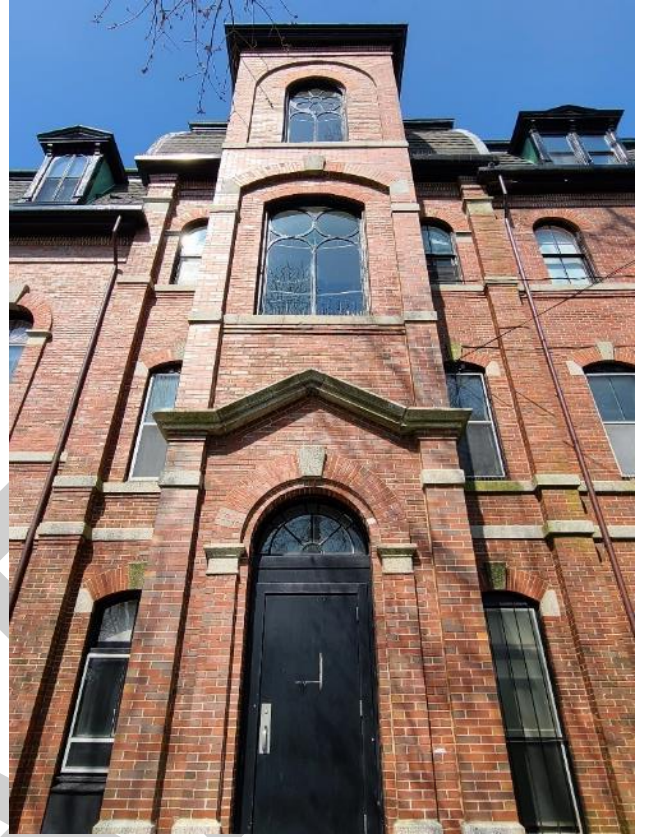
East Elevation – Interior of stairwell tower, 2nd floor landing

- Windows at the second and third floor of the stairwell tower are unique to all other windows. These feature decorative circular mullions.
- The exterior door at the base of the stairwell tower has been replaced; however, still features an arched window above.
- Paint and sealant were observed to be deteriorated.
- See following observation.

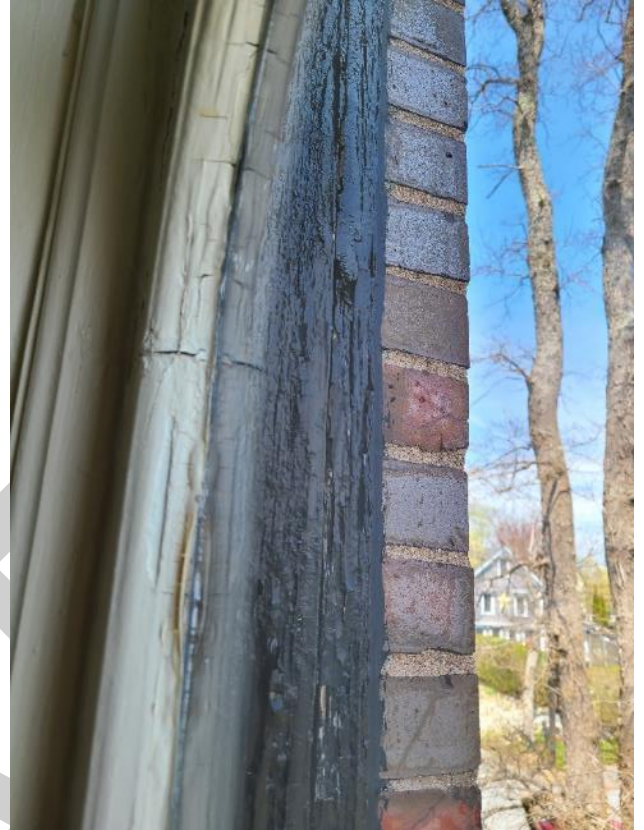
East Elevation

- In general, wood sashes and window frames were observed to be in deteriorating condition and in need of rejuvenation.
- Crazeing can be seen at the masonry.

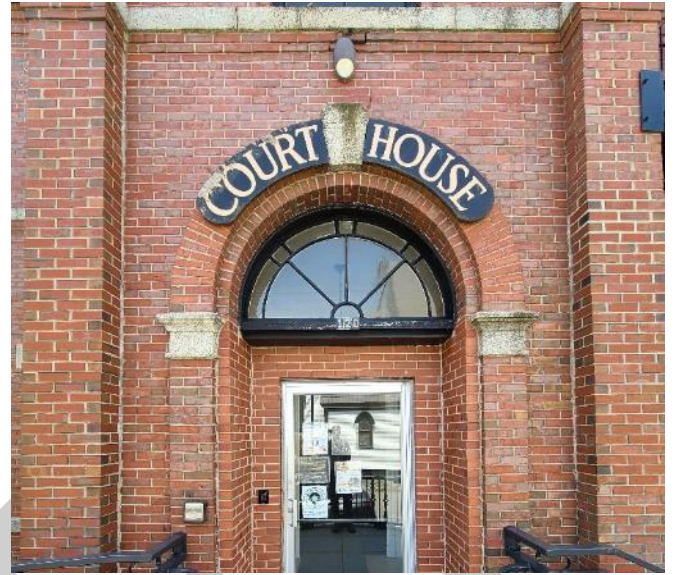
North Elevation – at entrance

- An arched window is observed over the north entrance. This appears to match the arched window over the south entrance.
- Deteriorated paint/stain and sealant was observed.

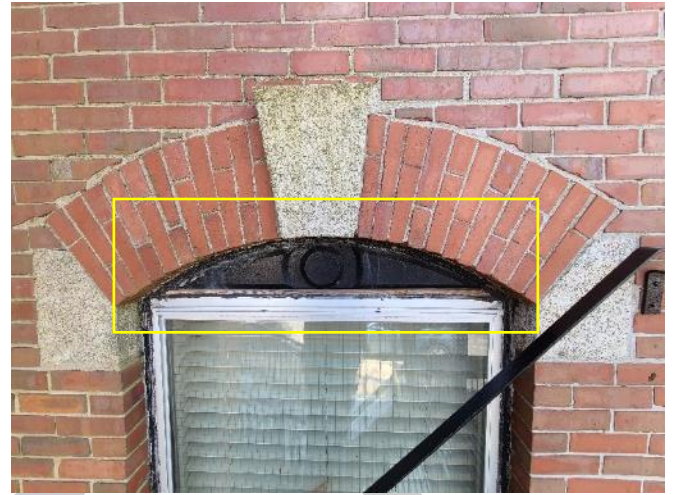
North Elevation – right of entrance

- The head of the first-floor windows was observed to be square with a shallow, decorative wooden arch above.
- Sealant was observed to be deteriorated.

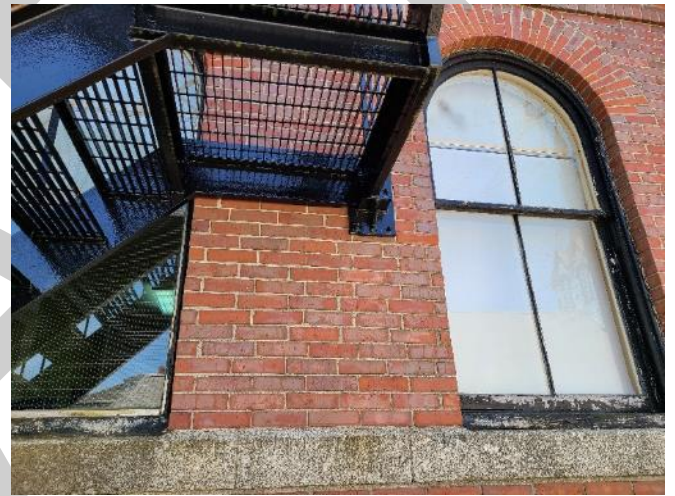
North Elevation – right of entrance

- The second-floor features arched, vertical sliding windows.
- Deteriorated paint/stain was observed as well as deteriorated sealant.
- The window visible at the left of the image was observed to be replaced with a Georgia-wire glass, likely as an increased security measure. See following image.

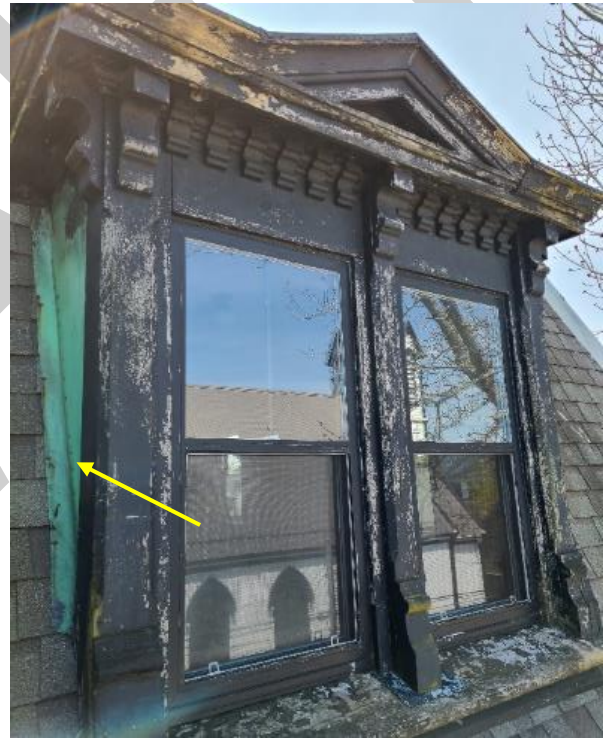
North Elevation – right of entrance

- The installation suggests there are no step flashings at the vertical sides of dormers.

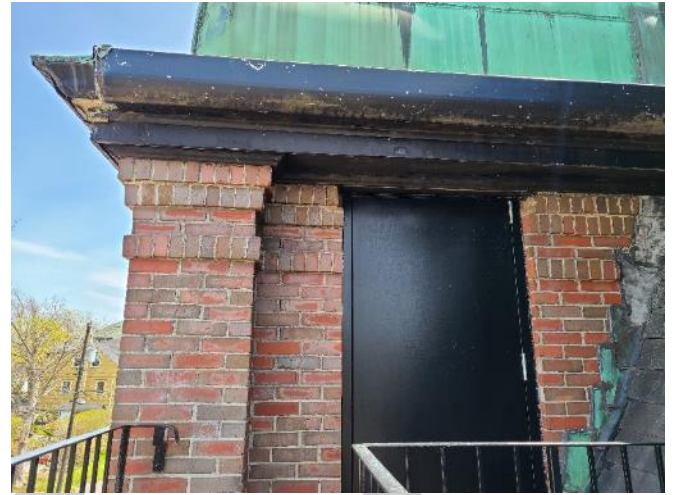
West Elevation

- Newly installed metal slab door for emergency egress at the third floor. This does not appear to be part of the original construction.
- FSA could not confirm if an adequate header/lintel was installed above the door.

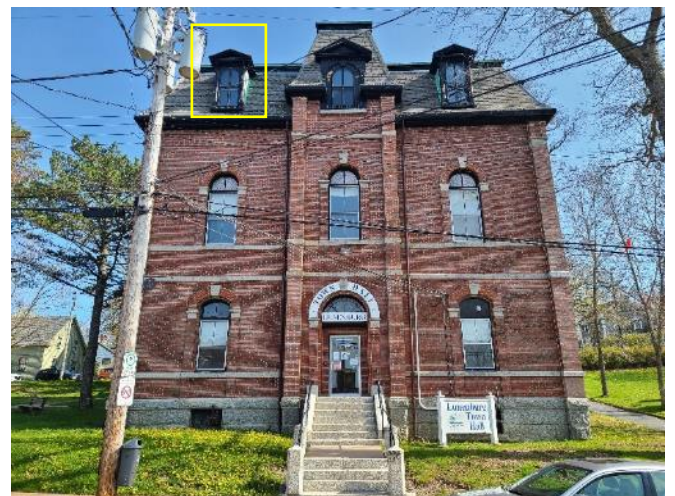
East Elevation

- Prominent mansard roof and dormers typical around the building.
- The roof of the left dormer was observed to be temporarily repaired; however, the pressure sensitive material applied is now damaged, missing and no longer providing protection.

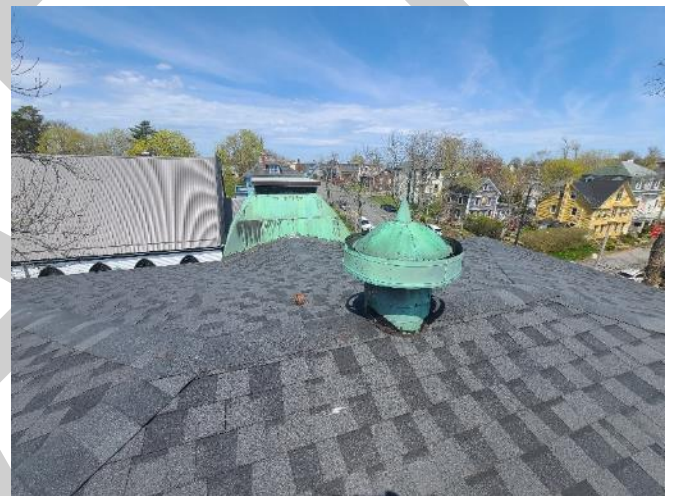
Copper Roof (Dome) – North tower

- Shingled roof area.
- Copper elements were observed to be deteriorating. Various repairs have been made and sealants applied likely in an effort to mitigate water ingress being experienced at the interior.

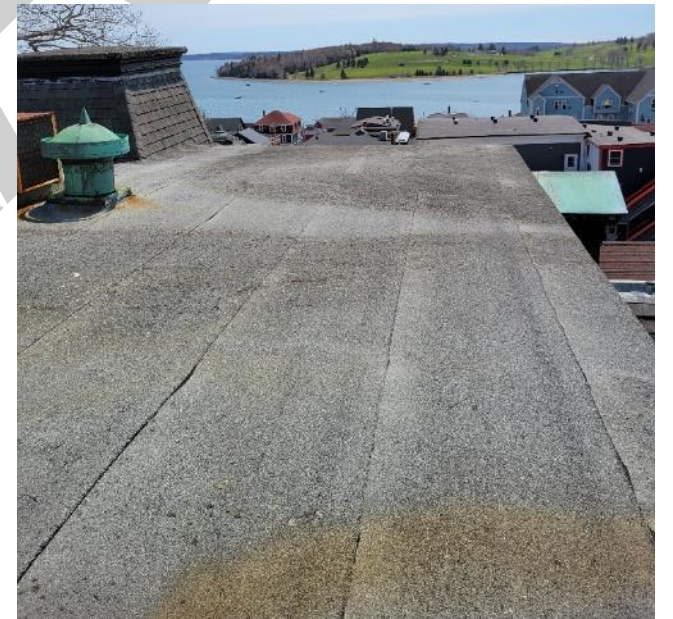
General Image – low slope/mod. bit. membrane roof area

- Low slope roof area is of mod. bit. membrane construction. In general, the roof area has reached the end of its useful life and needs replacement.
- Staining and organic growth were observed at various locations.
- Various open seams were observed in the MB membrane at the roof area.

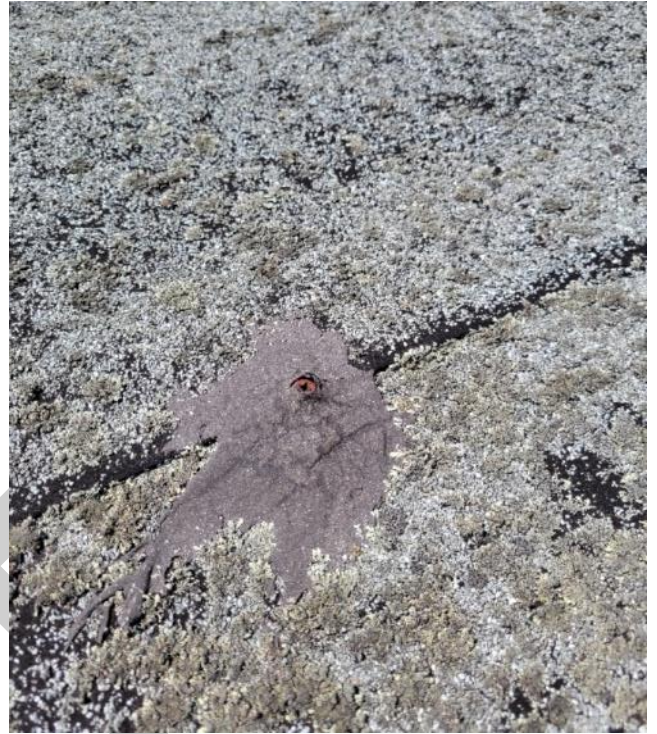
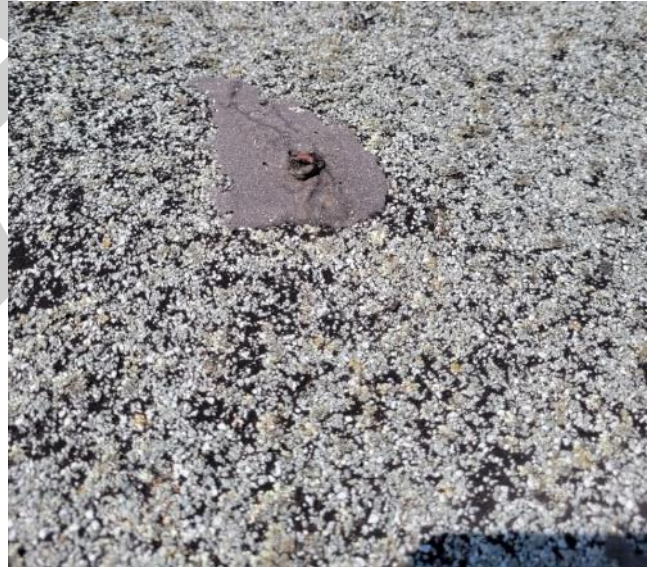
- Multiple fasteners were observed penetrating the mod. bit. membrane in the field of the roof. Corroded fasteners and deteriorated sealant were observed.
- Note the deterioration of the mod. bit. cap sheet.
- Note the organic growth visible at the mod. bit. cap sheet.
- See following observation.

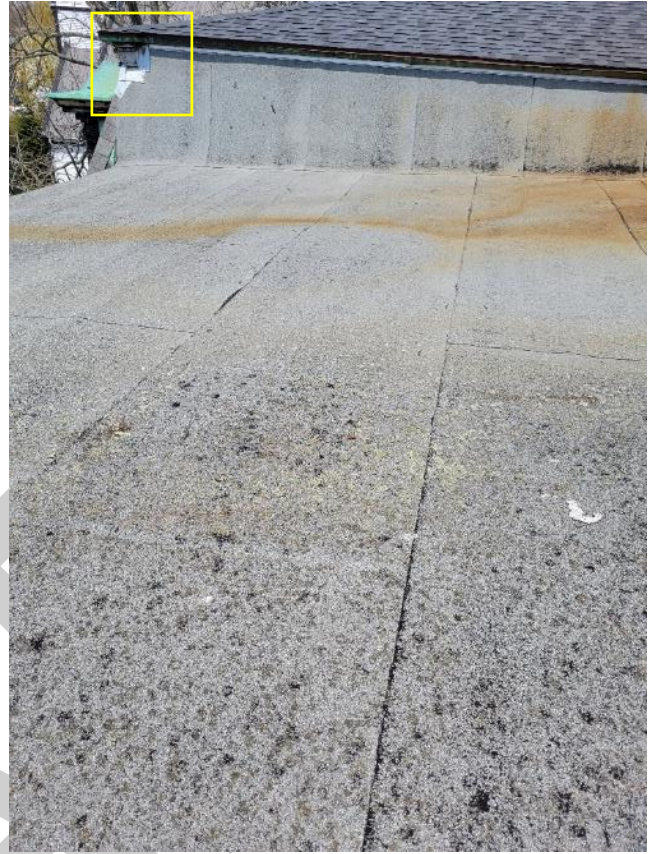
General Image – low slope/mod. bit. membrane roof area, facing north

- In general, the mod. bit. membrane cap sheet was observed to have reached the end of its serviceable life and replacement is recommended.
- Organic growth and loss of granules was observed across the field of the roof area.
- Deteriorated wood trim along with paint/stain were observed (yellow box). See following observation.

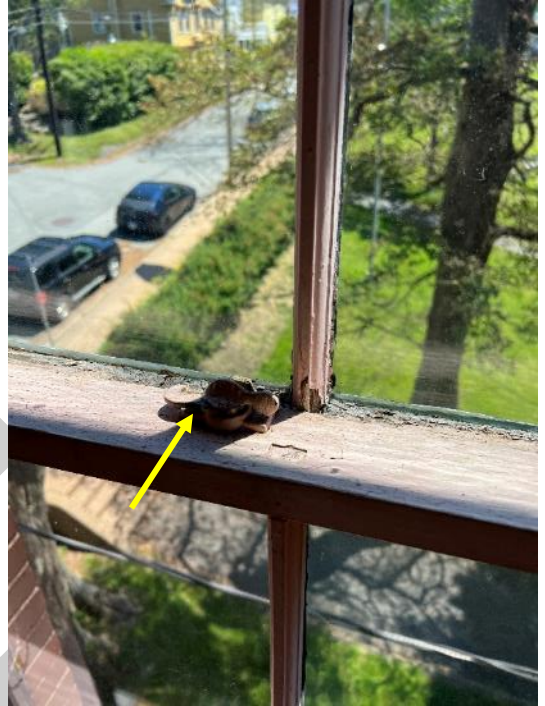
- At the interior, windows were observed to be in various stages of repair and operation. Aging and poorly functioning window locks are visible here.

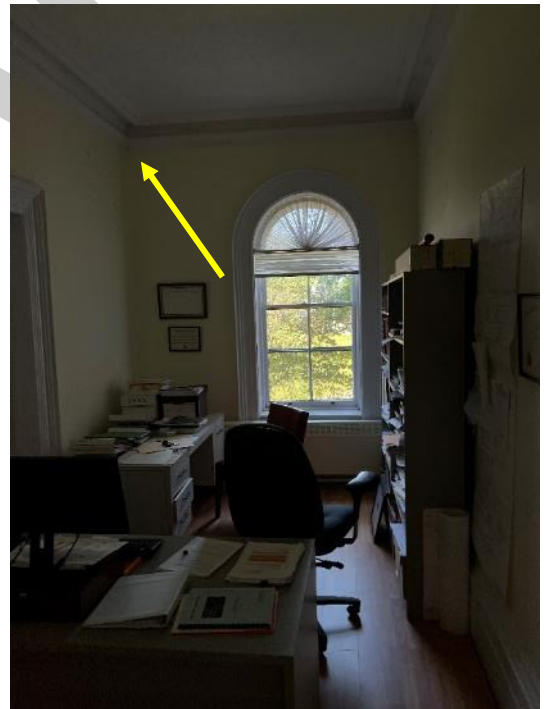
- Various diagonal cracks were observed in the plaster wall covering at the exterior walls throughout the building typical for the age and type of construction.

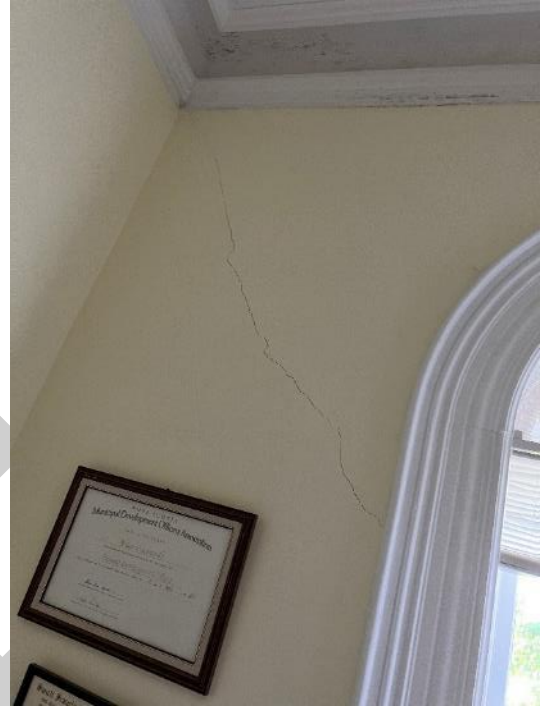
- Notice the diagonal crack traveling from the window casing towards the ceiling.
- This crack suggests significant movement of the exterior wall. Further intrusive investigation is recommended to determine the overall degree and implications of any deterioration within the mass masonry wall.

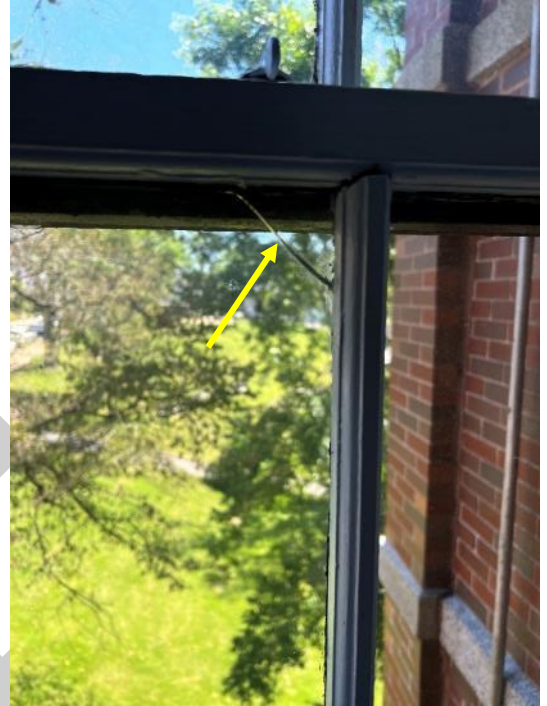
- In general, single-glazing was observed to be in good condition; however, some cracked and damaged panes were observed requiring replacement.

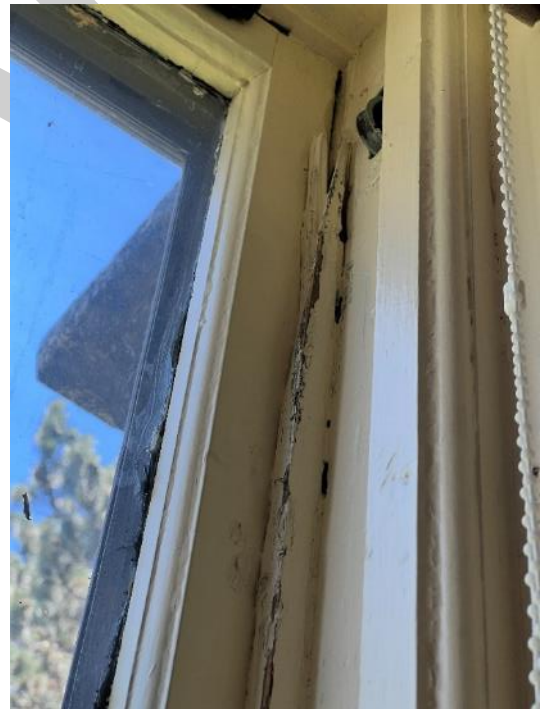
- At the courthouse room, missing and damaged window stops were observed requiring repair.

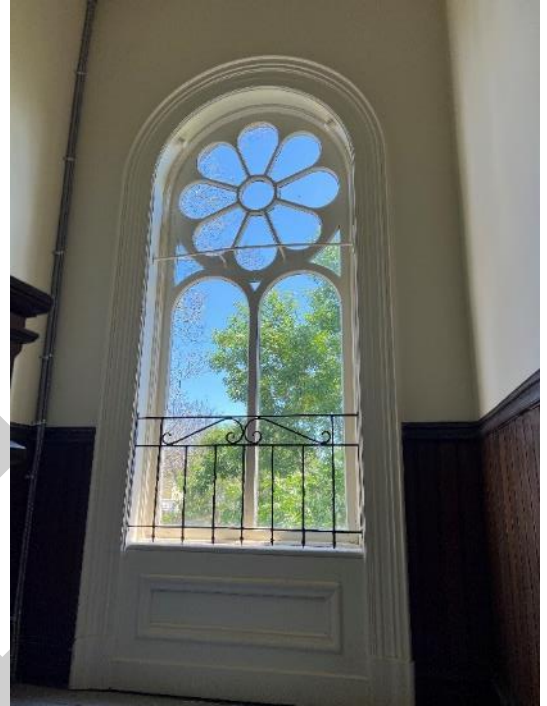
- The window interior windowsill was observed to be in fair condition requiring rejuvenation.
- This is typical of many windowsills. In general, sanding, minor repairs and paint/stain would address the deficiencies observed at the interior.

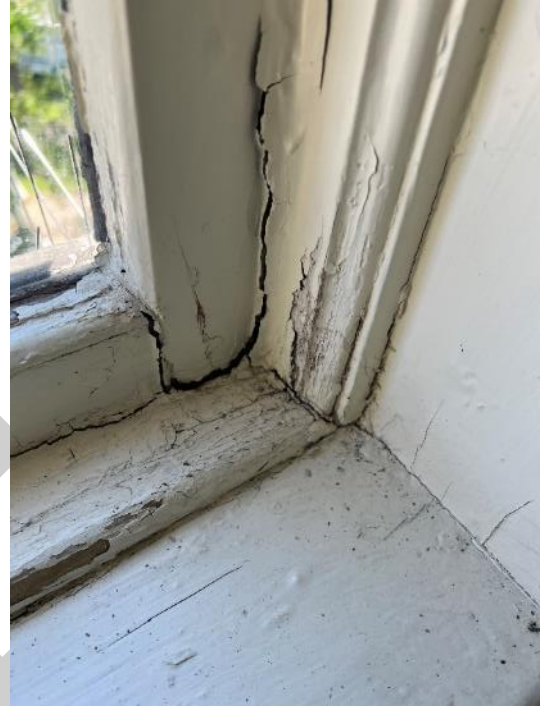
- Signs of water ingress and/or damaged caused by condensation were observed at the sill. See following image.

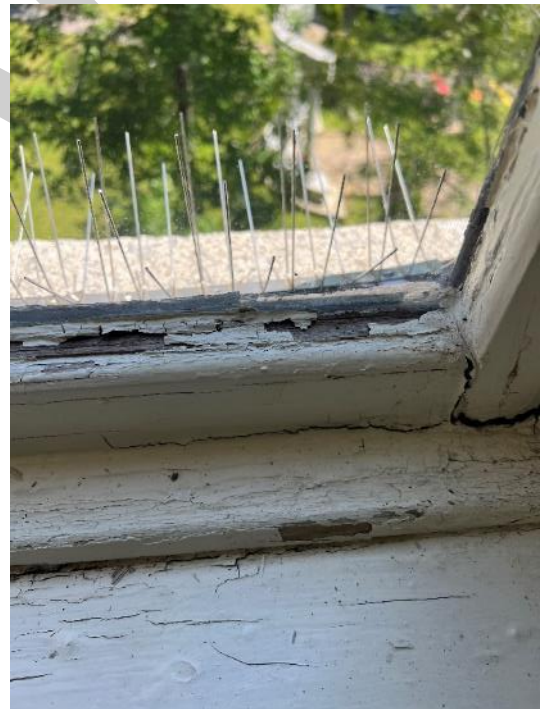
- Many individually glazed units require removal, sanding of frames and reglazing to improve their performance and ensure performance equal to their design.

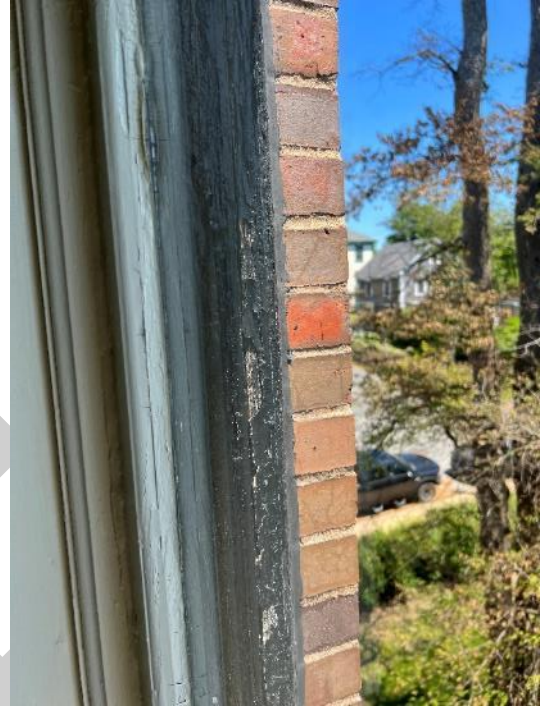
- At the exterior, some deterioration of the window frame was observed requiring the removal of all sealants, stripping and sanding of the window frame, sash, mullions and sill followed by refinishing.

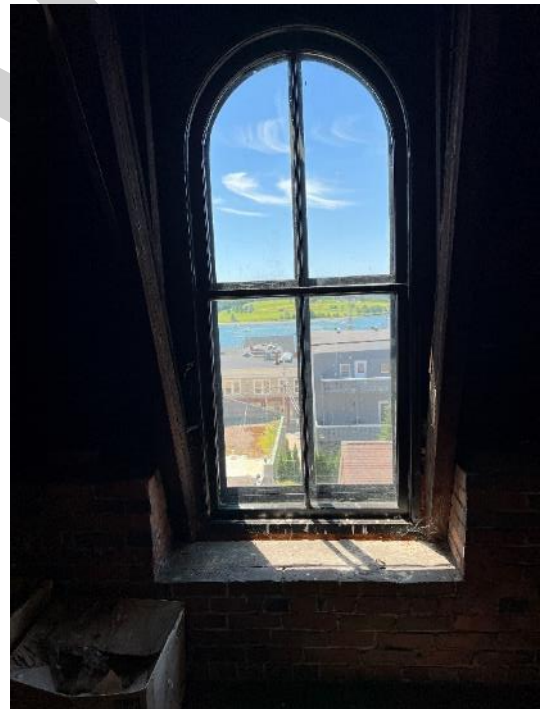
- Within the mansard at the south of the building, windows were observed to be in good to fair condition.
- Bird nests and droppings were observed around window frames and at windowsills requiring maintenance.
- Newer spray polyurethane foam (SPF) was observed around multiple windows, likely in an effort to mitigate water ingress and drafts.

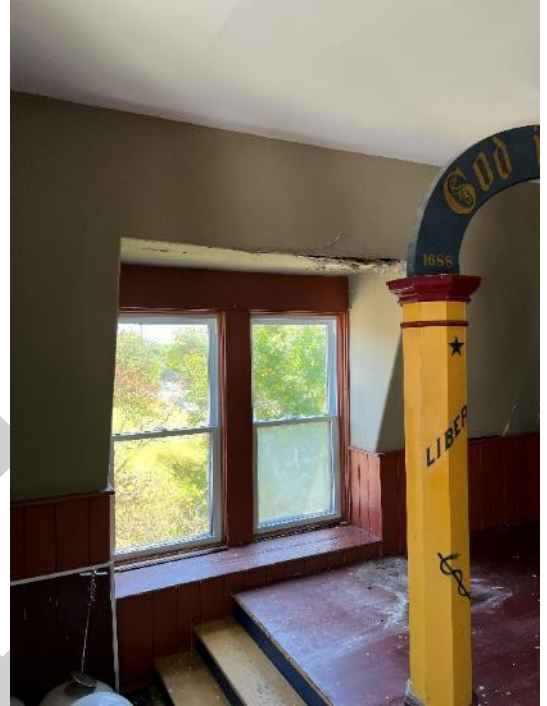
- Newer vinyl windows were observed to be installed at the north upper floor.
- At the north interior, substantial water ingress was observed around dormer windows.
- Deteriorated, crumbling and stained drywall and/or plaster was observed. Water stains were further observed around windows.

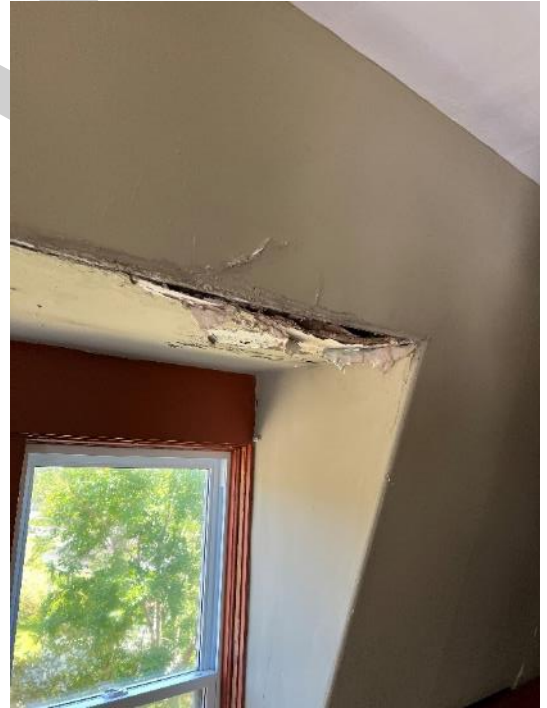
- Significant water ingress was observed possibly due to roofing and/or flashing deficiencies at the exterior. These areas of water ingress will be addressed in the overall rejuvenation effort.
- Ongoing water intrusion has the potential to create indoor air quality issues and the growth of harmful organics. Mold may be present in these areas. Further evaluation is recommended.

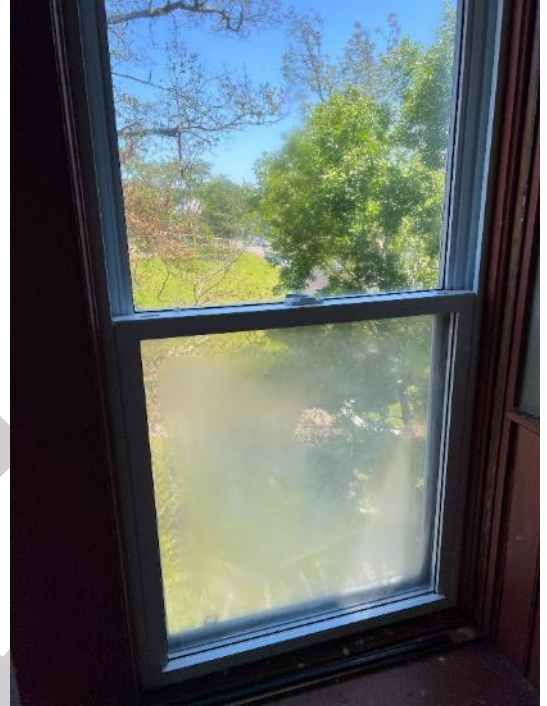
- A newer vinyl window was observed to have a broken seal between glazing causing condensation and fogging.

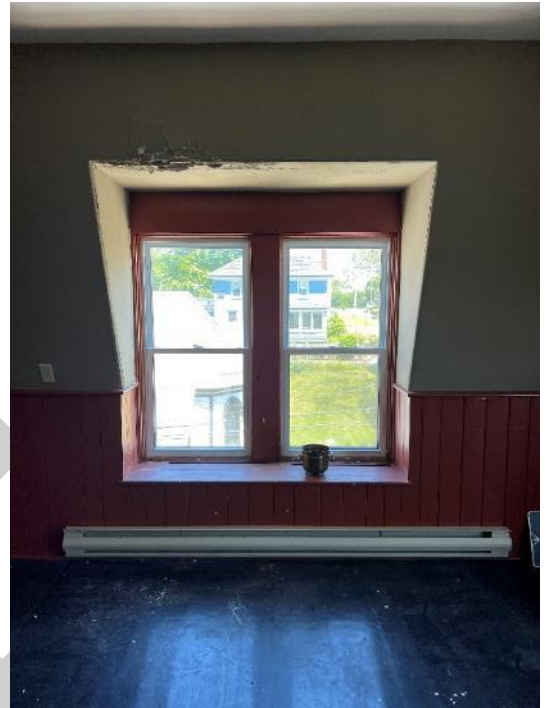
- Significant water ingress was observed possibly due to roofing and/or flashing deficiencies at the exterior. These areas of water ingress will be addressed in the overall rejuvenation effort.
- Ongoing water intrusion has the potential to create indoor air quality issues and the growth of harmful organics. Mold may be present in these areas. Further evaluation is recommended.

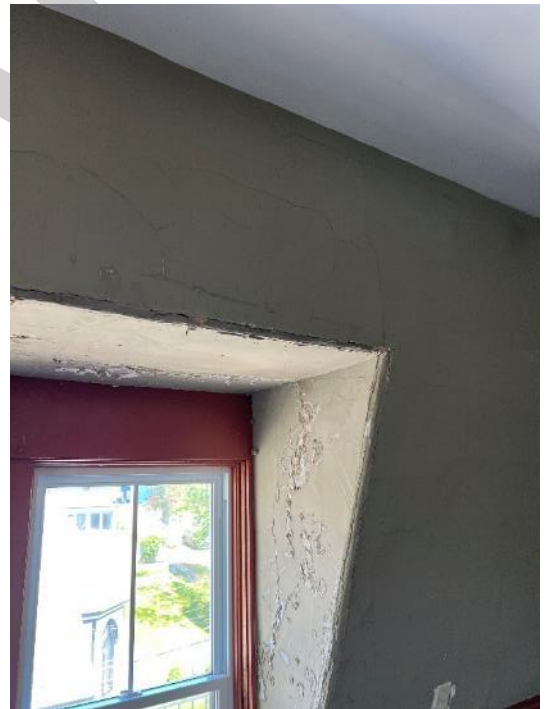
- Significant water ingress was observed possibly due to roofing and/or flashing deficiencies at the exterior. These areas of water ingress will be addressed in the overall rejuvenation effort.
- Ongoing water intrusion has the potential to create indoor air quality issues and the growth of harmful organics. Mold may be present in these areas. Further evaluation is recommended.

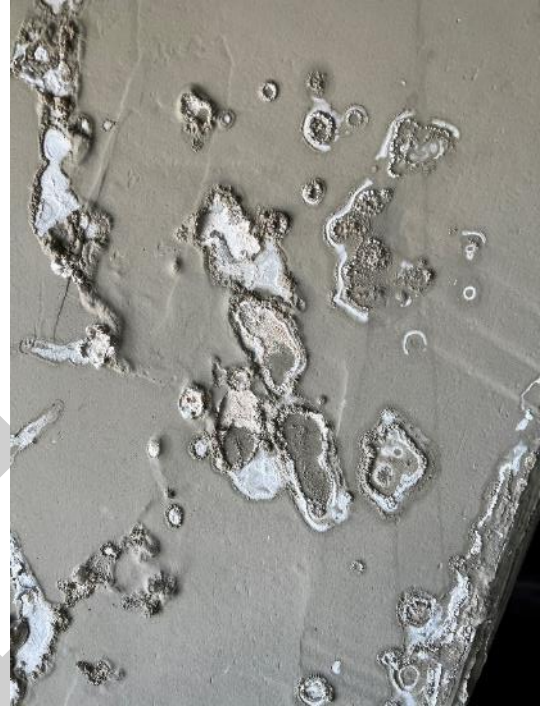
- Significant water ingress was observed possibly due to roofing and/or flashing deficiencies at the exterior. These areas of water ingress will be addressed in the overall rejuvenation effort.
- Ongoing water intrusion has the potential to create indoor air quality issues and the growth of harmful organics. Mold may be present in these areas. Further evaluation is recommended.
