40 & 42 DUKE STREET

OLD FIRE HALL BUILDING ENVELOPE CONDITION ASSESSMENT

Lunenburg, Nova Scotia

January 24, 2025
TOR.140136.0001

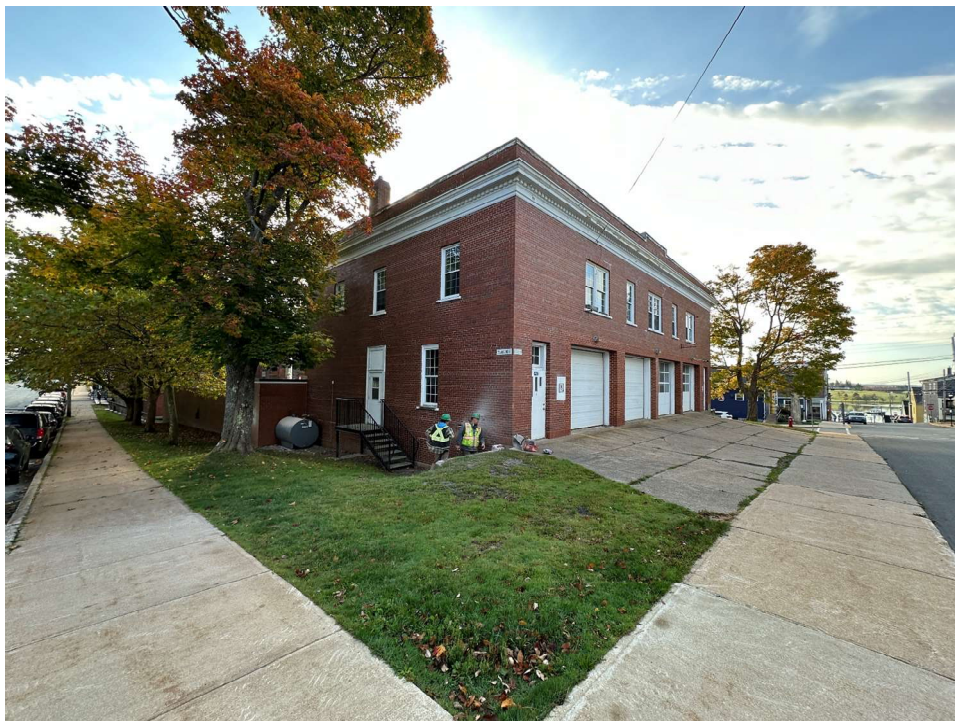
- .5 The configuration of the west elevation bay doors has been altered since original construction. Bricks dissimilar in appearance, exist around the four bay doors – the original drawings show three bay doors with windows in between (*Refer to Figure 1 and Photo 2 in Appendix A*).

Photo 2: Overview of Old Fire Hall north and west elevation

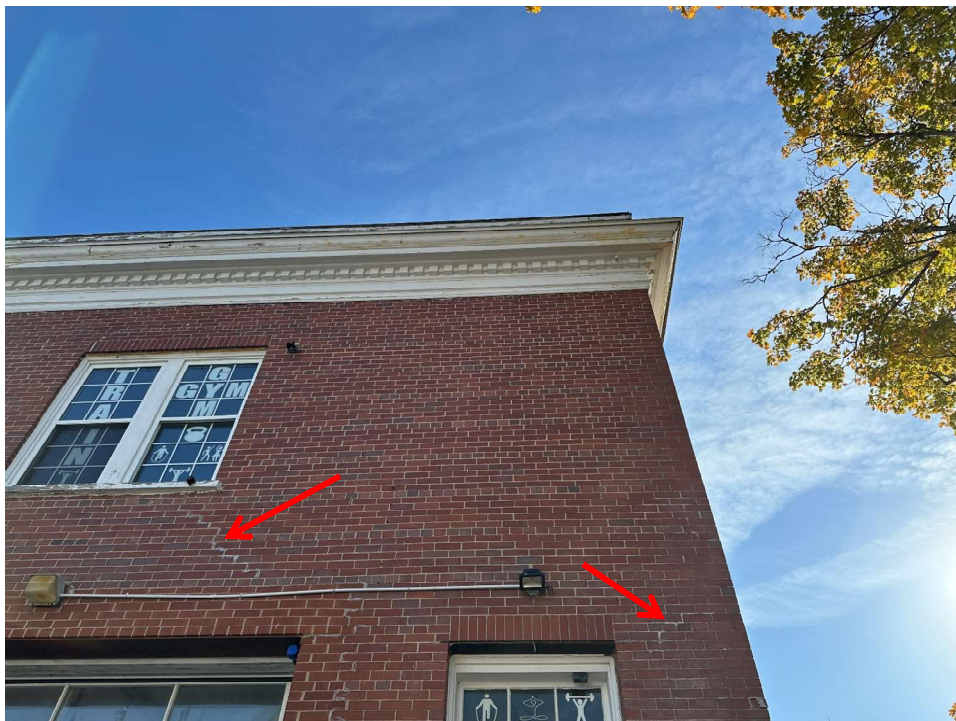
- .1 Overall, the exterior brick masonry cladding of the Old Fire Hall remains in good condition with localized areas appearing in fair condition. Localized deterioration was observed in the form of brick cracking and mortar joint step cracking. Touch-up sealant repair attempts were noted at areas of step cracking which is not a recommended repair method (*Refer to Photo 4 to Photo 5 in Appendix A*).

Photo 4: Localized step cracking with touch-up sealant repair attempts

- .1 Removal and replacement of the roofing membrane. Roof insulation could also be added or upgraded during replacement of the membrane and this should be confirmed pending space use.
- .2 Removal and replacement of waterproofing/flashings and repainting on the wood cornices
- .3 Localized repointing on brick cladding, and
- .4 Repainting and resealing of wood framing around the window and door openings.

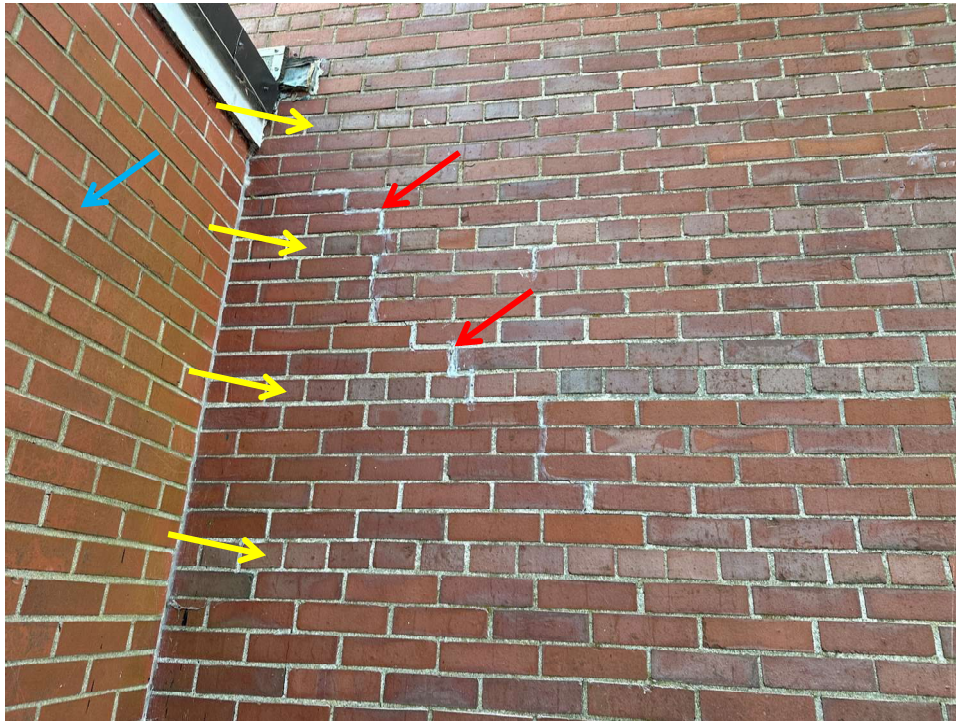
- .2 The brick masonry cladding is constructed in a common bond pattern with five stretcher courses and one header course spaced every sixth course (*Refer to Photo 6 in Appendix A*).

Photo 5: Typical brick masonry bond pattern. Yellow arrows at header courses. Red arrow at step cracking with touch up sealant repair attempt. Blue arrow on west wall of Electric Light Shop

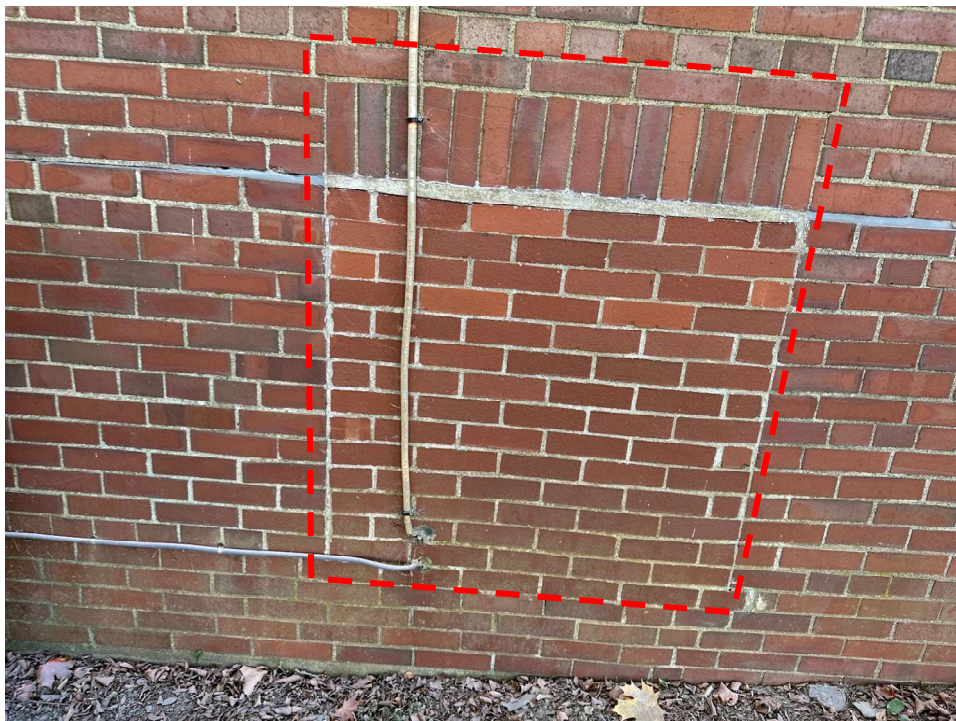
- .3 It appears that the brick masonry cladding is intended to be a mass wall system that is undrained and face-sealed.
- .4 Brick-infilled openings exist on the lower portion of the north elevation. Soldier course brick exists above these openings and it is evident that mortar was installed over the lintel shelf angles (*Refer to Photo 6 in Appendix A*).

Photo 6: Brick infill at pre-existing window opening (typ. at two locations)

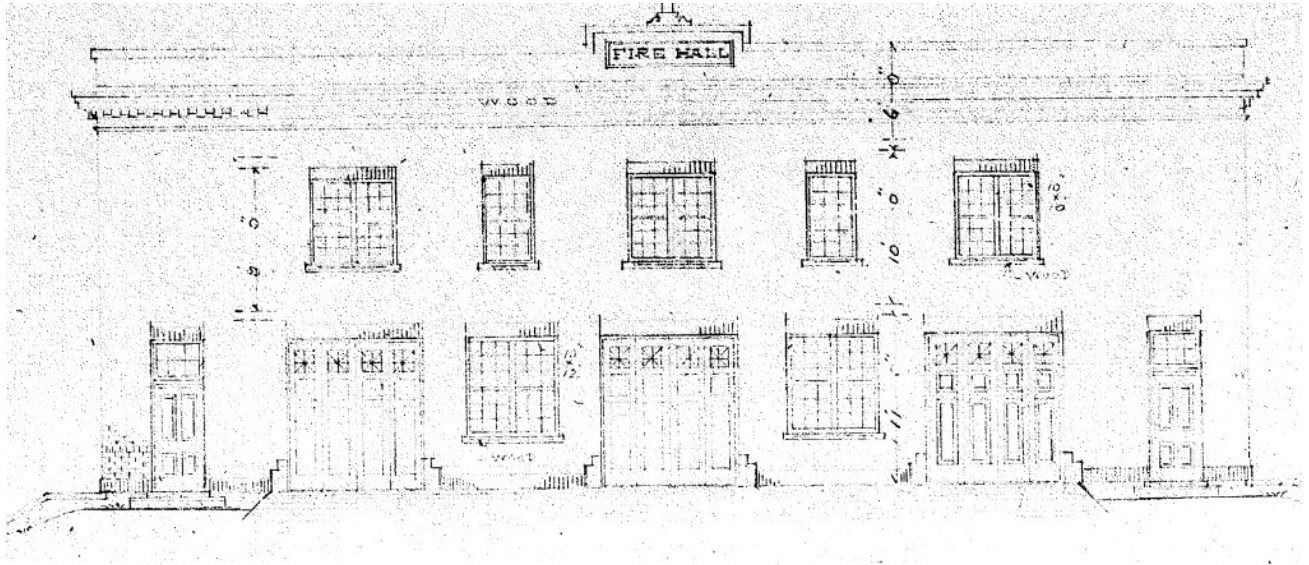
Figure 1: Original (circa 1928) bay door configuration on east elevation from circa 1928 drawings

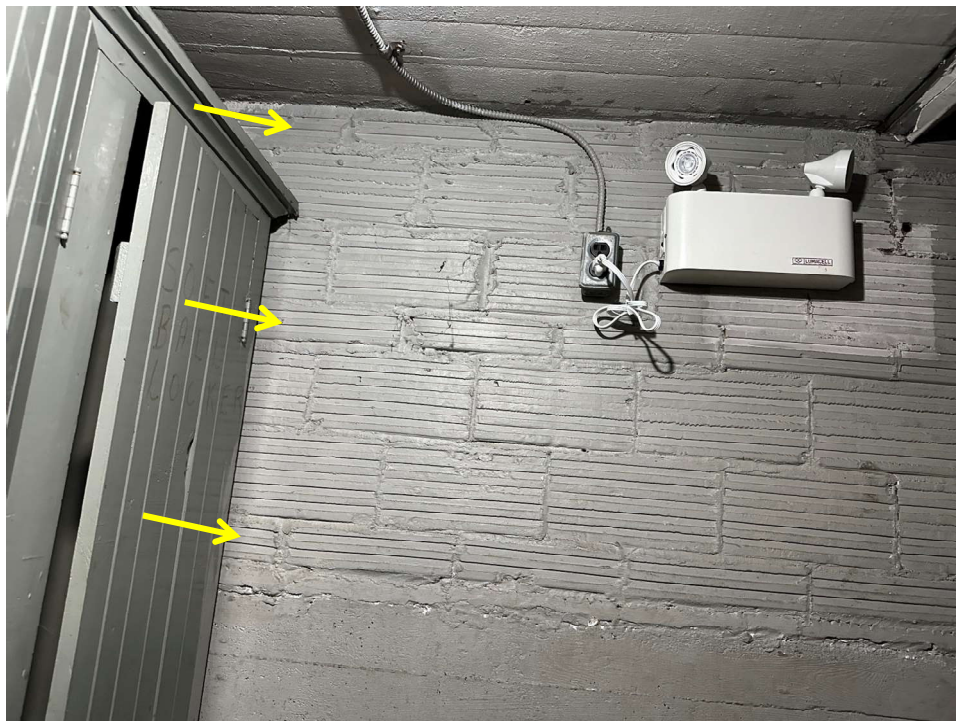
- .1 Where visible from inside the building, the structural clay tiles appeared in good condition. No areas of significant cracking or deterioration were noted (*Refer to Photo 7 in Appendix A*).

- .2 Where visible, the typical structural clay tile bond pattern appeared to alternate between two courses on edge, and one course on bed (*Refer to Photo 7 in Appendix A*). Available drawings indicate the ground level wall thickness as 16", the second floor wall thickness as 12", and the attic space wall thickness as 8". As such, in addition to the exterior brick masonry and air space, the ground floor likely has three wythes of structural clay tile, the second floor wall has two, and the attic space wall one wythe.

Photo 7: Structural clay tile as visible from building basement. Yellow arrows at on bed courses

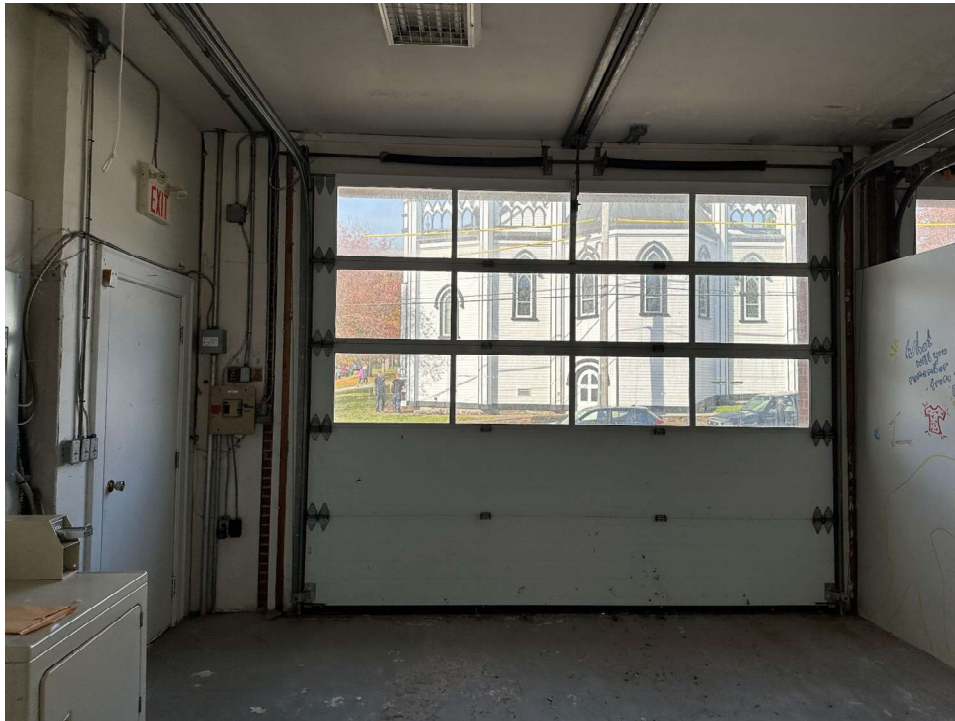
- .1 There are four bay doors on the west elevation and one bay door on the east elevation and they all appeared in fair condition, and it is our understanding they perform as intended (*Refer to Photo 8 in Appendix A*). However, if the Town is considering converting this building to occupied space, it is anticipated that these doors will negatively affect the overall thermal performance of the building and the general comfort of the occupants.

Photo 8: West elevation bay door interior (one of four)

- .1 Removal and replacement of exterior access doors – two on east elevation, two on west elevation.
- .2 Removal or retrofitting of the existing bay doors – one on the east elevation, four on west elevation.

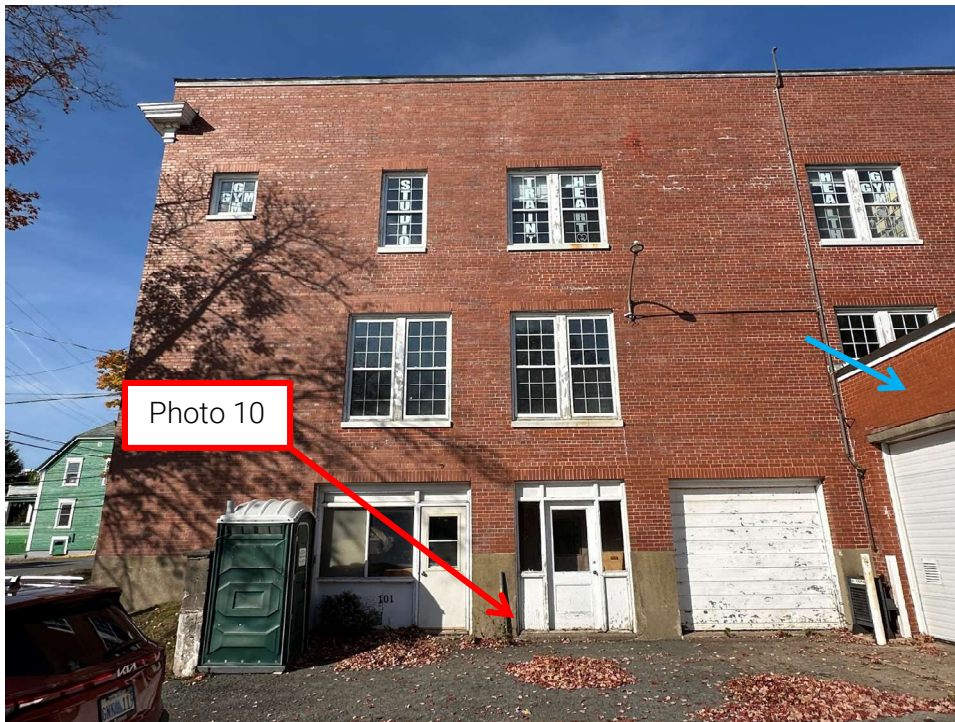
- .3 Except for the north elevation door which appeared newer and in good condition, the other older doors were observed to be in fair to poor condition. Furthermore, the wood door frames at all locations need rejuvenation, resealing and repainting (*Refer to Photo 9, Photo 10 and Photo 11 in Appendix A*).

Photo 9: Basement access doors and bay door on east elevation (rear of building). Blue arrow on south wall of Electric Light Shop

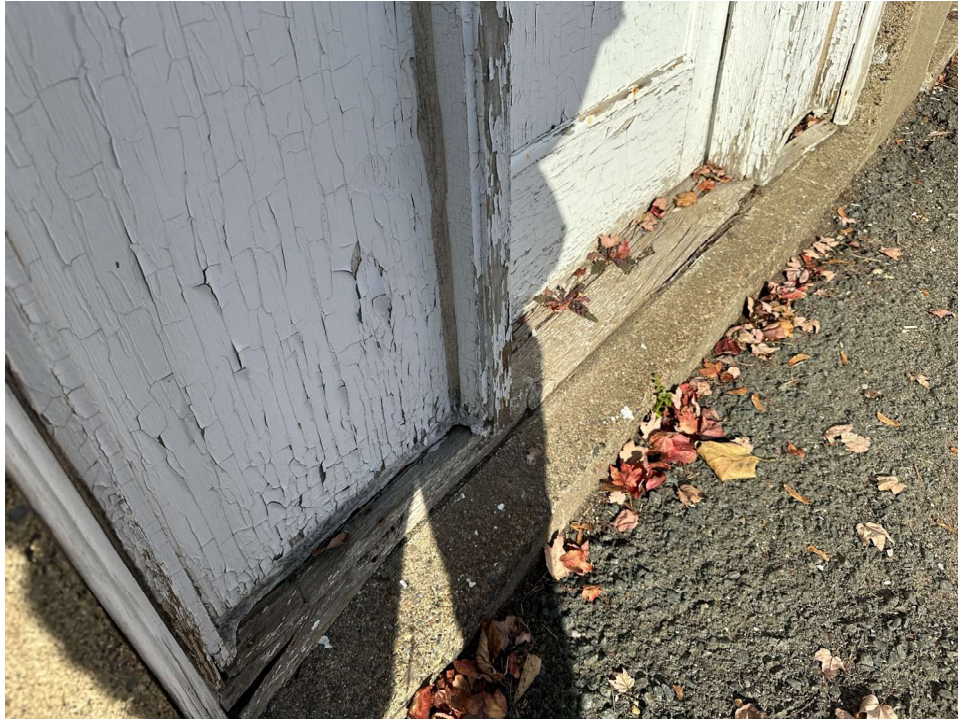
Photo 10: Close up of east elevation door with deteriorated wood threshold and failing paint finish

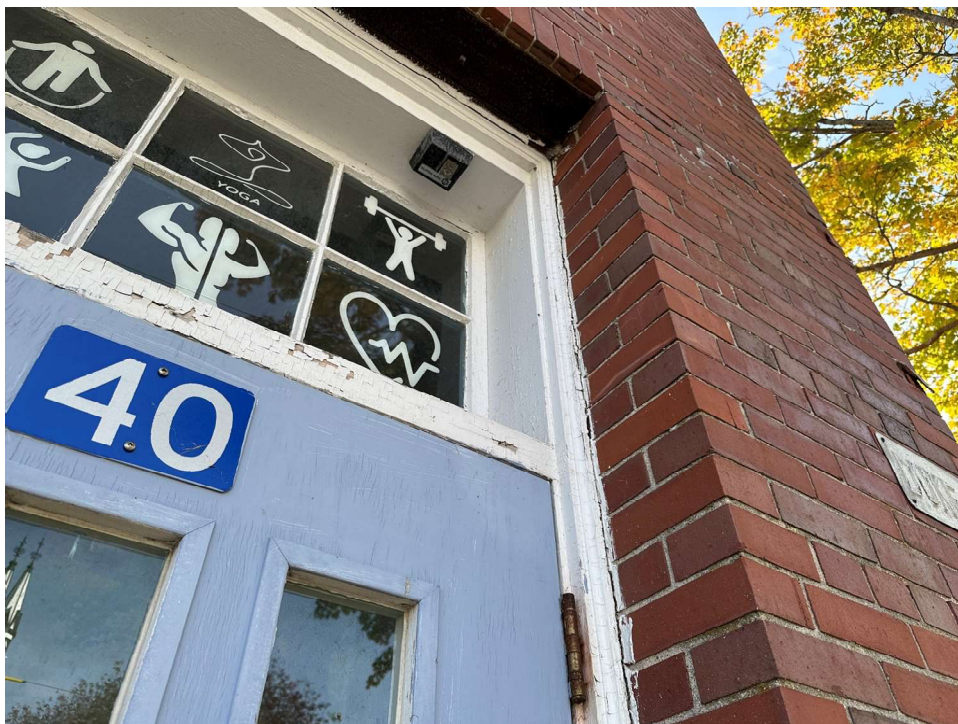
Photo 11: Close up of west elevation door with failing paint finish near southwest corner of building

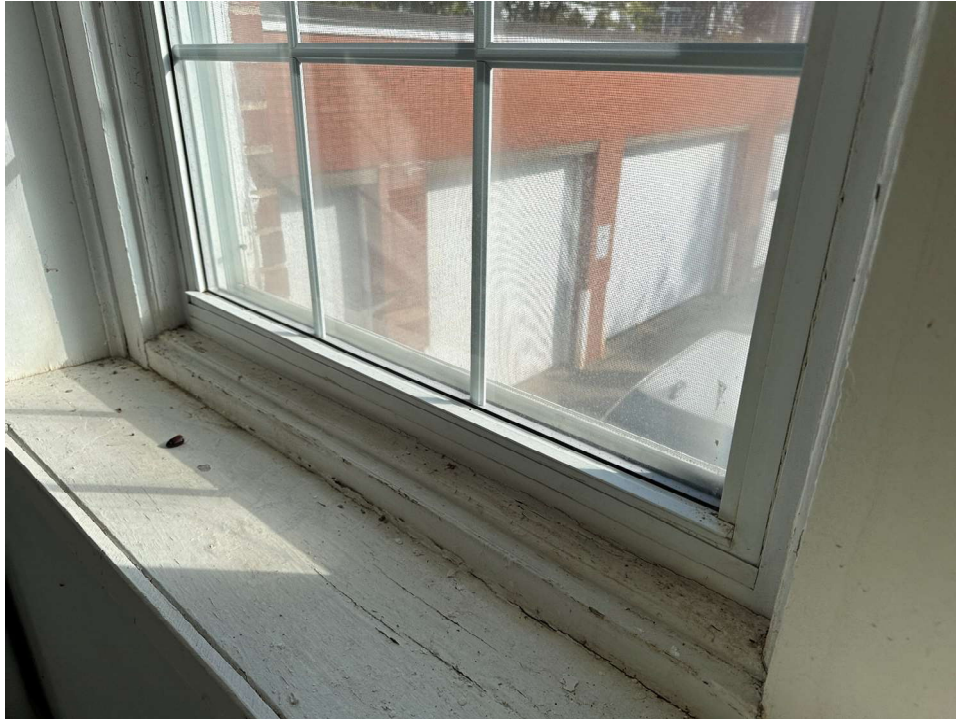
- .1 The vinyl windows throughout the building appear newer and in good condition. However, the vinyl windows were installed into the original wood window openings which are in poor condition and require repairs, resealing and repainting (*Refer to Photo 12 and Photo 13 in Appendix A*).

Photo 12: Interior close up of newer vinyl window (typ. throughout building) set in original wood frame in fair to poor condition

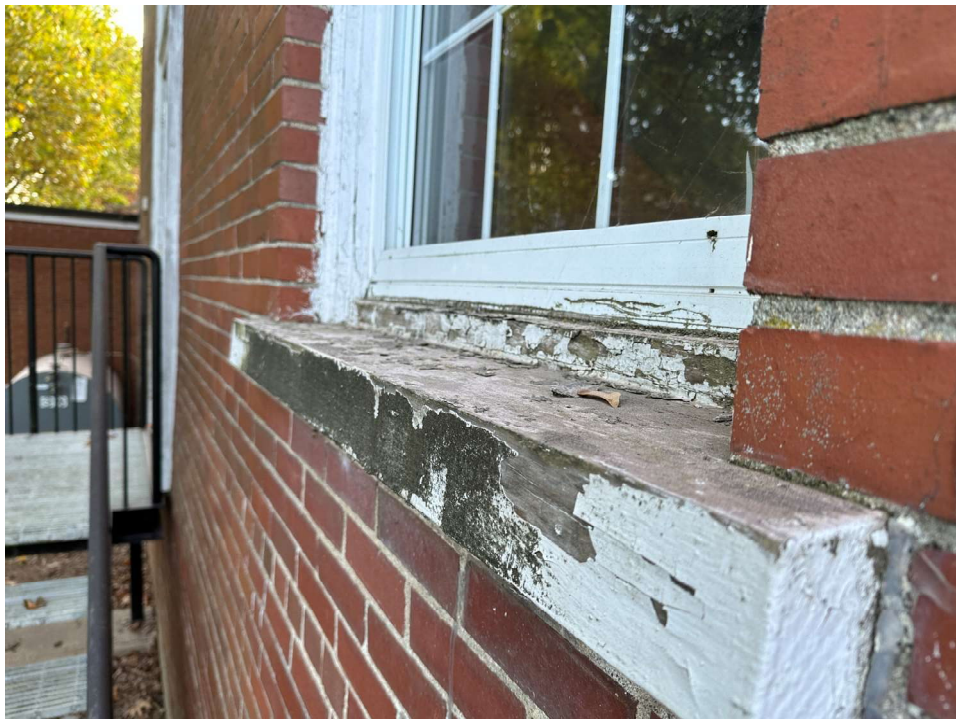
Photo 13: Failing paint finish on exterior window sill (typ. condition at others)

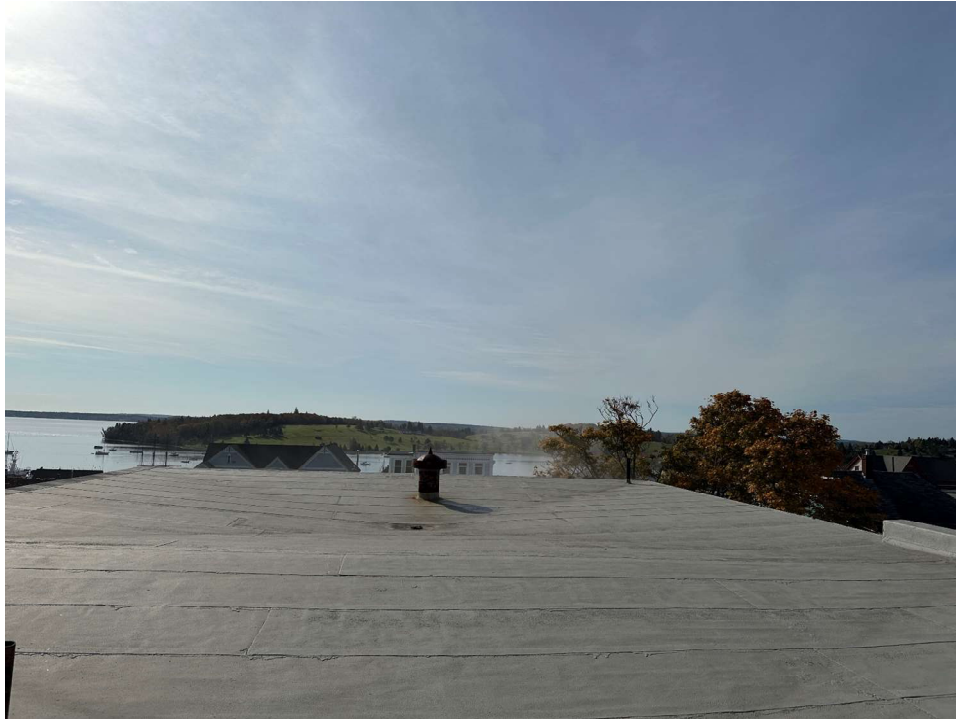
- .1 The existing roof membrane, which appeared to be a modified bitumen sheet roofing overlain with a liquid-applied membrane, appeared deteriorated and in poor condition. Blistering, debonded areas and alligator cracking were noted and tie-ins at roof projects also appeared deteriorated (*Refer to Photo 14, Photo 15 and Photo 16 in Appendix A*). Given the recent investment into roof re-strengthening, it is recommended that the roofing membrane be removed and replaced to protect the underlying structural system and prevent leaks into the building.

Photo 14: Overview of existing roofing membrane

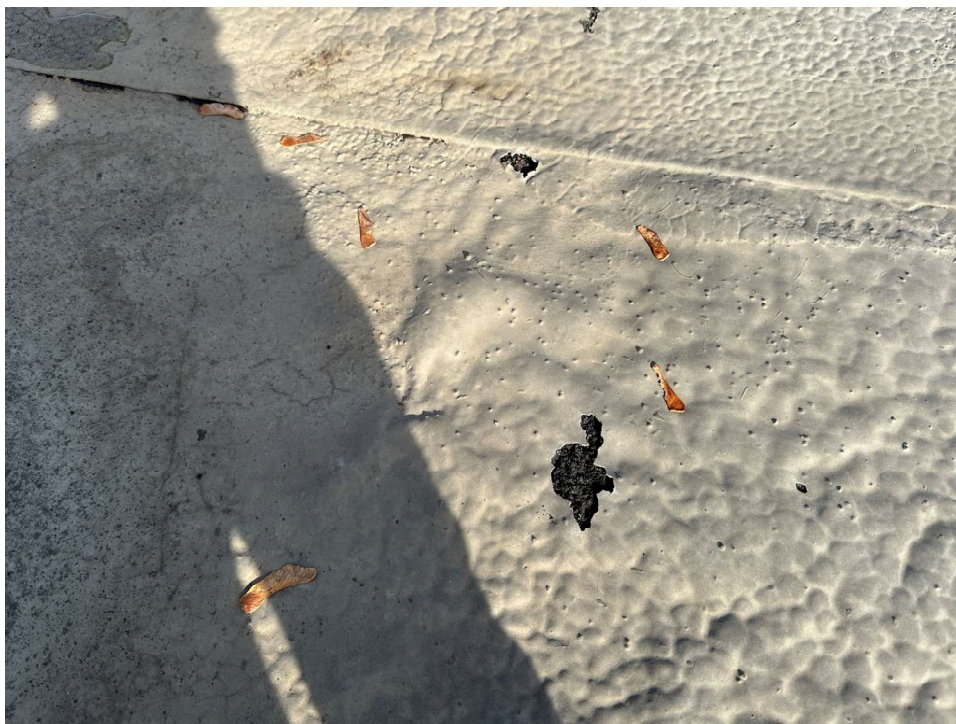
Photo 15: Close up of deteriorated roofing membrane that had a coating applied overtop

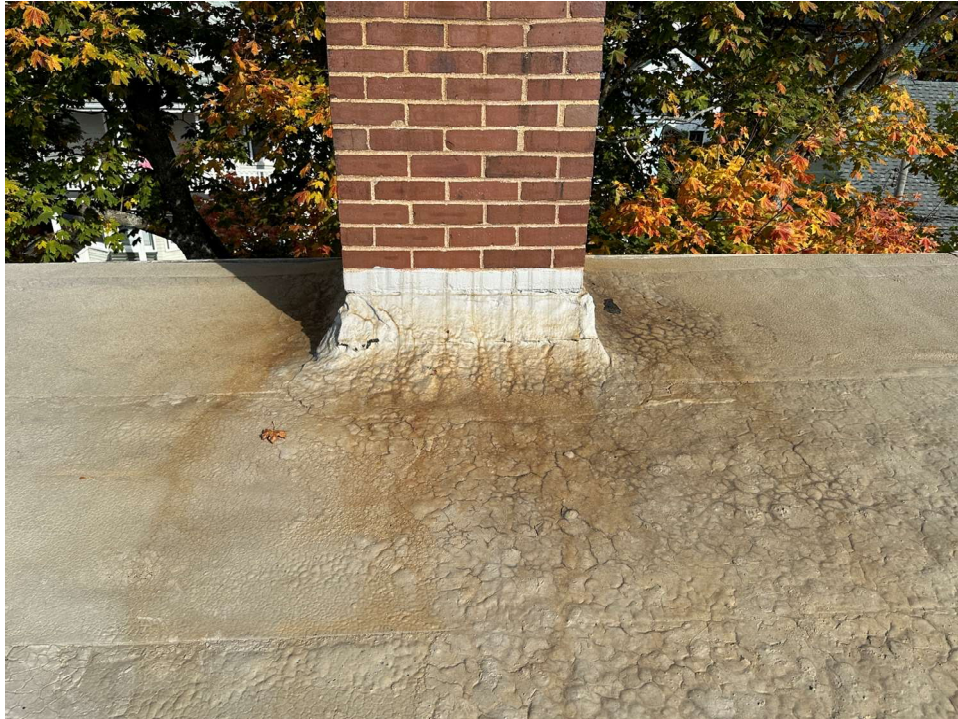
Photo 16: Alligator cracking on roofing membrane telescoping through the coating at north chimney

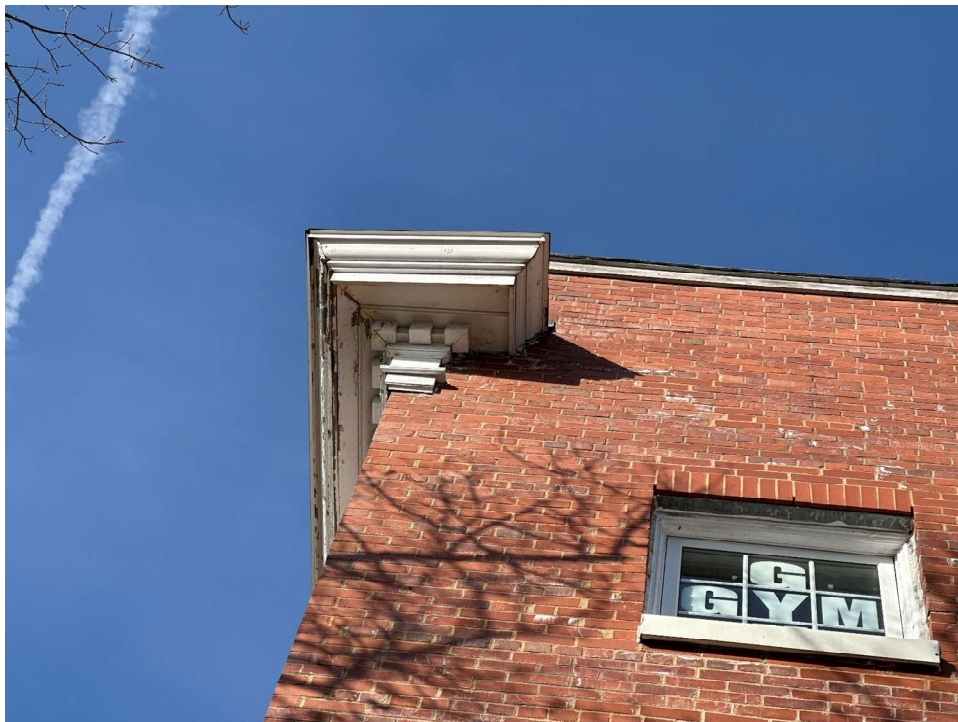
- .2 From ground level, failing paint finish and areas of splitting and warping were noted on the underside of the wood cornices on the north, west and south elevation walls (located approximately 600 mm below the roof edge) (*Refer to Photo 17 in Appendix A*). The top surfaces of the cornices were not accessible for our review, but based on how the cornices are detailed on the original drawings, there is the potential for moisture ingress into the wall assembly if waterproofing and watershed are not maintained on the cornices (*Refer to Figure 2 in Appendix A*).

Photo 17: Failing paint finish and deterioration on underside of wood cornice at southeast corner

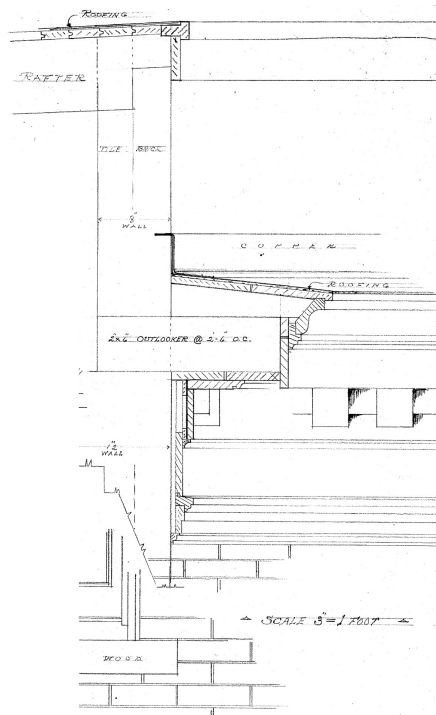
Figure 2: Original (circa 1928) typical cornice detail. Note, moisture ingress has potential to deteriorate “outlooker” and wall cavity if the cornice detailing is poor

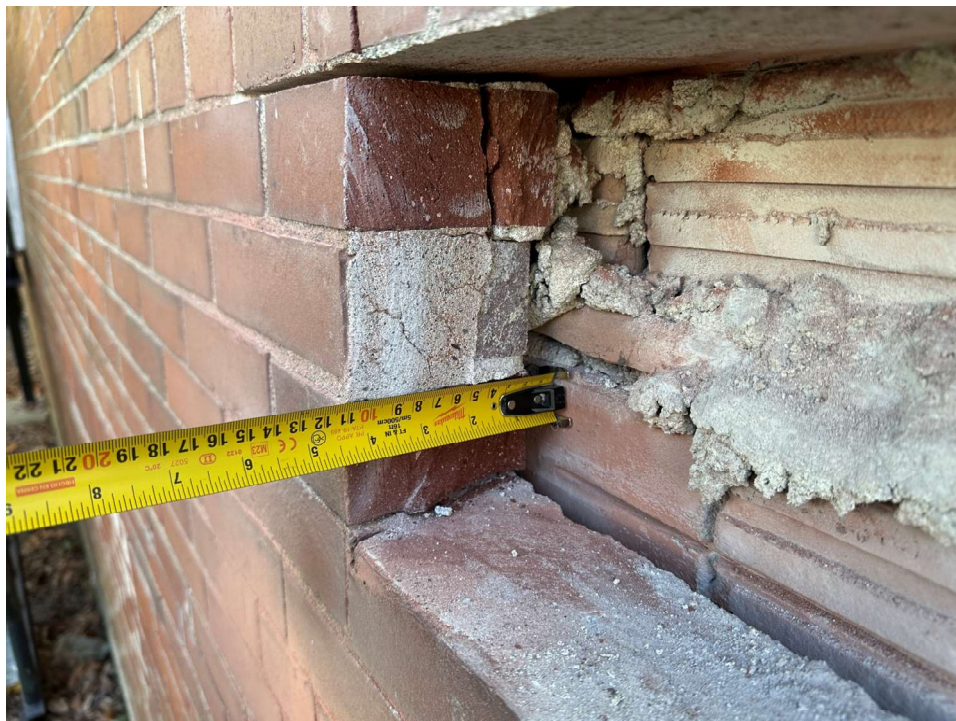
Two exploratory openings were created in the brick cladding to allow for a localized sample review of the concealed elements of the building enclosure (*Refer to Photo 18 and Photo 19 in Appendix A*). The exploratory openings were approximately 24" by 18" in size and were performed to examine the condition and composition of the building envelope.

- .1 In general, the condition and composition at both exploratory openings were observed to be the same. The following wall construction was observed (from exterior to interior):
 - Clay masonry brick (4")
 - Air space (1/2")
 - Structural clay tile back up wall (thickness varies)
- .2 Membrane was not observed on the structural clay tile back up wall at either exploratory opening.
- .3 Brick ties were not observed at either opening exploratory openings, which is typical for brick mass masonry cladding constructed with the observed bond pattern.
- .4 The removed brick was reinstated.

Photo 18: Exploratory brick opening on north elevation

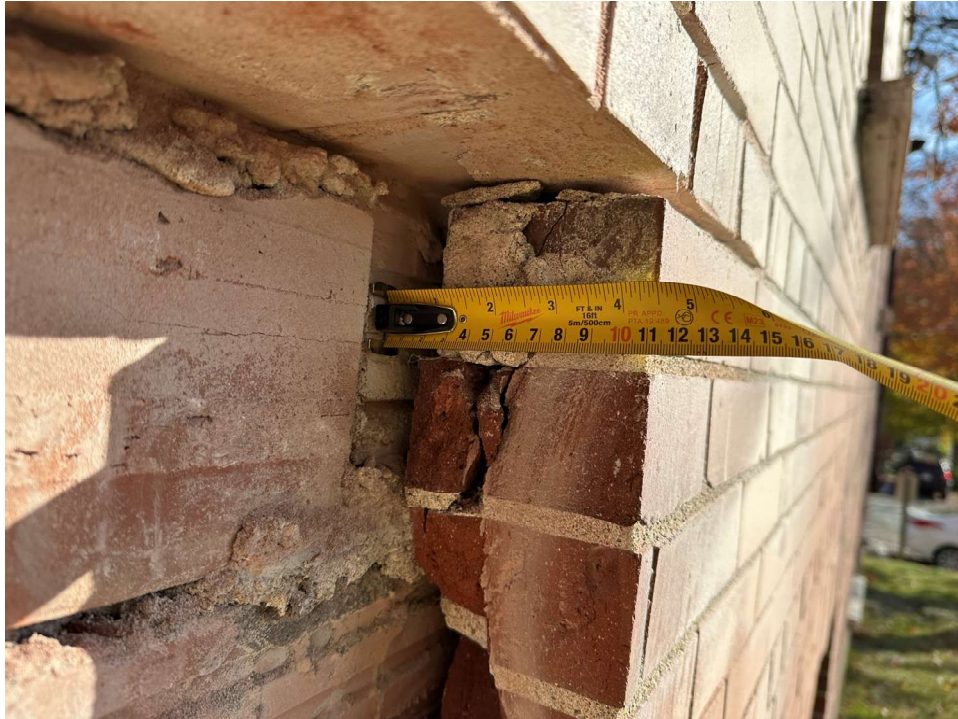
Photo 19: Exploratory brick opening on south elevation
