**REFERENCE IMAGES**

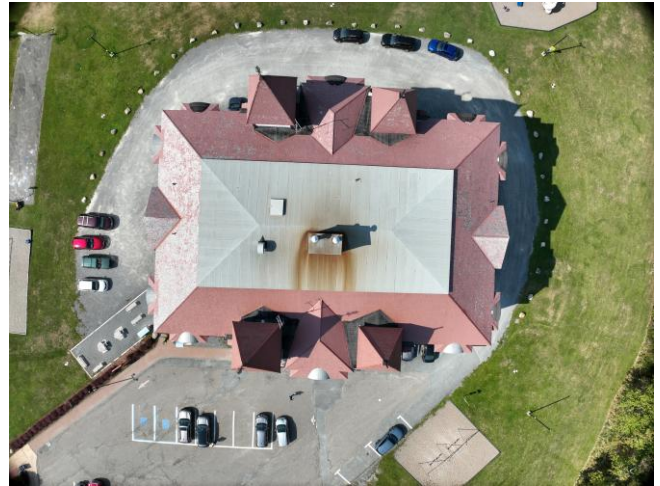
General Overhead – Mod. Bit.

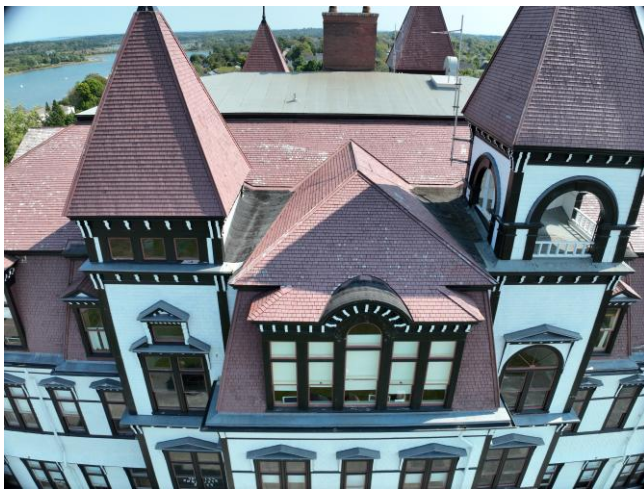
General – Towers and Hip

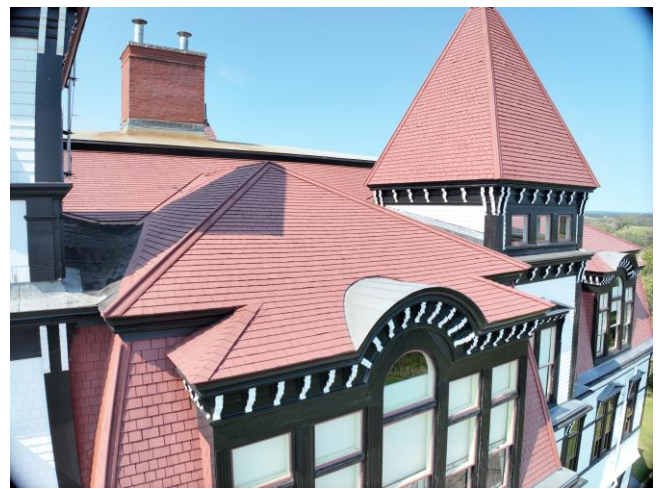
General – Hip and Tower

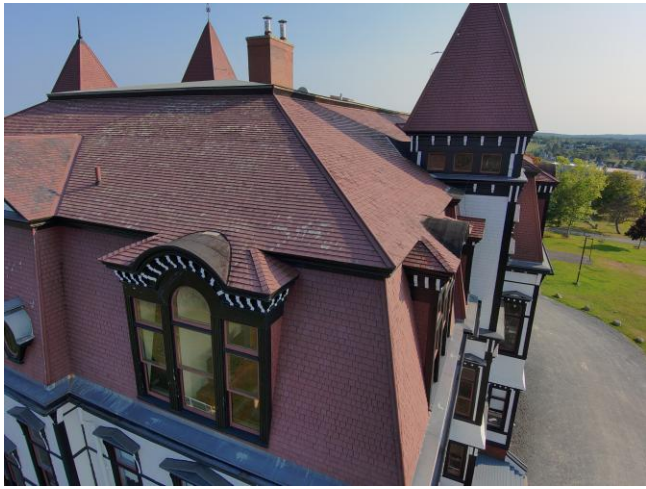
General – Sloped roof area and eye-brow dormer

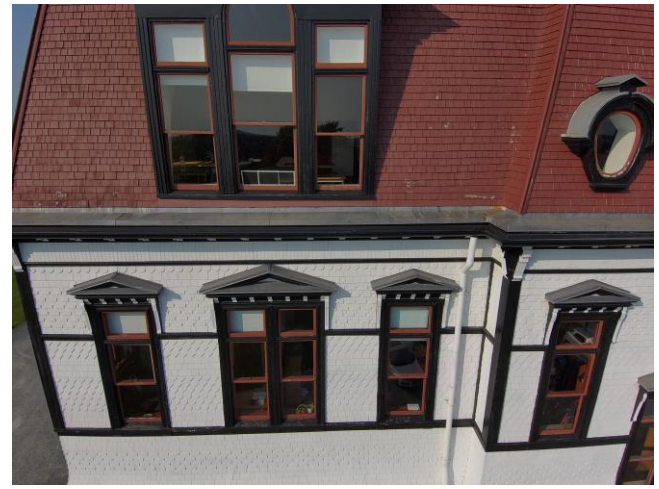
General - at Mansard

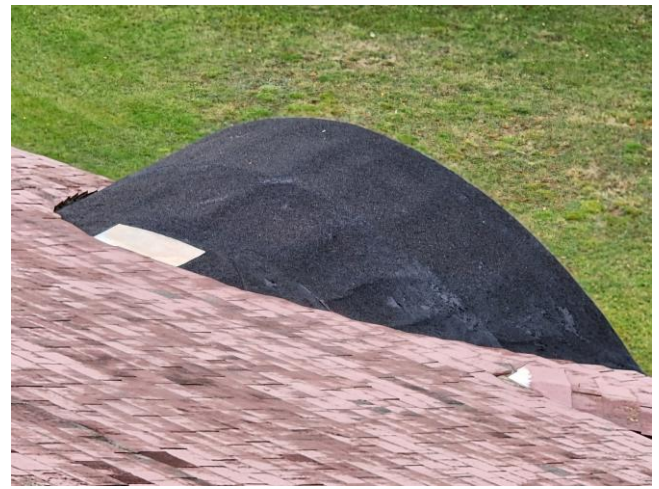
General – existing conditions – eyebrow dormer

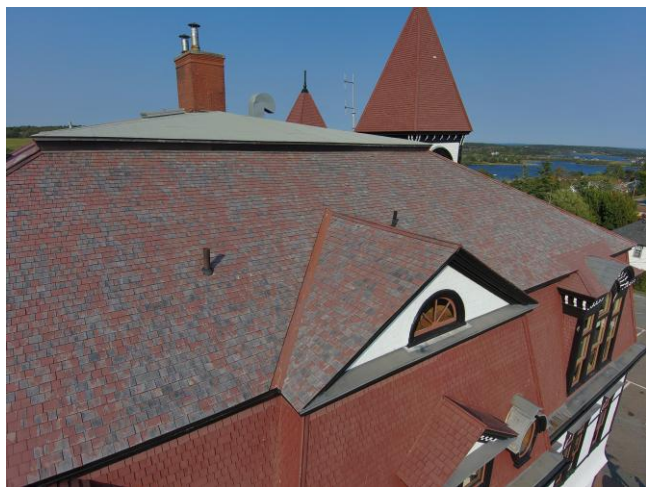
General – Gable with metal valleys

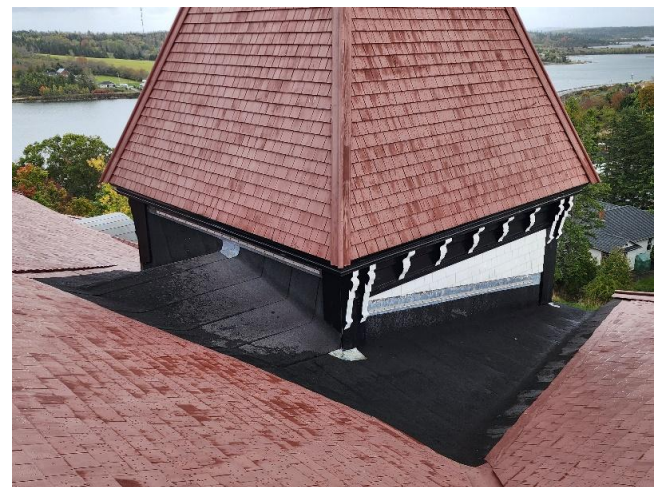
General – Mod. Bit. at Towers

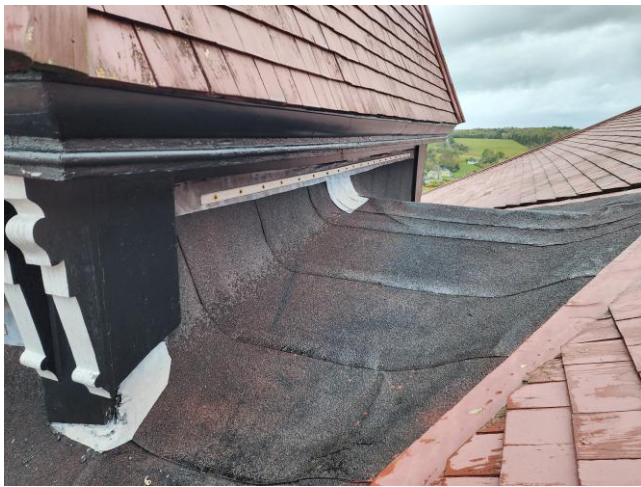
General – Existing saddle at backside of tower

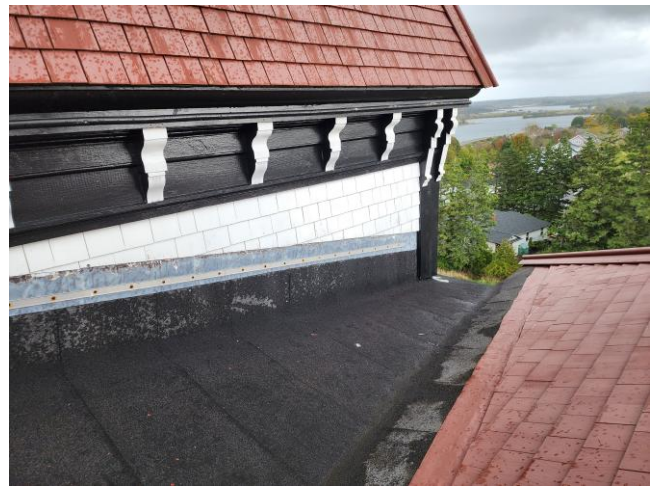
Existing – mod. bit. at sidewall of tower

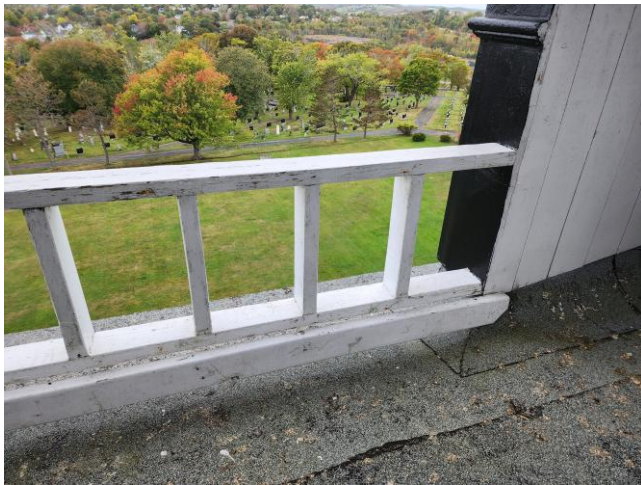
General – Existing Railing, Mod. Bit. at tower

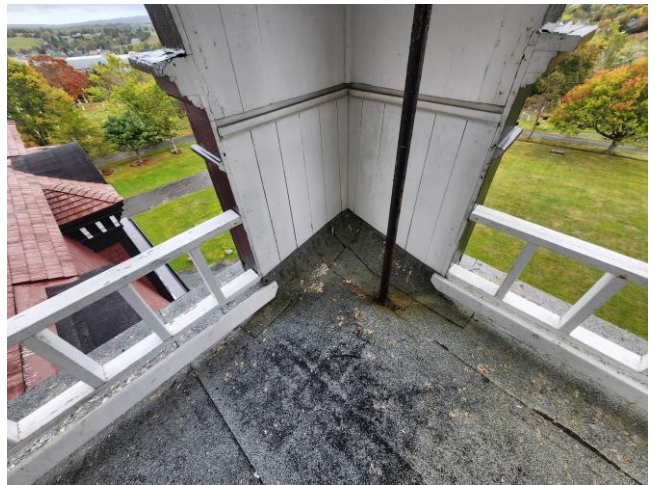
General – existing mod. bit., penetration at tower

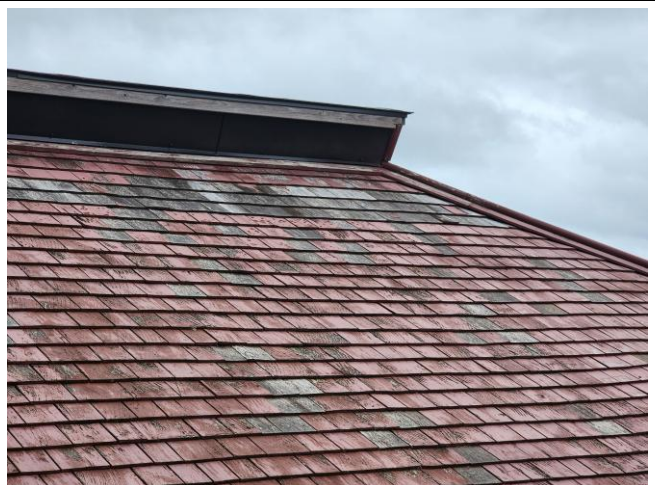
General – Existing condition at fascia below mod. bit.

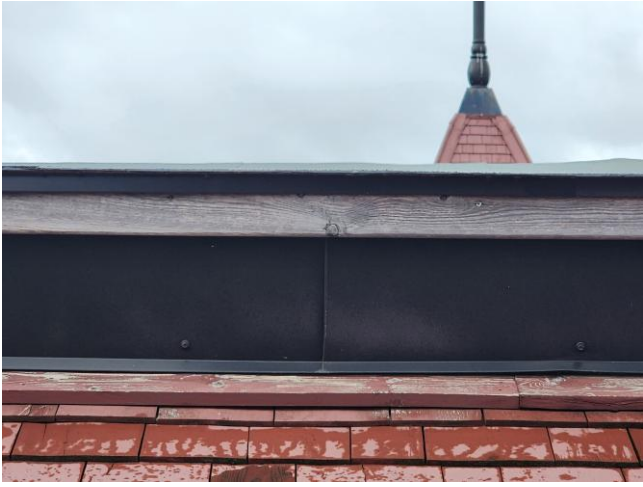
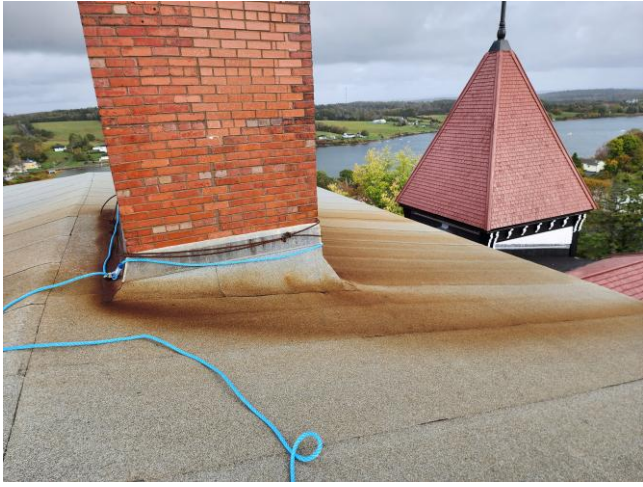
<p>General – Existing condition at fascia below mod. bit.</p>	<p>Existing condition at chimney</p>

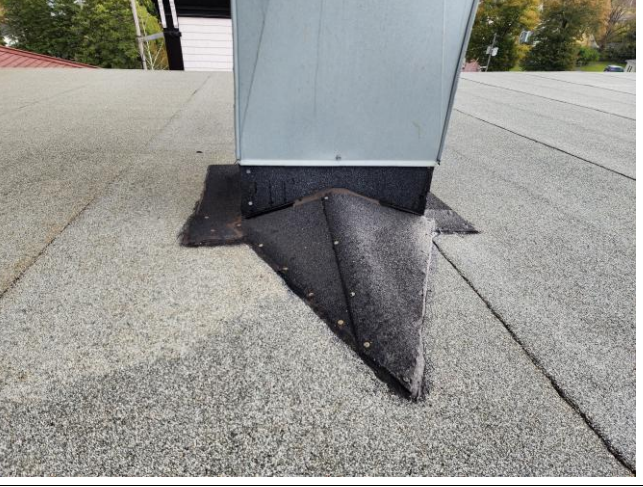
<p>Intentionally Blank</p>
<p>Existing condition – saddle at gooseneck penetration</p>
