**TOWN OF LUNENBURG
RFP #TOL2024016**

REQUEST FOR PROPOSALS
Community Centre Exterior Upgrades

South Side Exterior Upgrades

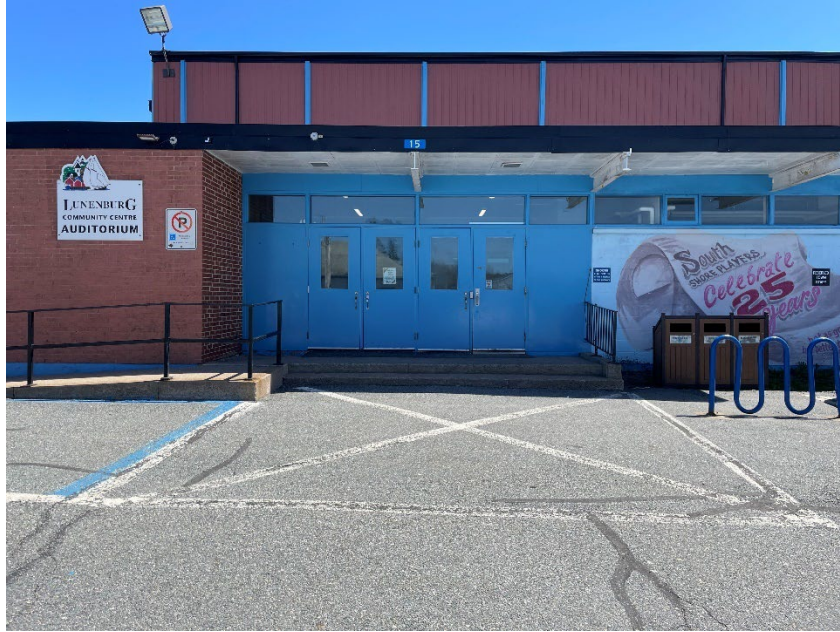
Photo 1. Existing Main Entrance

An Accessibility Audit was completed of the Community Centre facility, located at 15 Green St, Lunenburg, NS, in Spring 2023. Recommendations from the audit included changes to the exterior entrance pathway, including widening the sloped pathway to allow for easier access to the facility, making a level landing, and install handrails.

Replace the two sets of doors with two new sets of double doors that open without an obstruction post. One set of double doors must have a power-operated door opener button. The power-operated door opener button must be mounted within the level area upon approach of the door. A new full push bar should be provided for multiple levels of access.

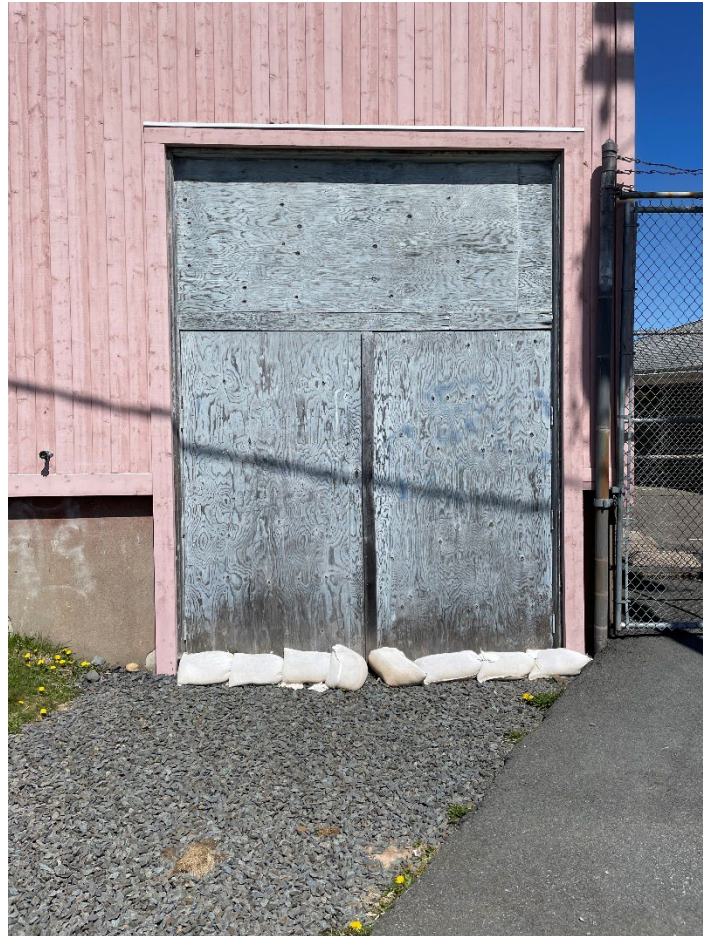
Photo 2. Existing South Side Wooden Doors

Also, there is a non-functional exterior wooden door on the South side of the Community Centre (facing the soccer field). Water enters the facility through this door during rain events causing water damage to the basement. The door needs to be removed and the foundation and exterior wall need to be reinstated to match existing conditions.

- Install concrete foundation to match existing building, approximately 4 feet high by 10 feet wide.
- Install sheathing and wood siding to match existing, approximately 8 feet high by 10 feet wide.

Replace the gravel apron with asphalt, to improve drainage. Match existing adjacent asphalt.

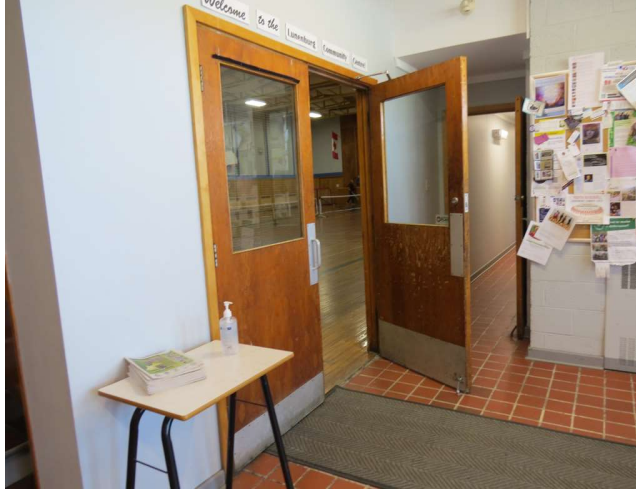
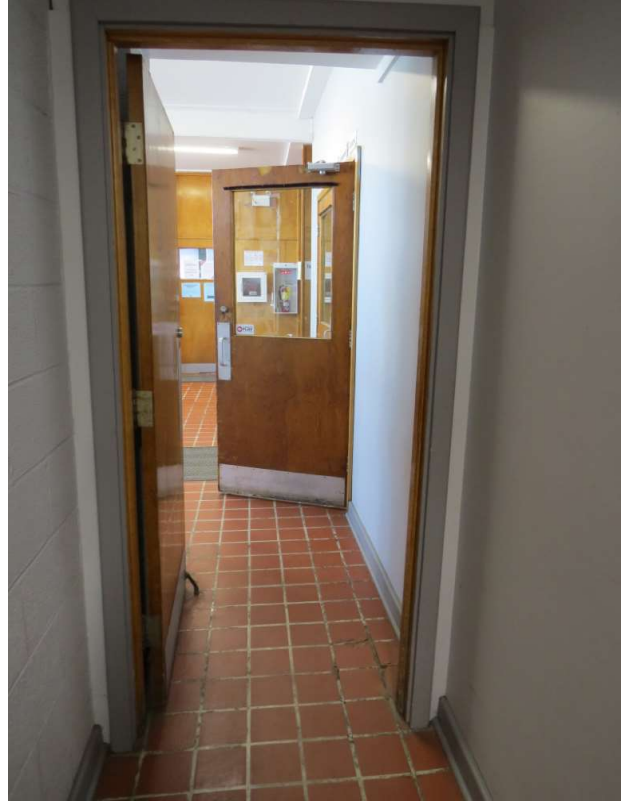
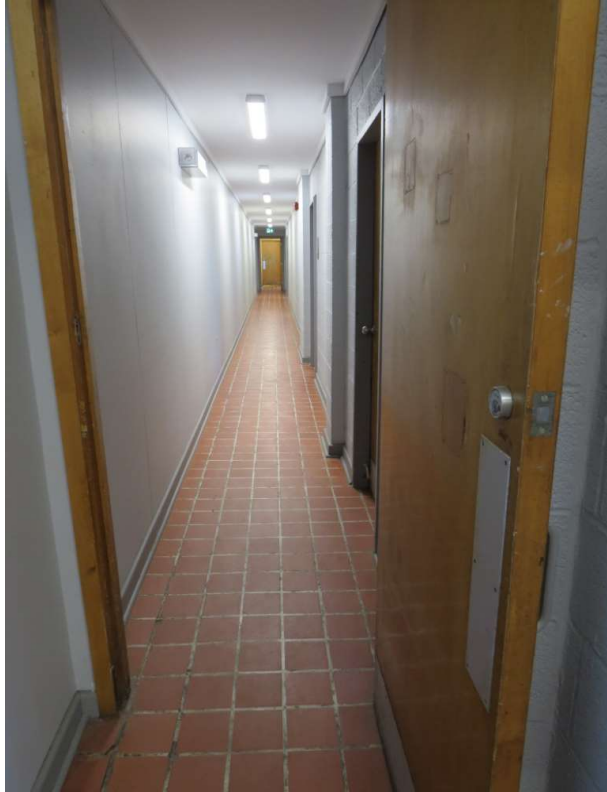
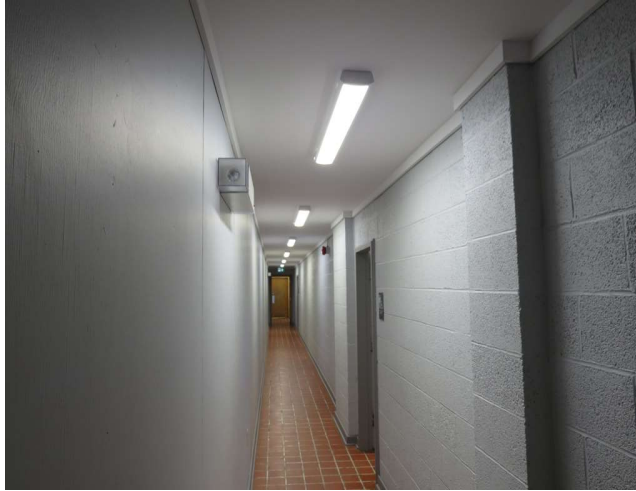
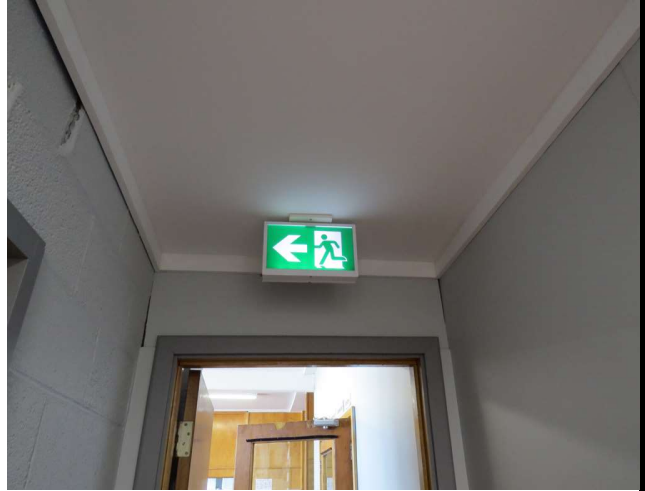
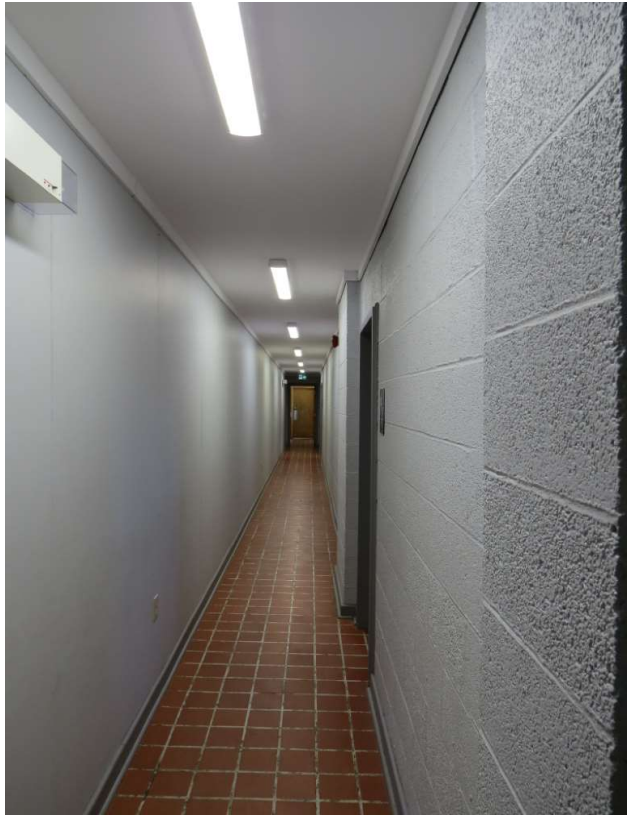
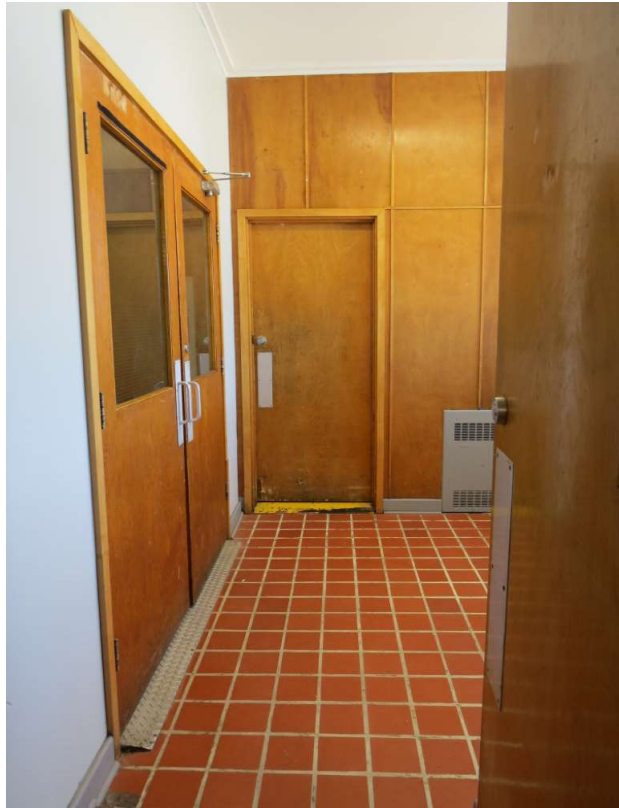
| AREA OF FOCUS | EXISTING CONDITIONS | POSSIBLE BARRIERS | PROPOSED SOLUTIONS | PRIORITY LEVEL |
|---|--|---|--|---|
| Hallway – Floor Surfaces | Floor surfaces are stable and do not produce glare in the hallway. However, the tile floor has some irregularities and may be slippery when wet. | Slippery floors and irregularities in the flooring can be a tripping hazard for all users. (A) | Consider using a non-slip treatment that does not produce glare on the floor tile and repair any broken tiles. | 2 |

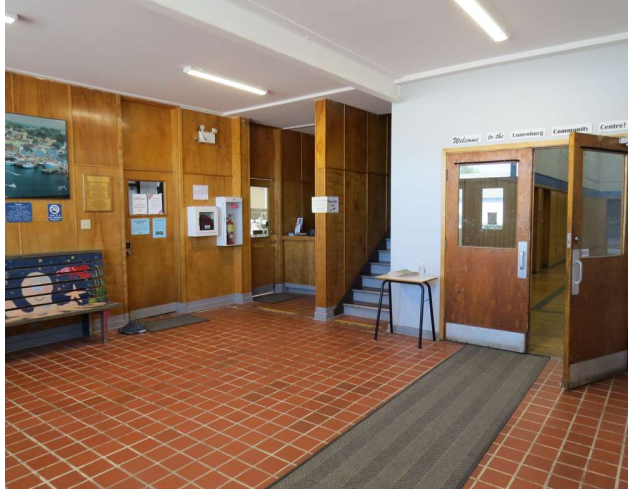
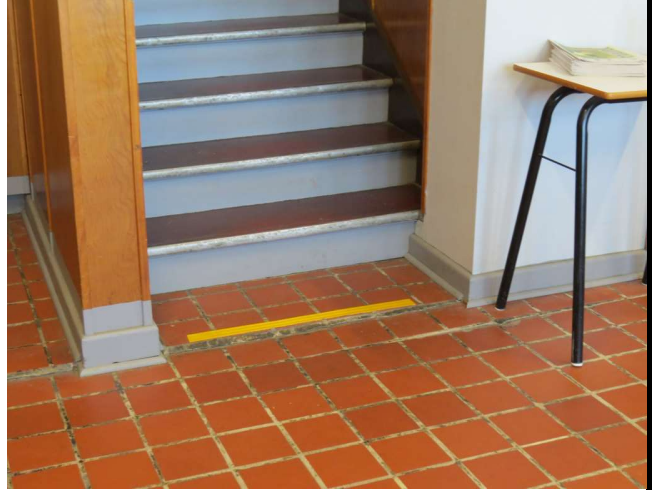
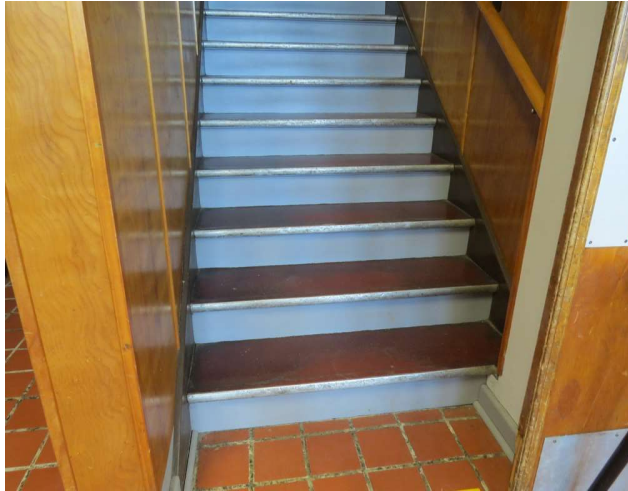
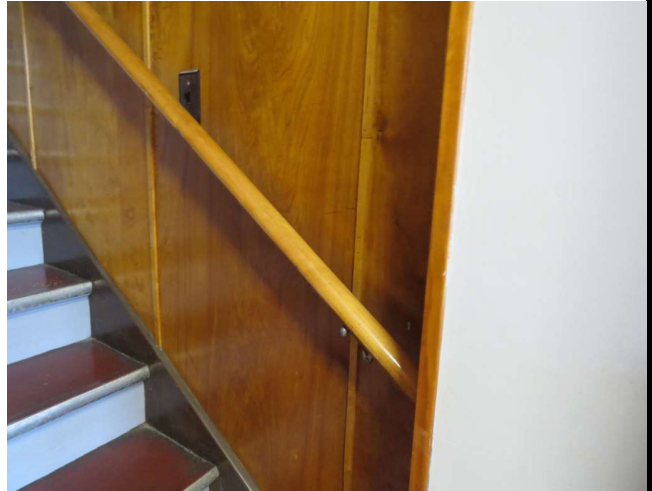
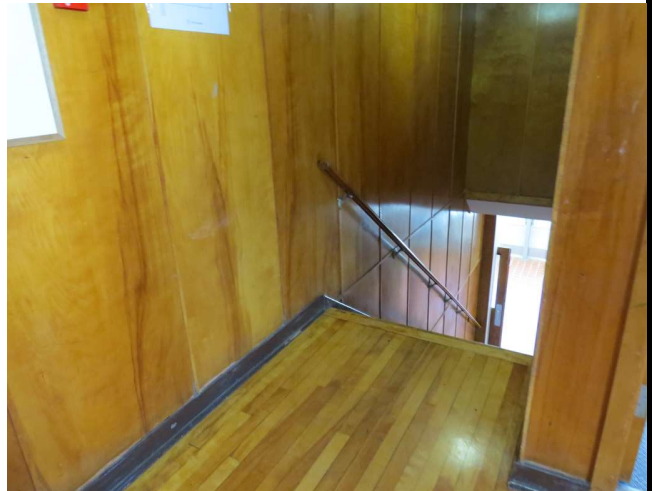
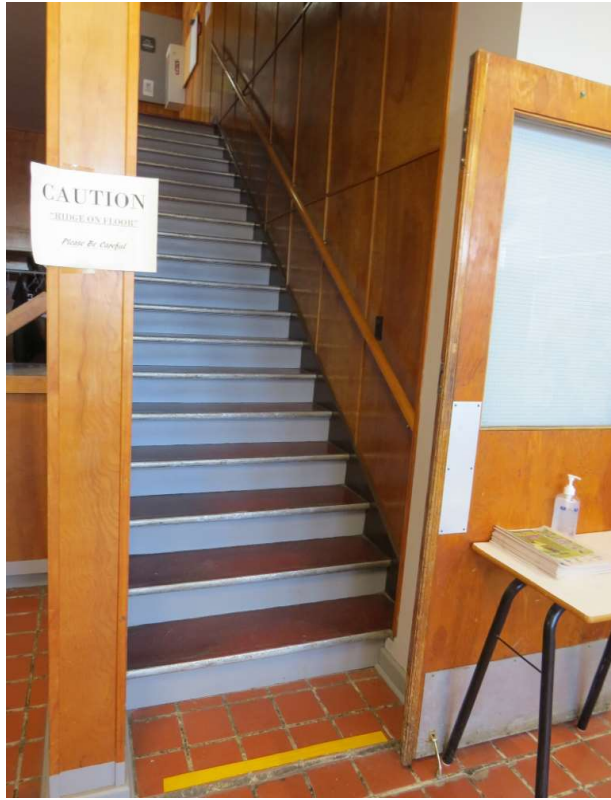
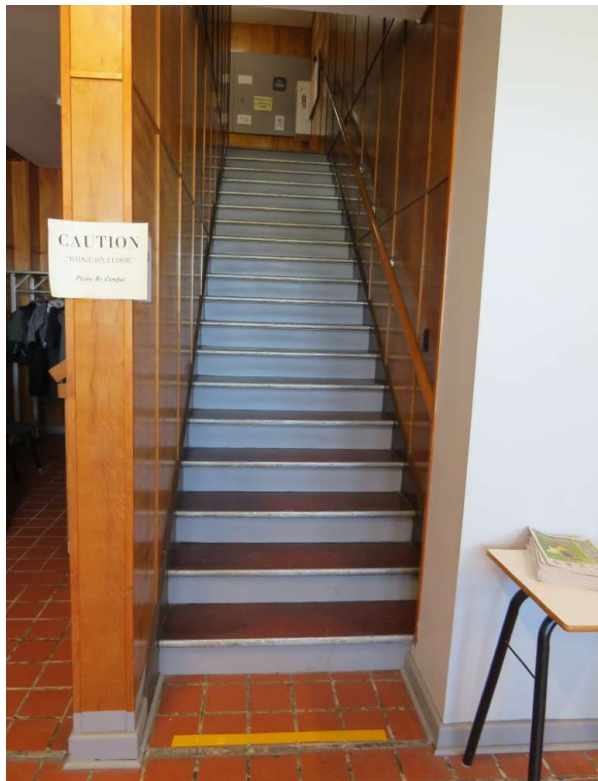
| AREA OF FOCUS | EXISTING CONDITIONS | POSSIBLE BARRIERS | PROPOSED SOLUTIONS | PRIORITY LEVEL |
|---|---|--|--|---|
| Main Stairs – Surfaces | The stair surface is not stable and can be slippery. | Unstable or slippery surfaces can be a hazard, especially in areas where people are navigating stairs. (A) | Consider renovating the stairs to provide slip-resistant surfaces to reduce the risk of falls and injuries. | 2 |
| Main Stairs – Landings | The landing at the top of the stairs is level and stable. The landing at the bottom of the stairs has a threshold and could be a hazard for some users. | Level landings offer users of the stairs a place to rest or steady themselves before continuing along the path of travel. (P)(A) | Consider renovating the threshold at the bottom of the main stairs to provide a level landing and safe path of travel. | 3 |

| Main Stairs – Nosing Design | Nosings have abrupt undersides. | Nosings with abrupt undersides can be a tripping hazard for individuals. (A) | Consider renovating the stairs to provide nosings that are designed without abrupt undersides to reduce the risk of tripping on the stairs. | 3 |
| Main Stairs – Tactile Attention Indicator | A tactile attention indicator is not present at the top of the stairs. | The absence of a tactile attention indicator can be a hazard to users with low vision or users who are blind. (S) | Install a tactile attention indicator at the top of the stairs to create a safe approach at the tops of all stairs by alerting users that they are approaching a descending set of stairs. | 2 |
| Main Stairs – Slip-Resistant Strips | Slip-resistant strips are not provided on the nosings of the stairs. | The absence of slip-resistant strips can be a hazard for all users. (A) | Install slip-resistant strips on the surface of the stairs to reduce the risk of falls and injuries. | 2 |
| Main Stairs – Colour Contrast Strips | Colour-contrast strips are not provided on the nosings of the stairs. Colour contrast is present when ascending the stairs due to the metal nosing, but strips are not present when descending the stairs. | The absence of colour-contrast strips can be a hazard for individuals with low vision, or those who need assistance in clearly identifying each step. (S)(A) | Install colour-contrast strips that wrap around the nosings of the stairs to create a safe use of the stairs for all users for both ascending and descending use. | 2 |

| Main Stairs – Handrails on Both Sides | Handrails are not provided on both sides of the staircase. | The absence of handrails on both sides of the staircase can be a significant hazard to users of all abilities, especially when users are ascending and descending at the same time. (A) | Install round and graspable handrails on both sides of the staircase to provide support and assistance for individuals using the staircase. | 2 |
| Main Stairs – Illumination | The stairs are not well-illuminated. | Inadequate lighting on stairs can create an unsafe path of travel and can be a hazard for all users. (A) | Increase illumination on the stairs to assist all users in navigating the staircase safely. | 1 |

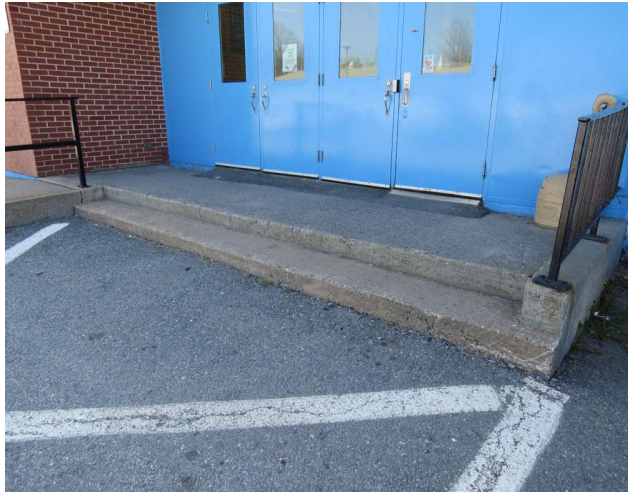
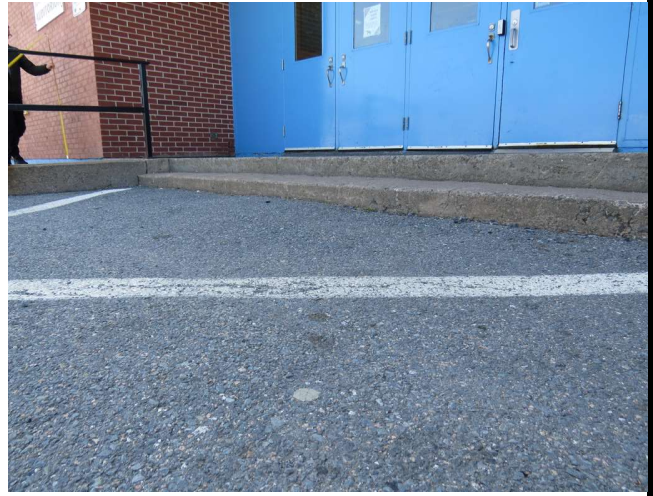
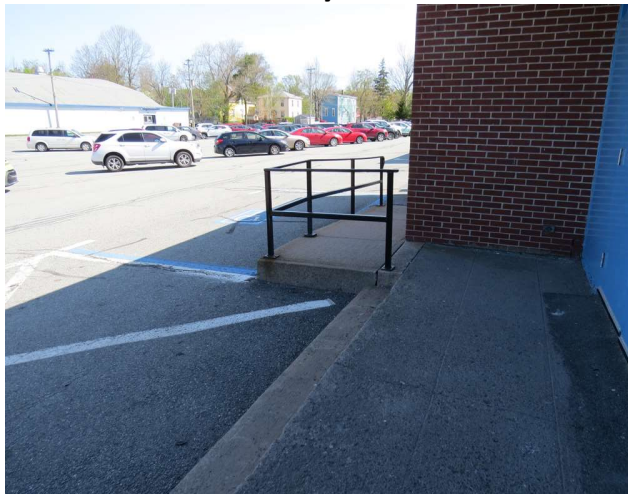
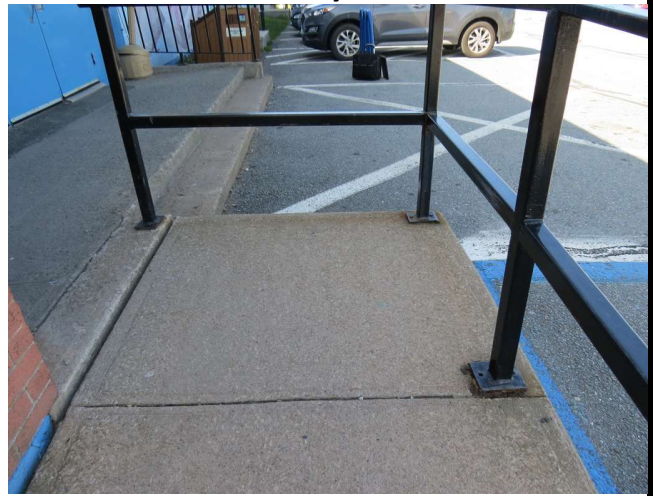
| Front Entry Stairs – Riser Height Consistency | Riser heights are not consistent on the stairs. | Inconsistent riser heights can be a tripping hazard for all individuals who use the stairs. (A) | Ensure that all riser heights are consistent throughout the staircase. | 5 |

| Front Entry Stairs – Tactile Attention Indicator | A tactile attention indicator is not present at the top of the stairs. | The absence of a tactile attention indicator can be a hazard to users with low vision or users who are blind. (S) | Install a tactile attention indicator at the top of the stairs to create a safe approach at the tops of all stairs by alerting users that they are approaching a descending set of stairs. | 2 |
| Front Entry Stairs – Slip-Resistant Strips | Slip-resistant strips are not provided on the nosings of the stairs. | The absence of slip-resistant strips can be a hazard for all users. (A) | Install slip-resistant strips on the surface of the stairs to reduce the risk of falls and injuries. | 3 |

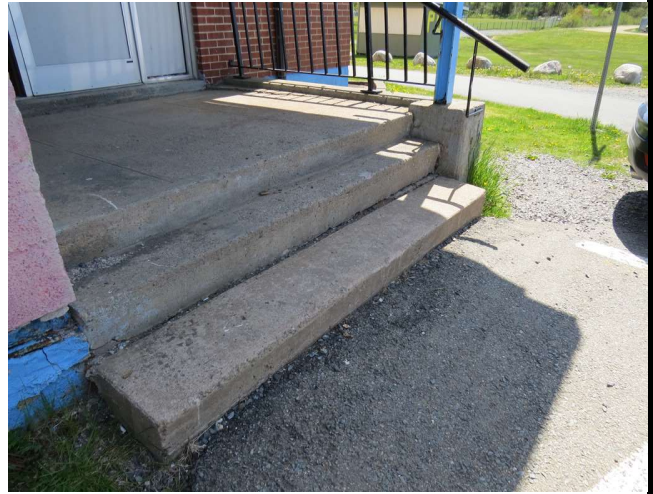
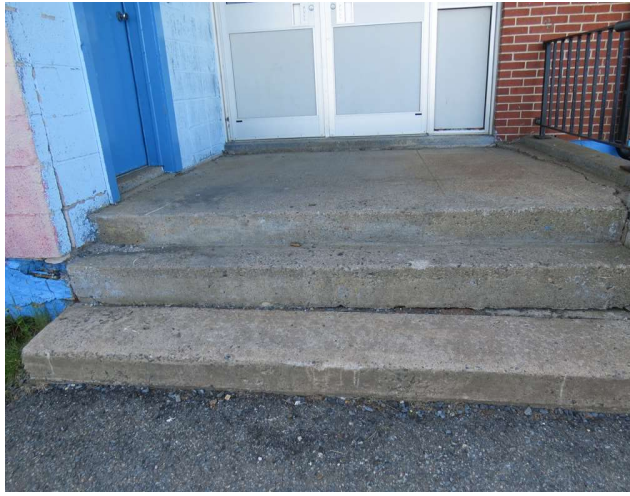
| Secondary Entry Stairs – Consistent Riser Heights | Riser heights are not consistent. | Inconsistent riser heights can be a tripping hazard for all individuals who use the stairs. (A) | Ensure that all riser heights are consistent throughout the staircase. | 4 |

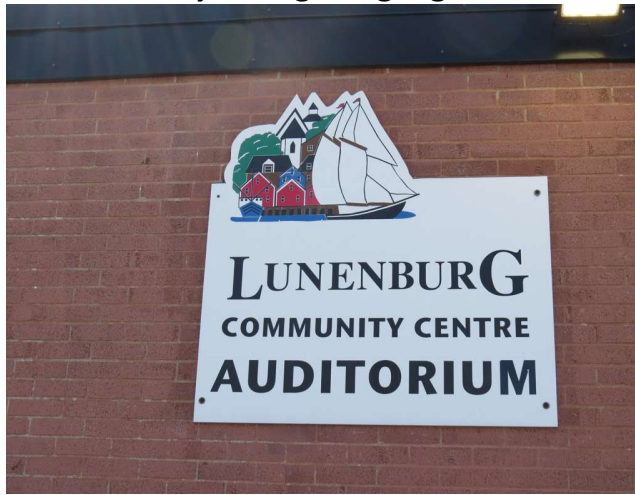
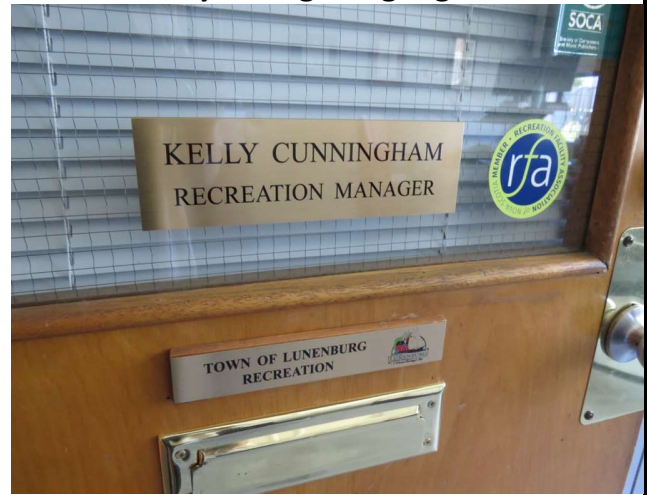
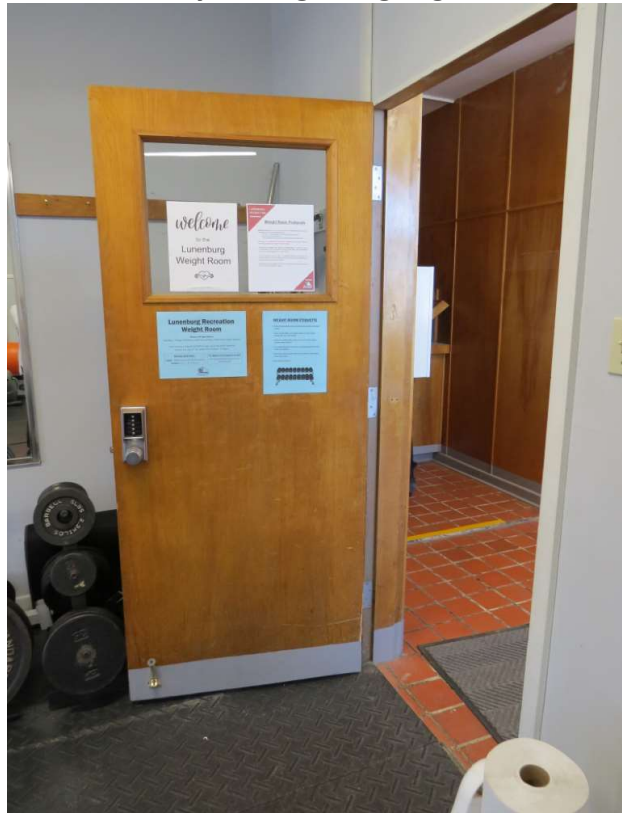
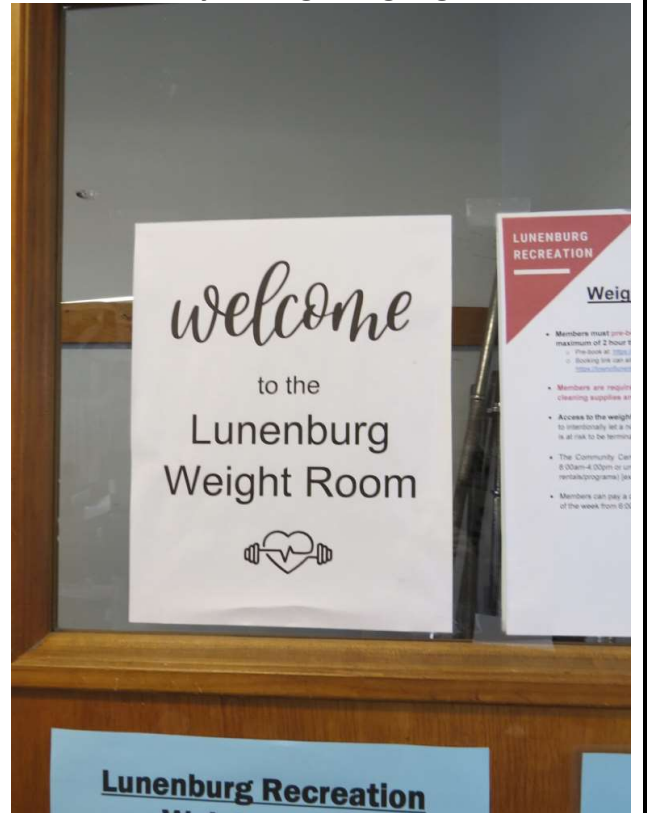
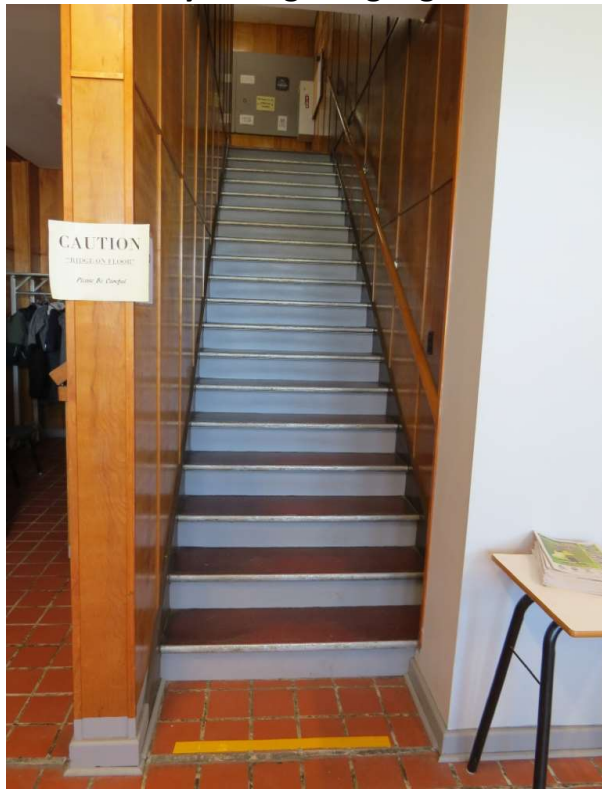
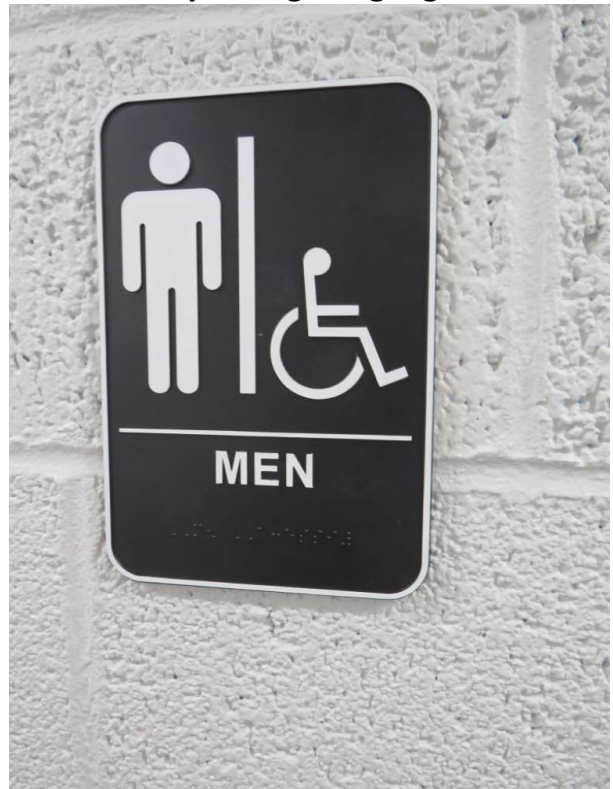
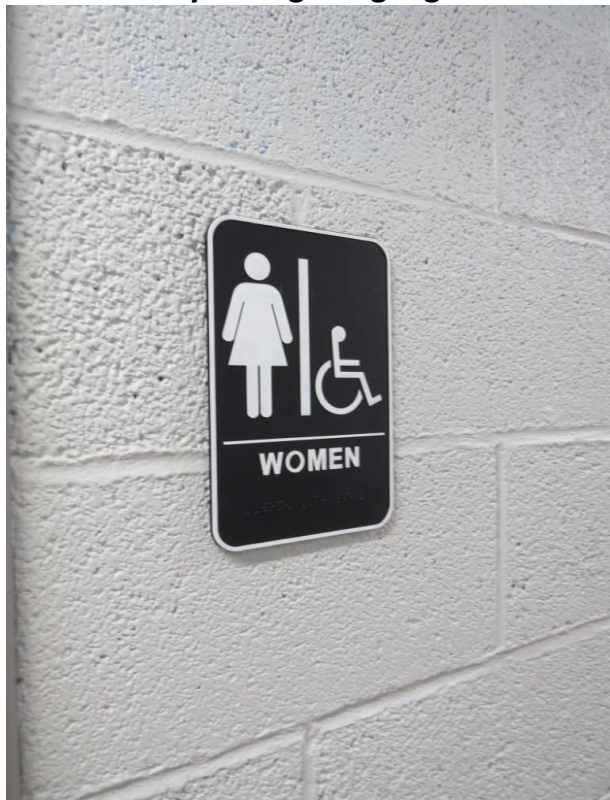
Wayfinding Photos

| Wayfinding & Signage – | The washroom identification signs are not installed on doors, but some identification signage is provided on the doors. Ensure no future room identification signs are installed on the doors. | Identification signs on the door can be a collision hazard for users with vision disabilities as they must stand in the path of travel to read the sign. (S) | Install room identification signs on the latch side of doors. | 2 |

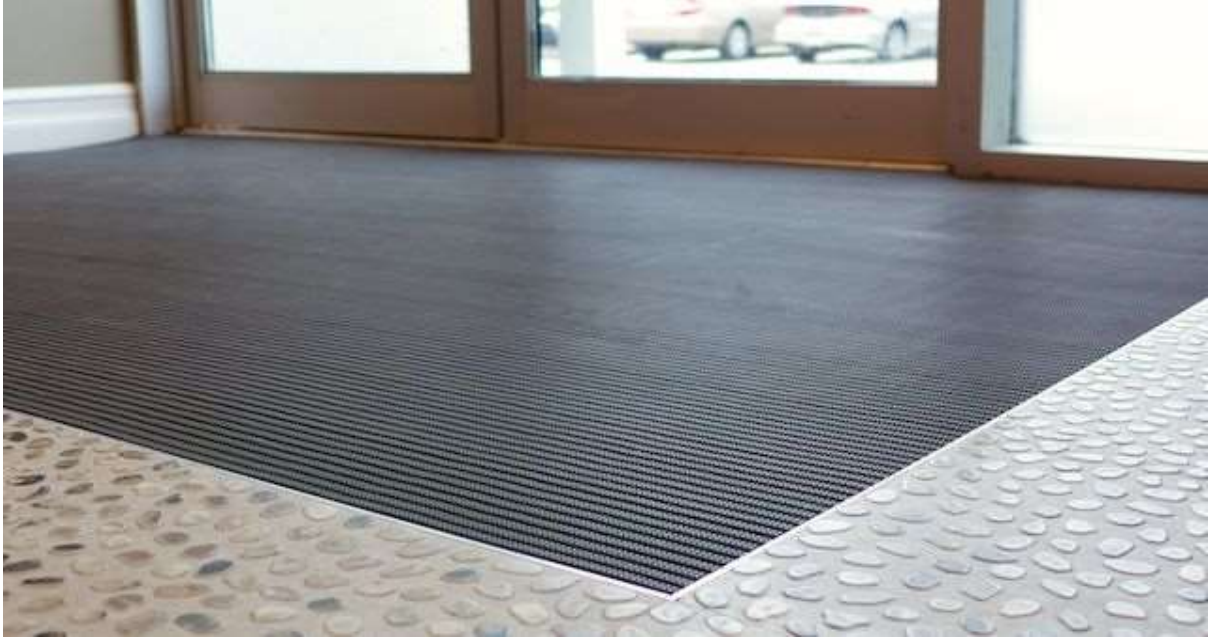
5. Recessed Mat

| Main Entrance – Recessed Mats | There are no recessed mats at the entry. | The lack of recessed mats can make it difficult to absorb moisture and dirt at the entries, which can be a tripping hazard for all users. (A) | Install recessed mats at the entry to make it easier to keep dry while maintaining a level floor area. | 3 |
