Building Condition Assessment

Lunenburg Townhall
119 Cumberland Street
Lunenburg, Nova Scotia

FSA Project No.: 22057DA
2022-09-23

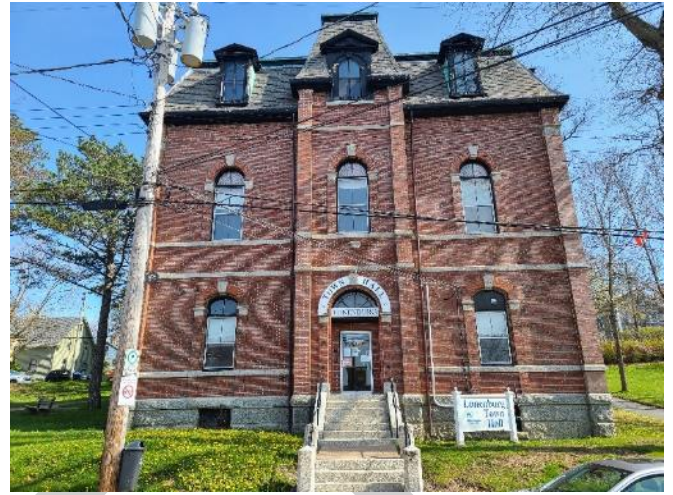
South Elevation

- Visible faced granite at foundation level.
- Mass clay brick masonry walls.
- Granite slab entrance stairs.
- Mansard roof with prominent dormers.

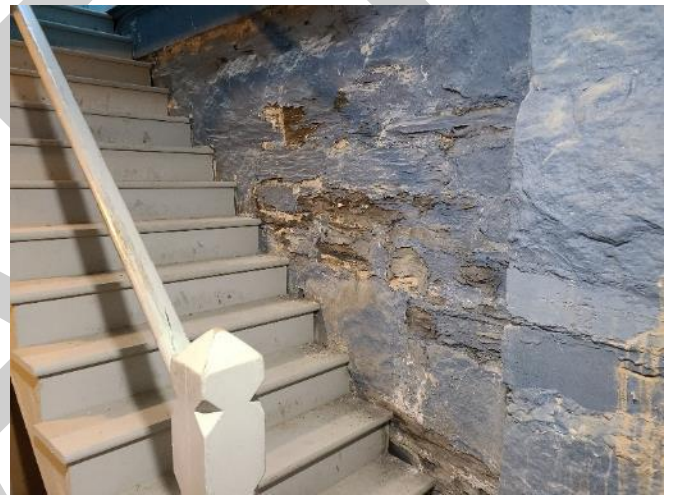
Basement

- Typical stone foundation visible throughout basement.

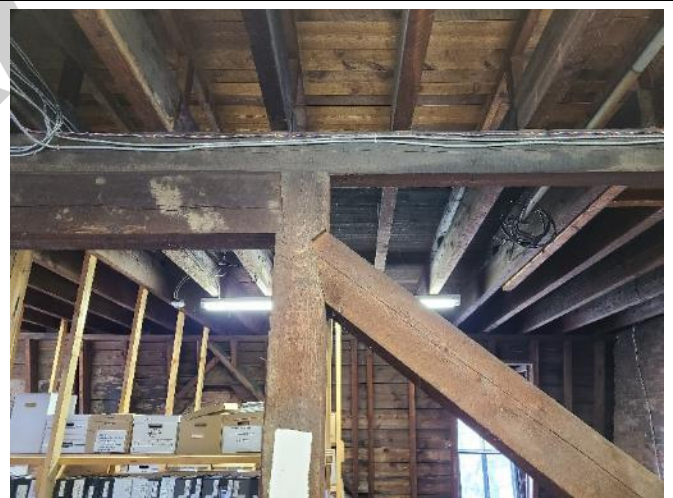
Roof Space

- Typical wood construction is visible within the mansard roof.

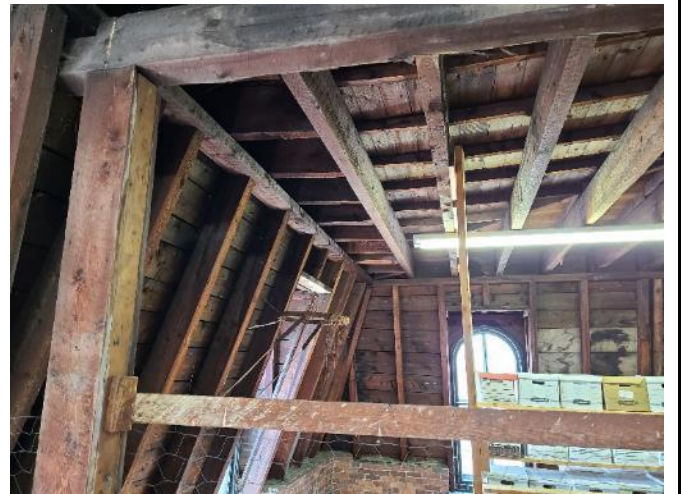
Roof Space

- Typical wood construction is visible within the mansard roof.

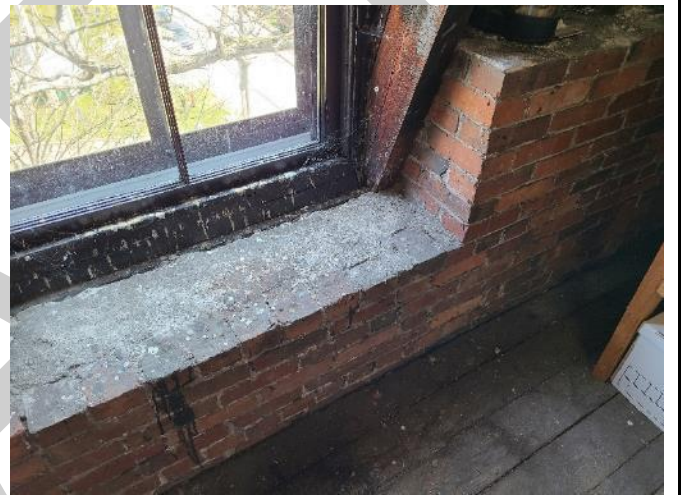
Roof Space

- Typical example of mass masonry wall at the top of the exterior wall at the base of the mansard.

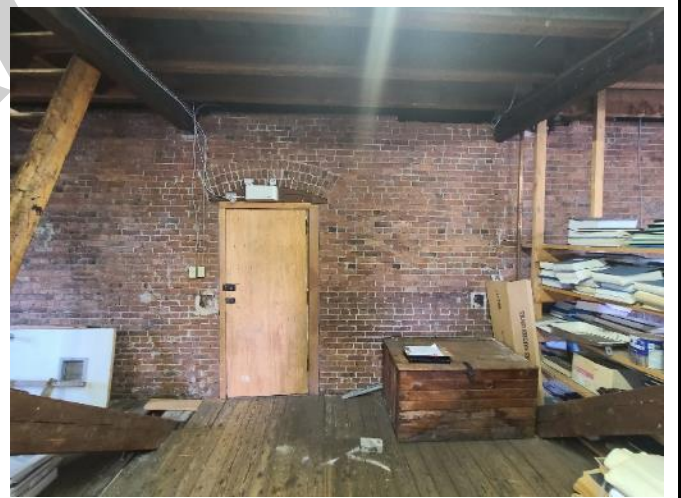
Roof Space

- Masonry wall separating building north to south is visible at the interior of the mansard roof area.

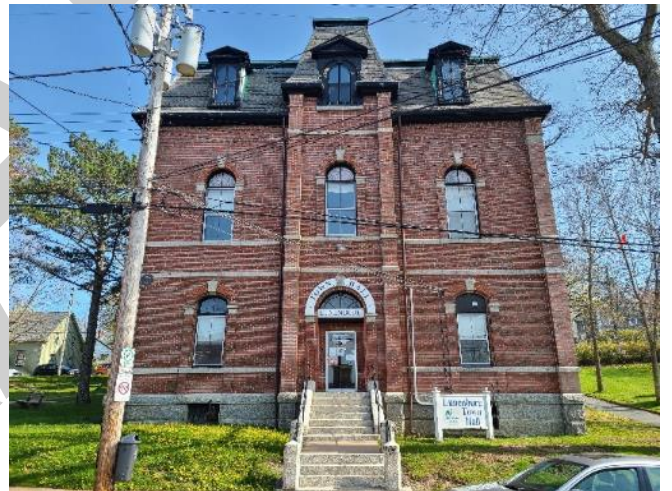
South Elevation

- General image of south elevation.

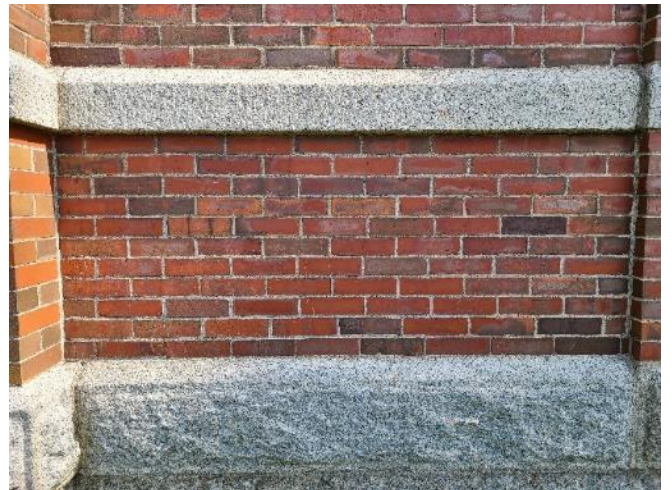
South Elevation

- Substantial crazing of masonry units was observed at all elevations.

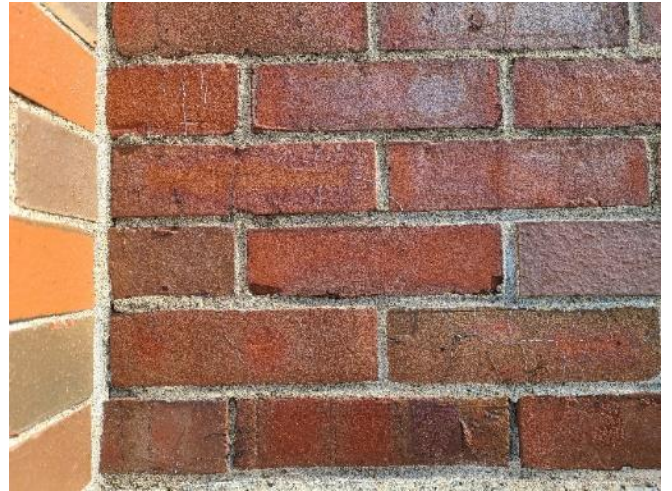
South Elevation

- Substantial crazing was observed at masonry units.
- Previous masonry repairs were observed at the pilaster as seen at the left of the image. New masonry units differ from the older, possibly original, masonry units.

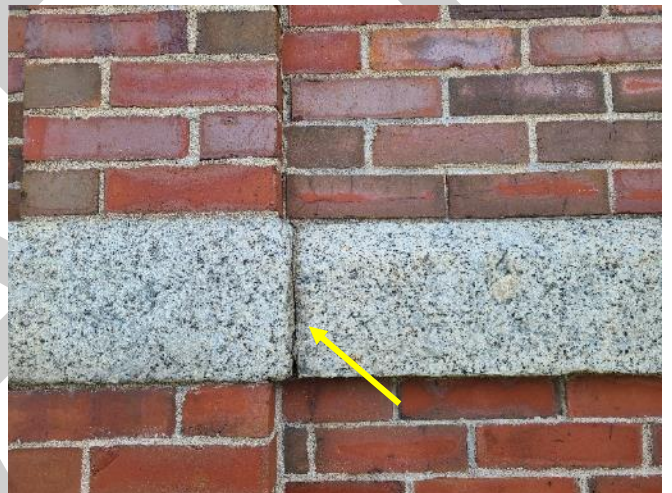
South Elevation

- Substantial crazing was observed at masonry units.
- Cracking was observed at mortar joints of masonry and granite (yellow arrow).

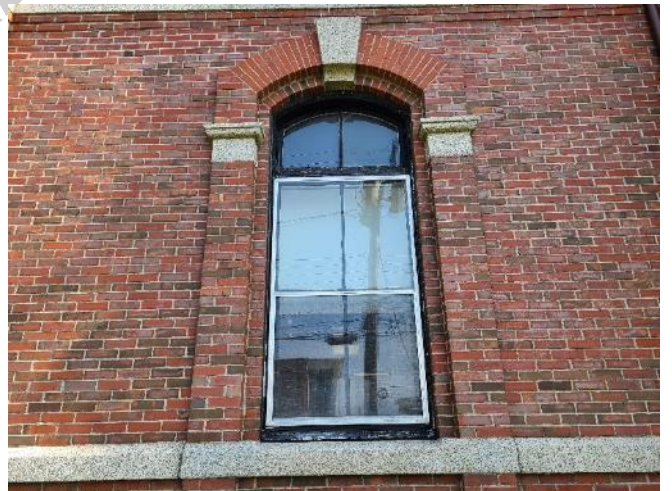
South Elevation

- Typical example of the masonry arches observed at windows at south elevation.

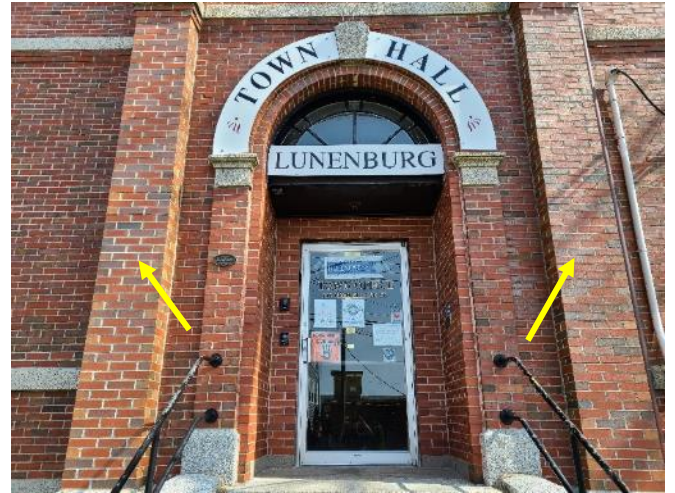
South Elevation

- The pilasters on either side of the main south entrance have been rebuilt.
- The inset entranceway appears to be of relatively new construction as the masonry varies from the original.

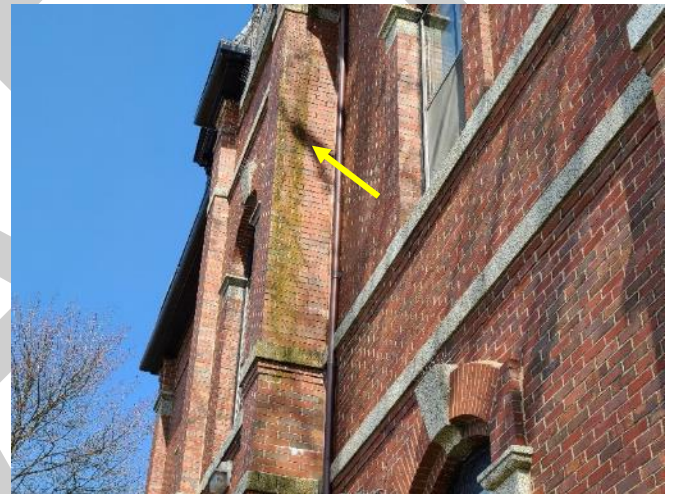
South Elevation

- Organic growth and staining were observed at the pilaster to the right of the main entrance. This may be caused by water run-off overshooting the eavestrough above. Continued wetting may result in premature deterioration of the clay brick masonry units and/or the mortar.

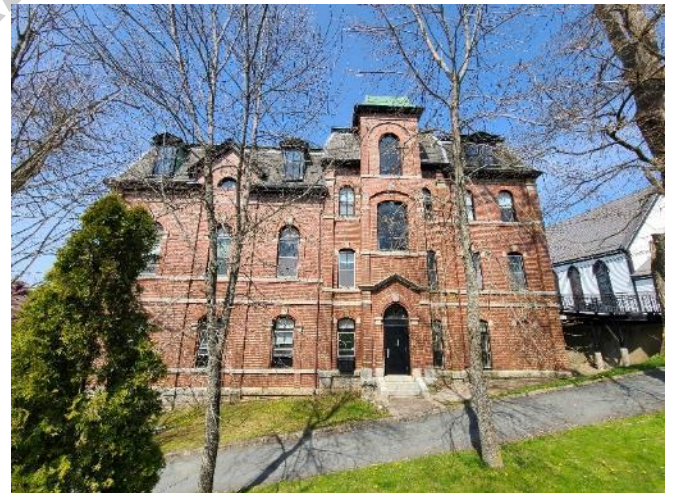
East Elevation

- General view of east elevation featuring a copper roof at the top of the stairway tower.

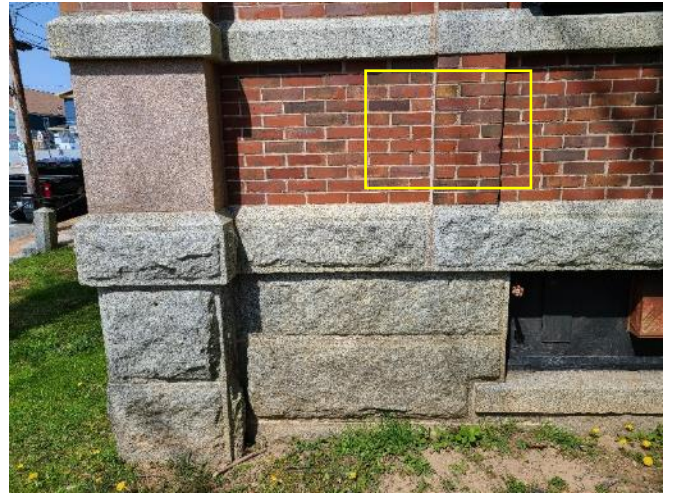
East Elevation

- Significant crazing of masonry was observed. See following image.

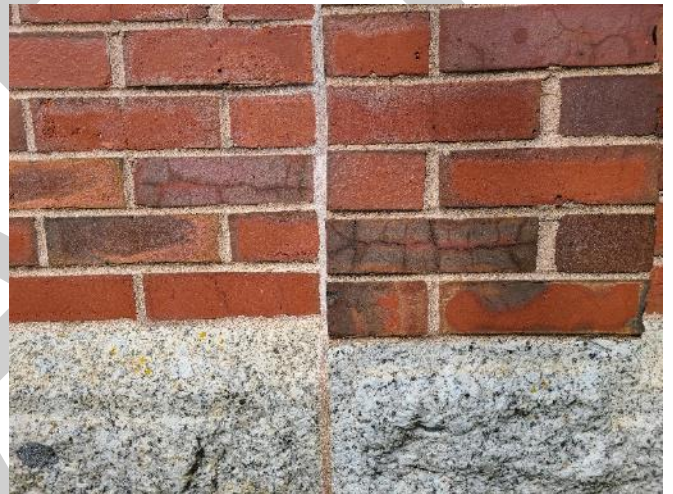
East Elevation

- Significant crazing of masonry was observed across the east elevation. See following image.

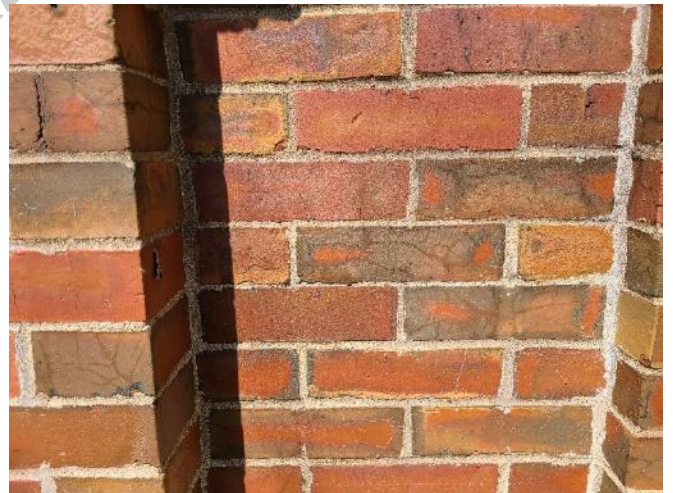
East Elevation

- Significant crazing of masonry was observed across the east elevation.

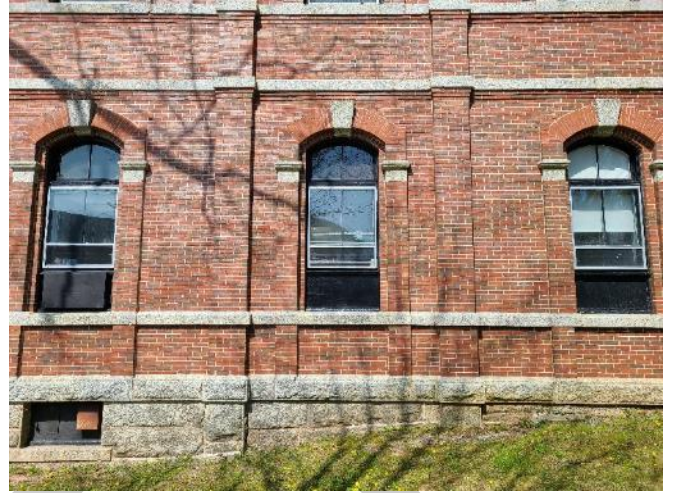
East Elevation

- Typical example of masonry arches at the first floor to the south of the stair tower.
- This detail is duplicated at the second-floor windows above; however, second floor windows feature a taller archway (see following observation), whereas the first-floor arch is shallower.

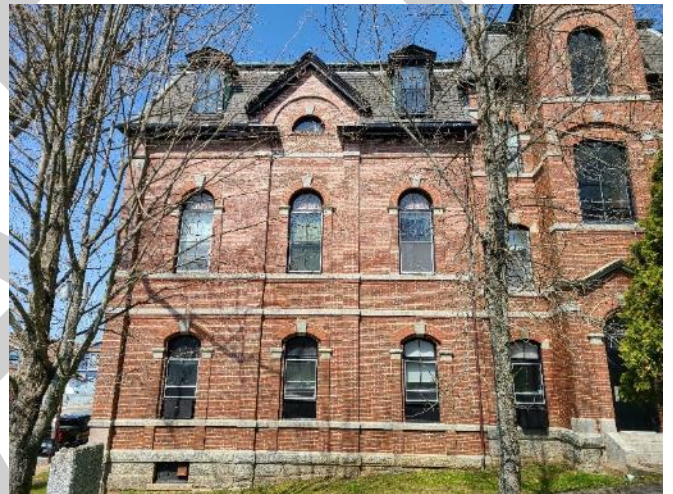
East Elevation

- Typical example of masonry arches at the first floor to the south of the stair tower.
- This detail is duplicated at the second-floor windows above; however, second floor windows feature a taller archway (see following observation), whereas the first-floor arch is shallower.

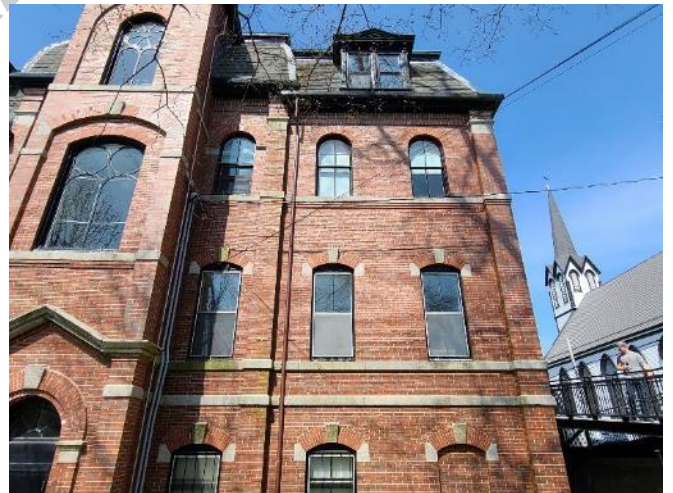
East Elevation

- Typical example of masonry arches above windows at the east elevation. Note, the lack of granite keystones at the third floor.
- Organic growth was observed to the right of the stair tower. See following observation.

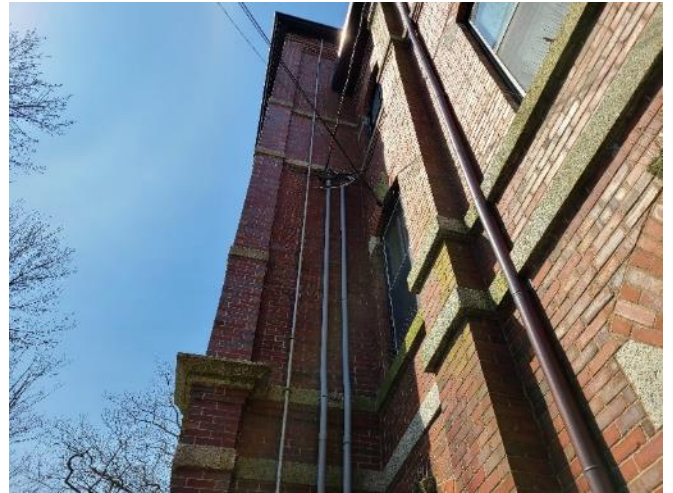
East Elevation

- Organic growth and staining were observed at various locations across the east elevation. This is likely exacerbated by substantial shading by large trees surrounding the property limiting the drying potential of the masonry.

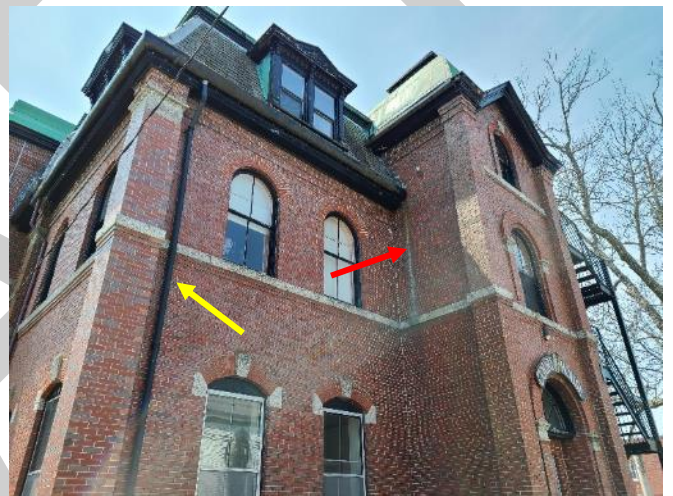
North Elevation – behind retaining wall

- General image of the north elevation behind the retaining wall.
- Notice, the original copper downspout has been replaced with plastic (yellow arrow).
- Staining of the masonry was observed at the interior corner. This is likely caused by water run-off from the roof passing between the gutter and the exterior wall (red arrow). The gutter end may also be damaged.
- Staining and discoloration of the granite ribbon was observed.

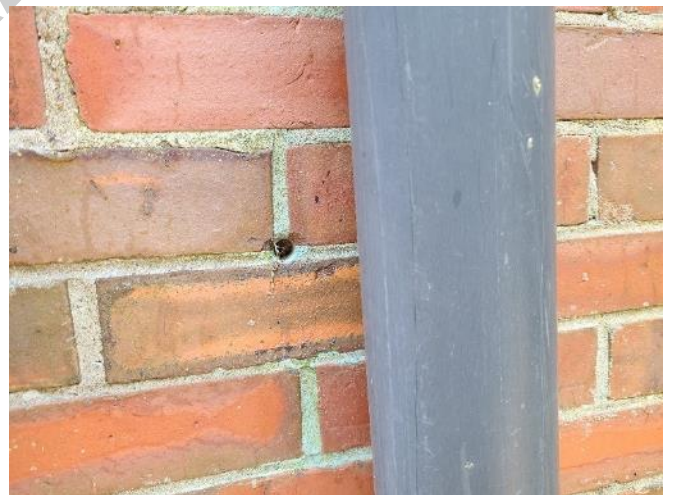
North Elevation – behind retaining wall

- Missing downspout support brackets were observed leaving openings in masonry.
- See following observation.

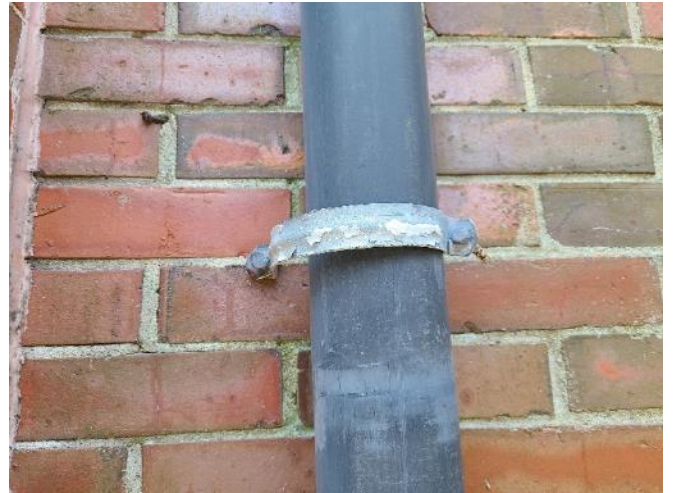
North Elevation – behind retaining wall

- Unsecured downspout support brackets were observed.

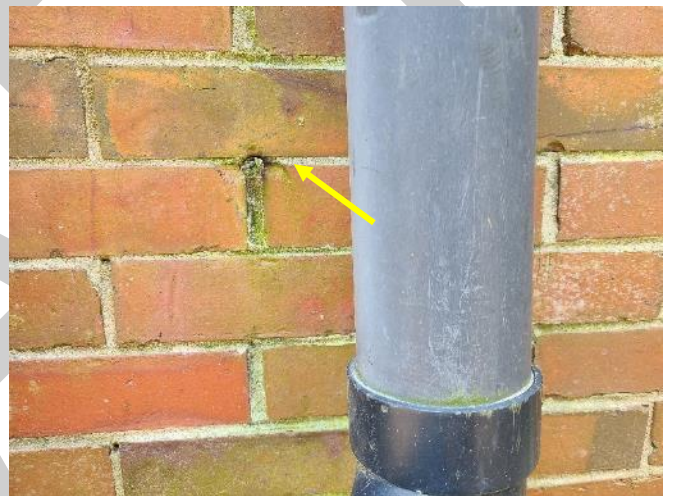
North Elevation – behind retaining wall

- Holes in masonry were observed to be plugged with wood.
- Notice the staining at the masonry.

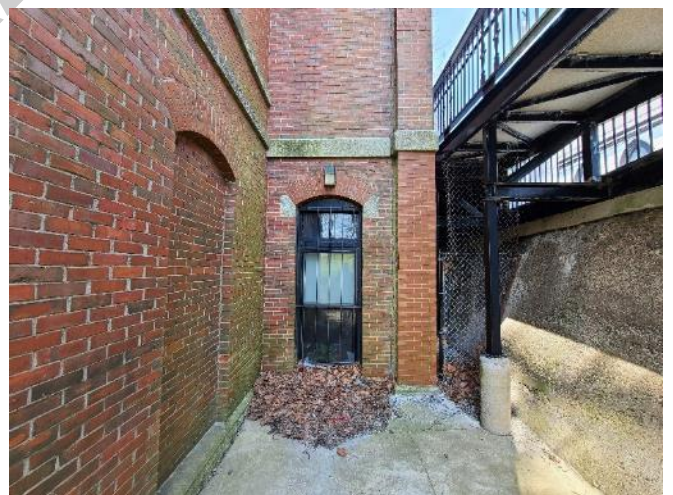
North Elevation – behind retaining wall

- General image of the north elevation behind the retaining wall.
- Organic growth was observed at the north elevation. This is likely exacerbated by this area being a mainly shaded throughout the day limiting the drying potential of the masonry.

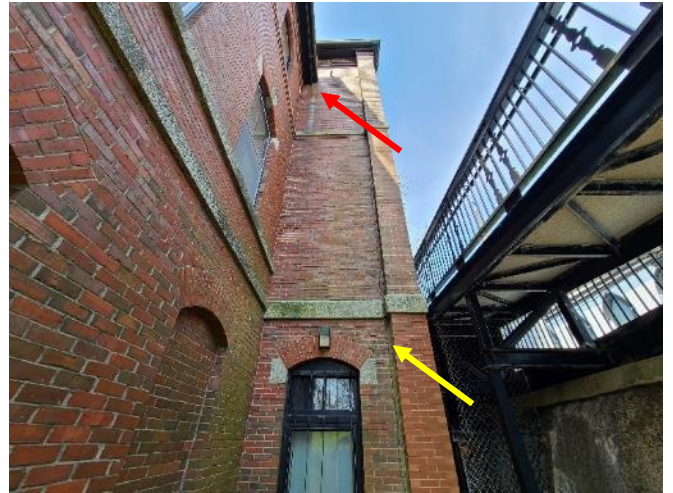
North Elevation – behind retaining wall

- Staining of the masonry was observed at the interior corner. This is likely caused by water run-off from the roof passing between the gutter and the exterior wall (red arrow). The gutter end may also be damaged.
- A crack was observed through the masonry at the upper right corner of the window (yellow arrow).
- See following observation.

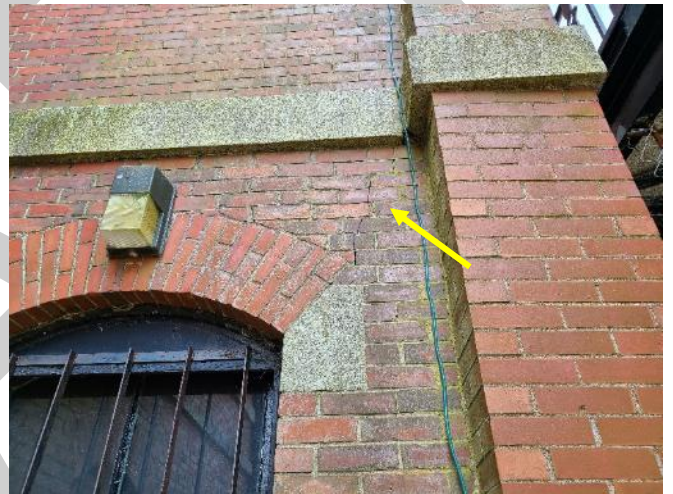
North Elevation – behind retaining wall

- The crack observed travels diagonally through masonry and terminates at the pilaster.
- The pilaster to the right of the window appears to have been rebuilt likely following the report provided by GF Duffus dated April 2008.
- See following observation.

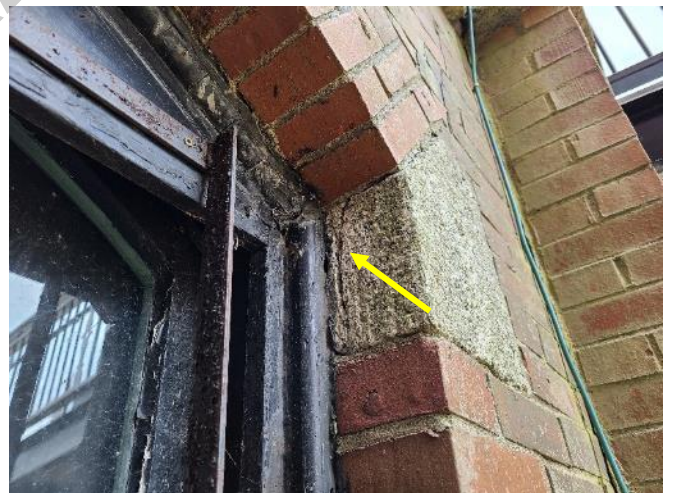
North Elevation – behind retaining wall

- The crack was observed to travel directly through the back of the granite coining.
- The pilaster to the right of the window appears to have been rebuilt likely following the report provided by G.F. Duffus dated April 2008.

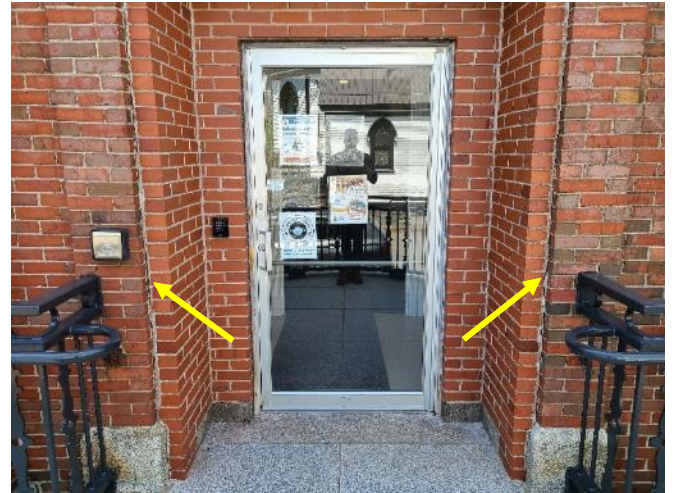
North Elevation

- Cracking of the mortar between the newer masonry and older, likely original, pilasters to the right and left of the entrance was observed.
- The inset entranceway, similar to that observed at the south elevation appears to be of relatively new construction as the masonry varies from the original.
- Significant crazing of masonry units was observed to both the right and left of the entrance. See following observation.

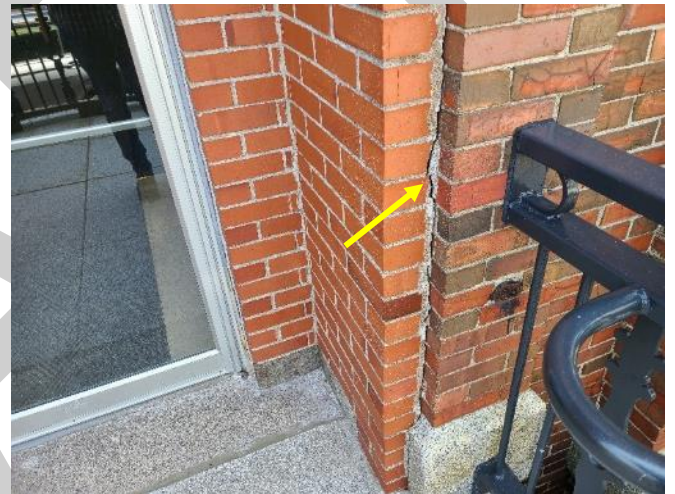
North Elevation

- Cracking of the mortar between the newer masonry and older pilasters to the right and left of the entrance was observed.
- Significant crazing of masonry units was observed to both the right and left of the entrance. See following observation.

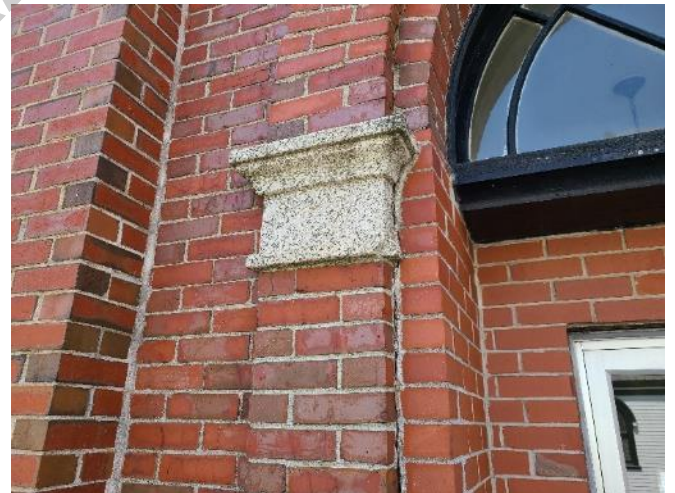
North Elevation

- Significant crazing of masonry units was observed to both the right and left of the entrance. See following observation.

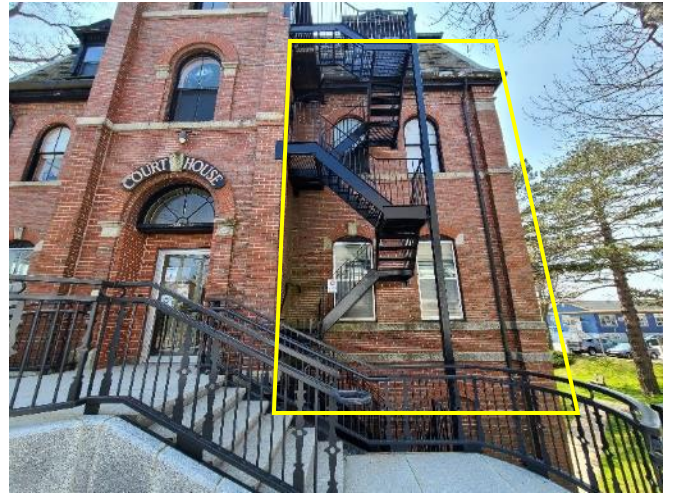
North Elevation

- Staining of masonry was observed at the elevation right of the main entrance.
- Cracking and crazing of masonry were observed at multiple locations.
- See following images.

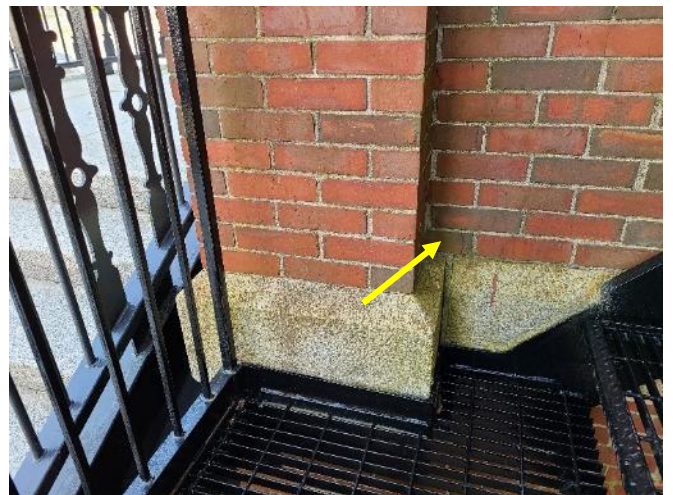
North Elevation

- Cracking of the masonry was observed (yellow arrow). See following image.

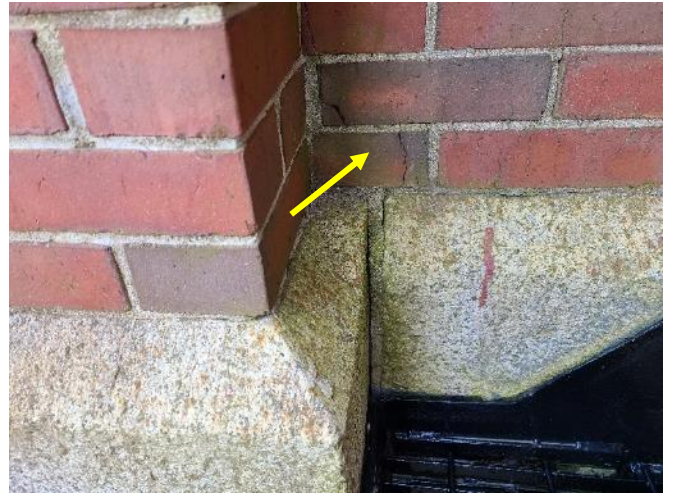
North Elevation

- Same as above.

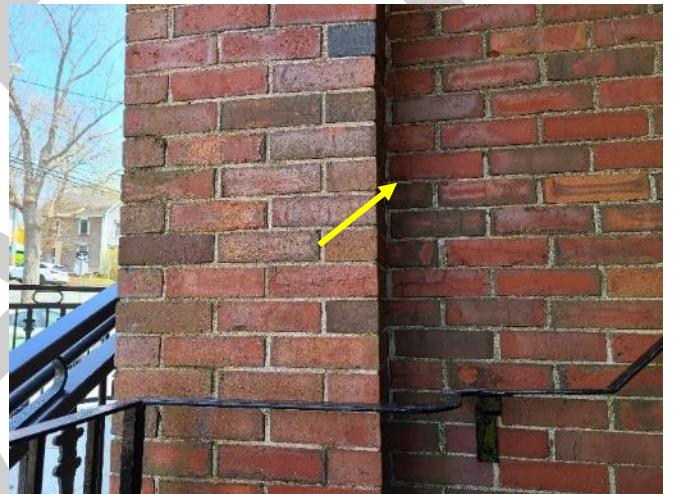
North Elevation

- The cracking shown in the previous observation was observed to travel vertically along the edge of the pilaster (yellow arrow).
- Significant crazing of masonry units was observed.

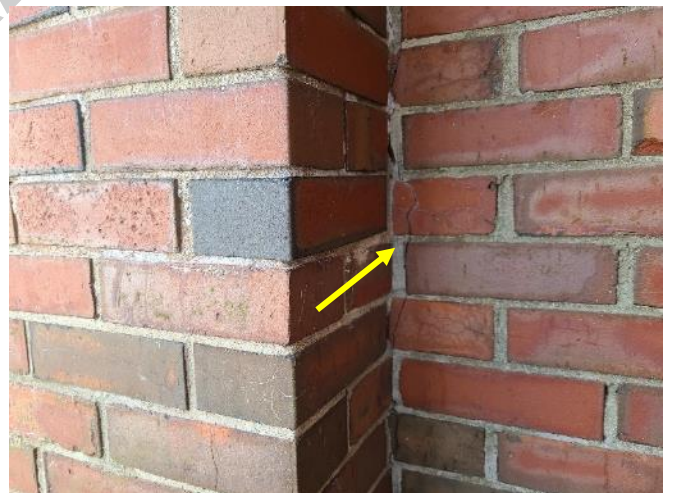
North Elevation

- Same as above.

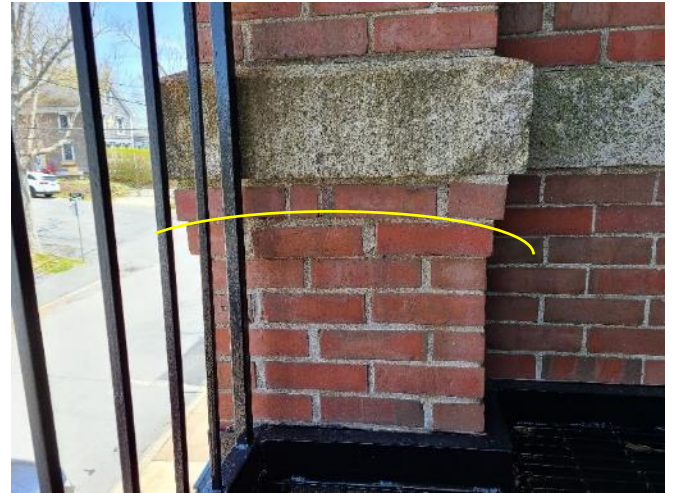
North Elevation

- Masonry making up the corbel below the granite ribbon was observed to be slightly bowed as indicated by the yellow marker.
- Staining of the granite was observed.

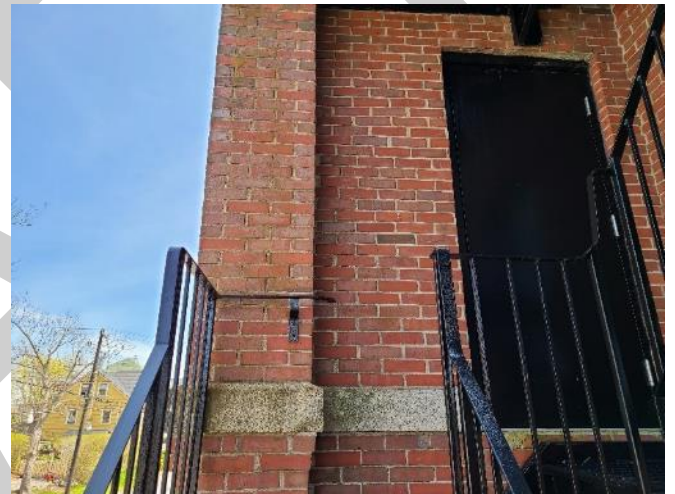
North Elevation

- No masonry lintel was observed above the exterior steel exit doors. See following image.
- Staining of the masonry was observed.
- Some organic growth was observed, particularly above the exit door. See following observation.

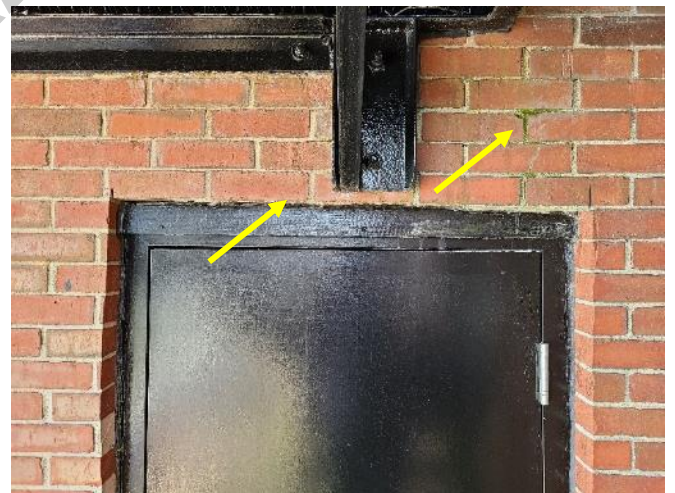
North Elevation

- No masonry lintel was observed above the exterior steel exit doors. See following image.
- Staining of the masonry was observed.
- Some organic growth was observed, particularly above the exit door.

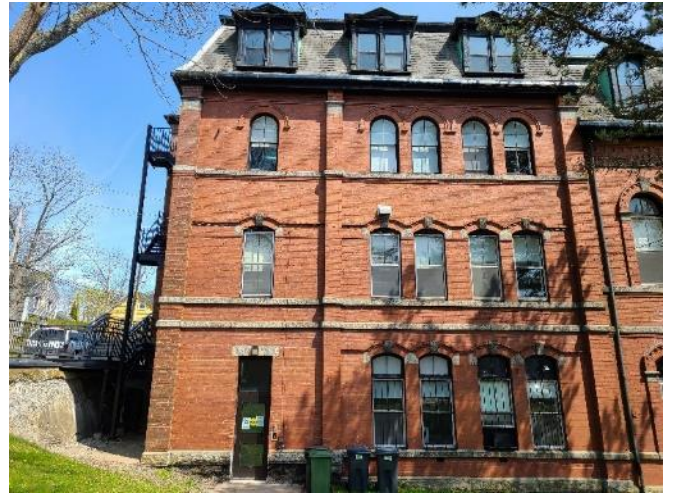
West Elevation

- General image of west elevation.
- The west elevation features two styles of masonry arches unique to the elevation pictured here.
- Cracking of masonry was observed at multiple locations.
- Cracking of masonry was observed at multiple locations.
- Deteriorated mortar joints were observed at multiple locations.

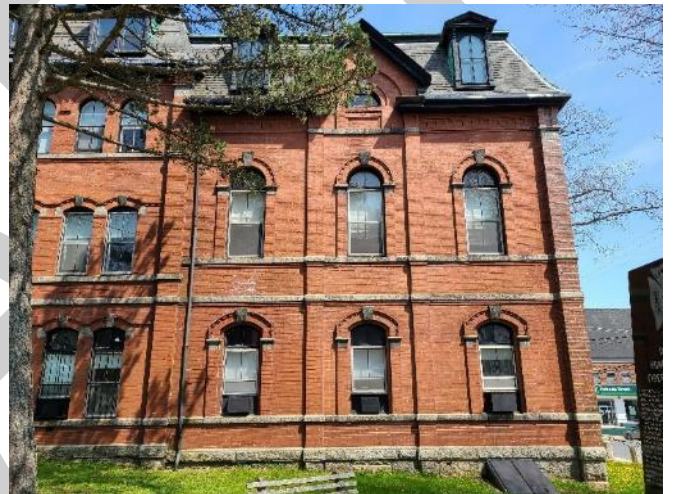
West Elevation

- General image of west elevation.
- Cracking of masonry was observed at multiple locations.
- Cracking of masonry was observed at multiple locations.
- Deteriorated mortar joints were observed at multiple locations.
- See following observations.

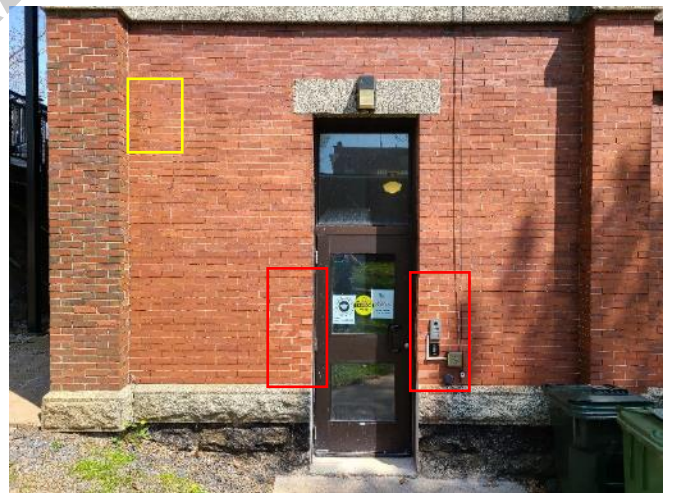
West Elevation

- Spalling of masonry faces was observed (yellow box).
- Previous repointing and masonry repairs were observed (red boxes).

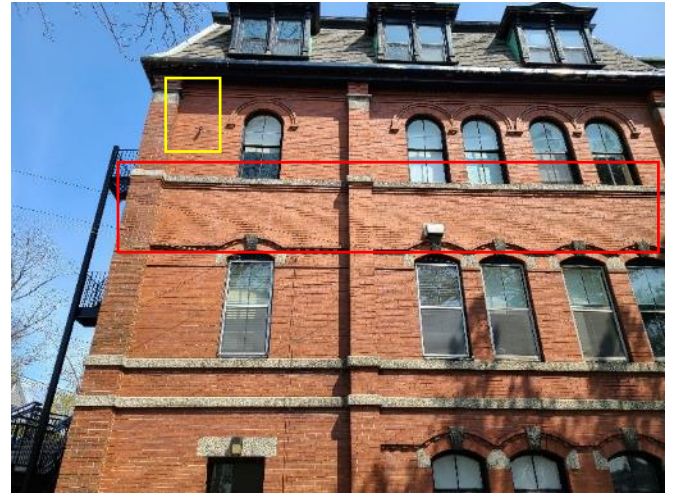
West Elevation

- An abandoned electrical insulator was observed along with an unsealed penetration approximately 50 mm in diameter (yellow box).
- Significant efflorescence was observed at the masonry between the second and third floors (red box).

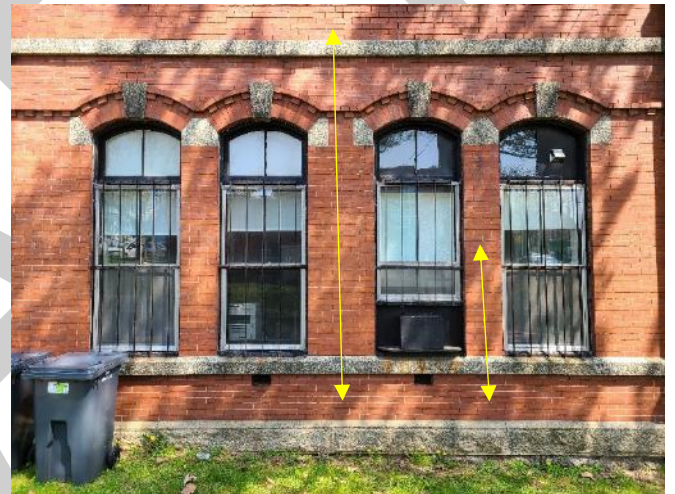
West Elevation

- Typical masonry detailing above first floor windows at the northern most side of the west elevation.
- Masonry cracking was observed at multiple locations (yellow arrow).
- The cracks observed originated at the granite foundation and travel vertically above the first-floor windows.
- See following observations.

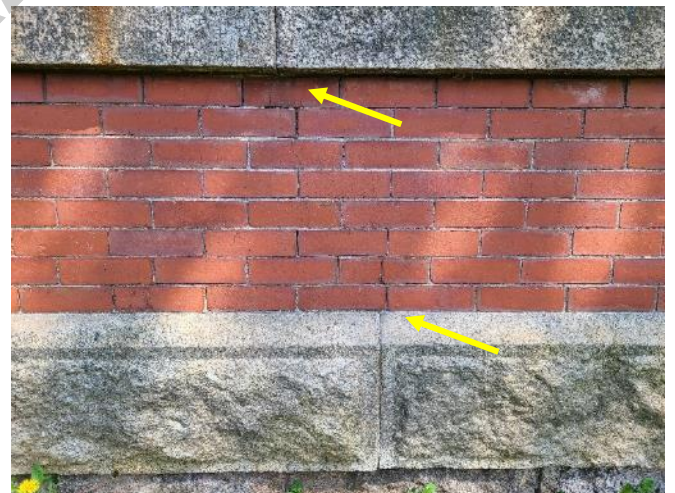
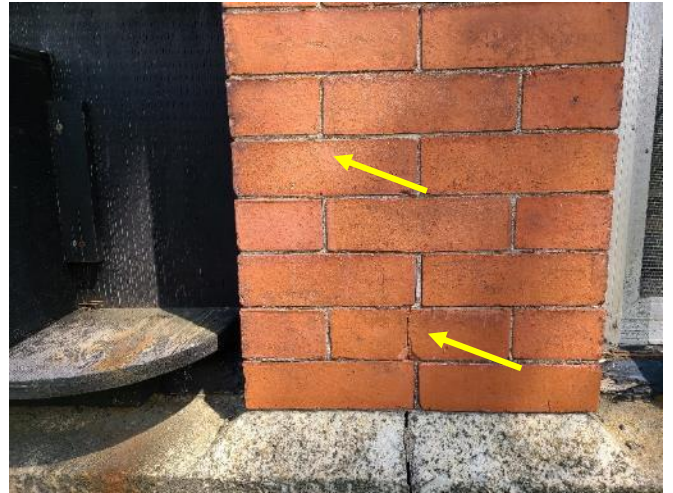
West Elevation

- Masonry cracking was observed at multiple locations.
- The crack, pictured here, originated at the granite foundation and travels vertically above the first-floor windows.

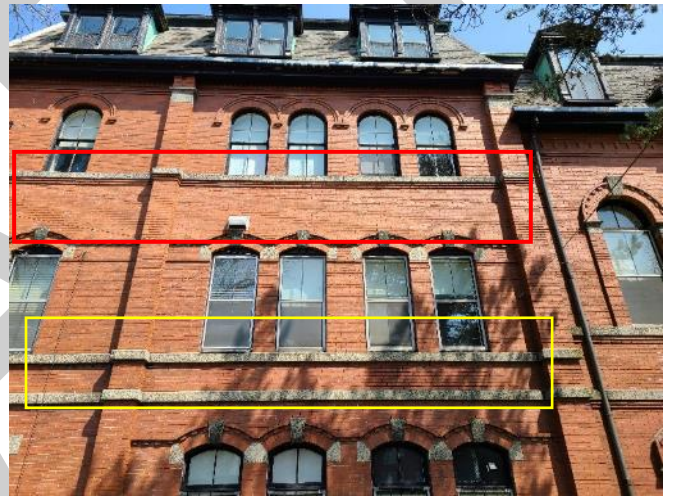
West Elevation

- Typical masonry detailing above third floor windows.
- Significant efflorescence was observed at the masonry between the second and third floors (red box).
- Deteriorated masonry was observed between the first and second floor windows. See following image.

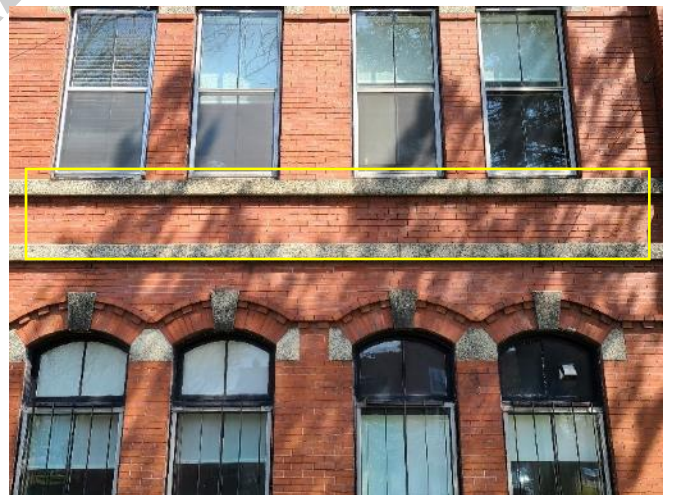
West Elevation

- Deteriorated masonry was observed between the first and second floor windows.

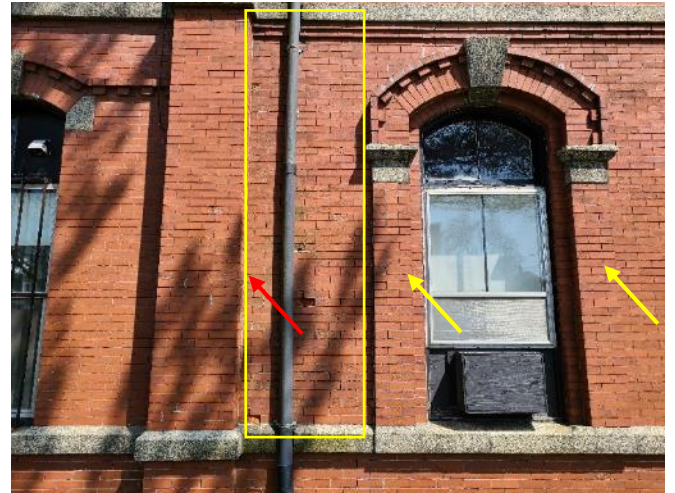
West Elevation

- Spalling masonry was observed near the downspout (yellow box).
- Deteriorated mortar joints were observed at the pilasters supporting the window arch (yellow arrow).
- Deteriorated sealant was observed at the pilaster to the left of the downspout (red arrow). Sealant was also used to repair masonry and joints.
- Previous repairs were also observed at the masonry arch which does not blend with the original masonry.

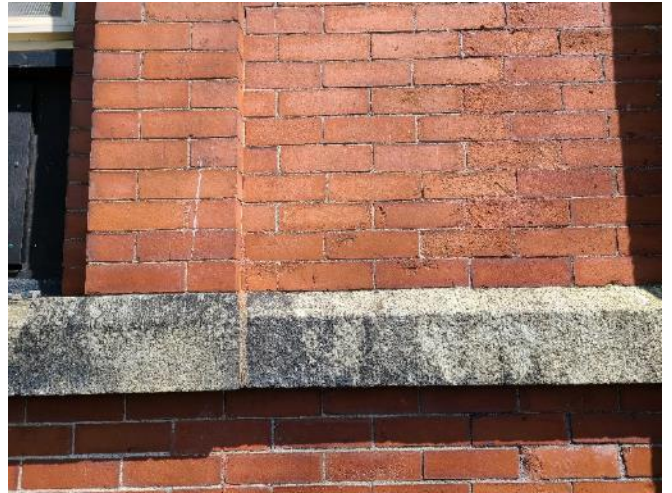
West Elevation

- Spalling of masonry was observed two the left of the pilaster.
- Staining of granite ribbons was observed.

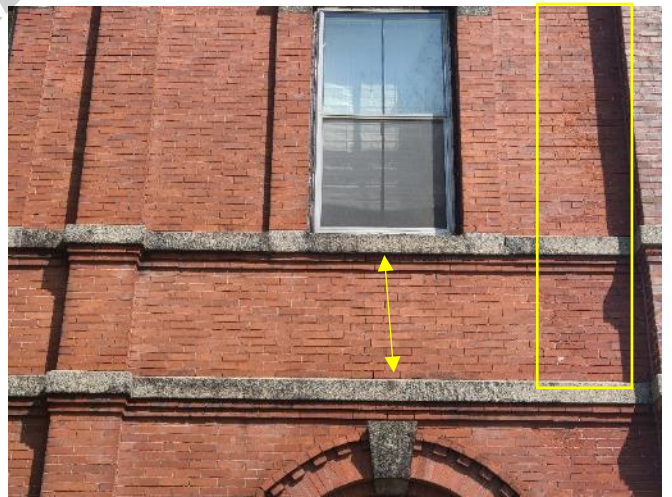
West Elevation

- Spalling of masonry was observed two the left of the pilaster (yellow box).
- A masonry crack was observed (yellow arrow).
- See following observation.

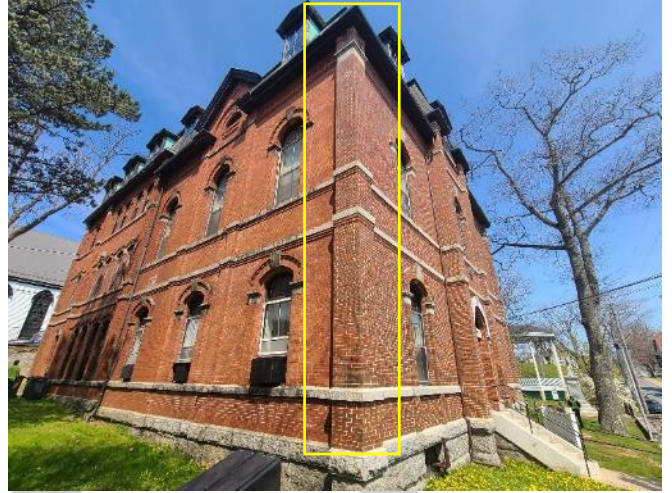
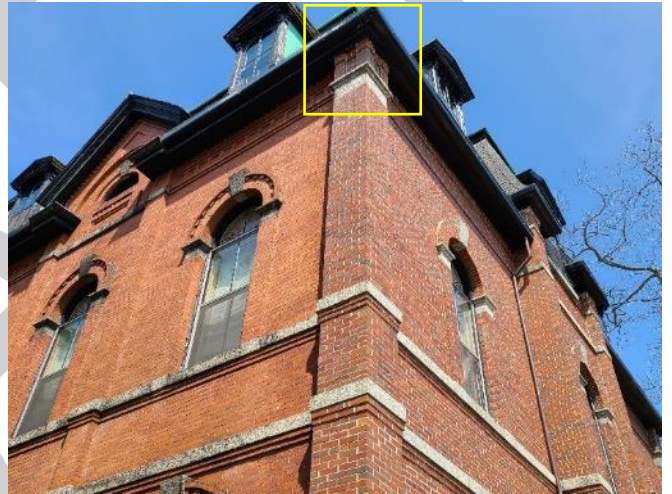
Southwest Corner

- Significant deflection was observed in the masonry forming the outermost pilaster. This was especially visible at the top of the pilaster.

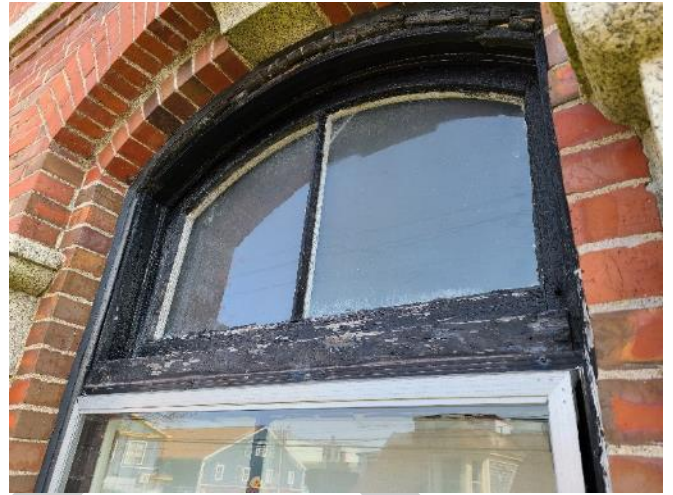
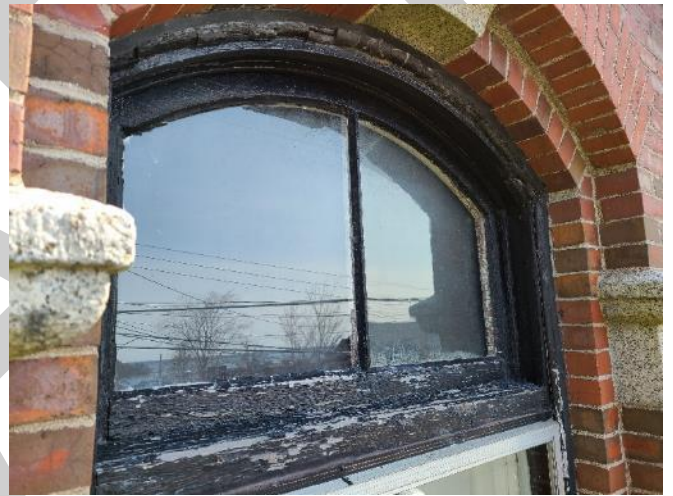
South Elevation

- Paint/stain at the upper arched window was observed to be deteriorated.
- The brickmould for the arch appears to be constructed of multiple pieces of quarter round. This does not appear to be of original construction.

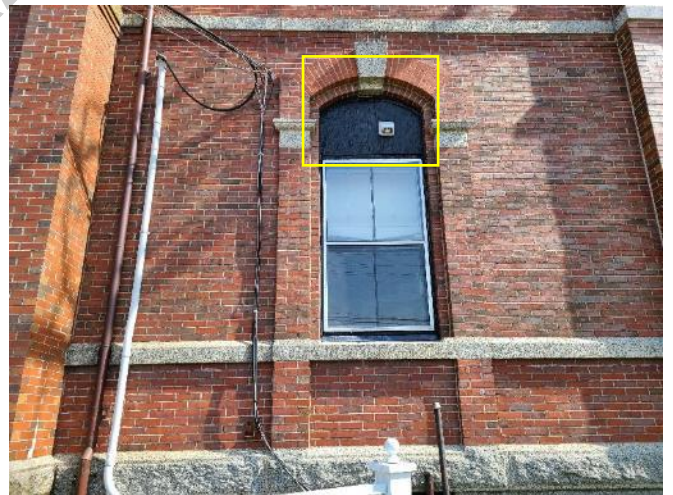
South Elevation

- Upper arched window is infilled with painted plywood to accept a mechanical exhaust vent.
- Paint/stain was observed to be deteriorated.

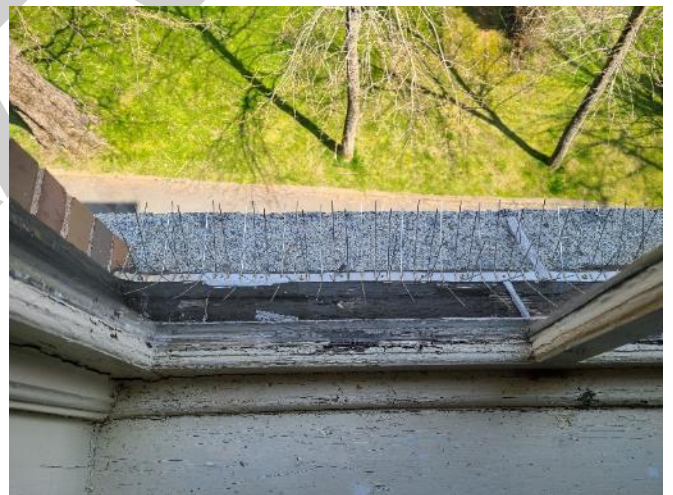
East Elevation – Interior of stairwell tower, 3rd floor landing

- In general, wood sashes and window frames were observed to be in deteriorating condition and in need of rejuvenation.

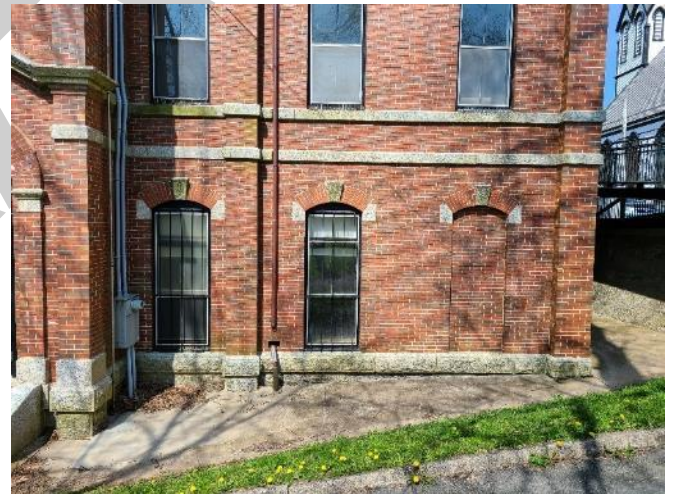
East Elevation

- First floor windows to the right of the stair tower are protected with metal security bars.
- The end window is infilled with masonry.
- Organic growth and staining was observed at the granite ribbon below second floor windows.

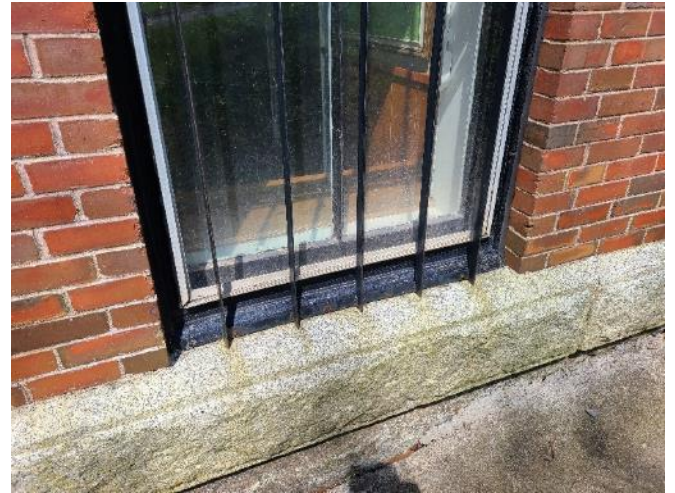
East Elevation

- In general, metal security bars were observed to be in fair condition. Corrosion was observed at multiple locations and translated to staining of the masonry walls below.
