Building Condition Assessment

Lunenburg Townhall
119 Cumberland Street
Lunenburg, Nova Scotia

FSA Project No.: 22057DA
2022-09-23

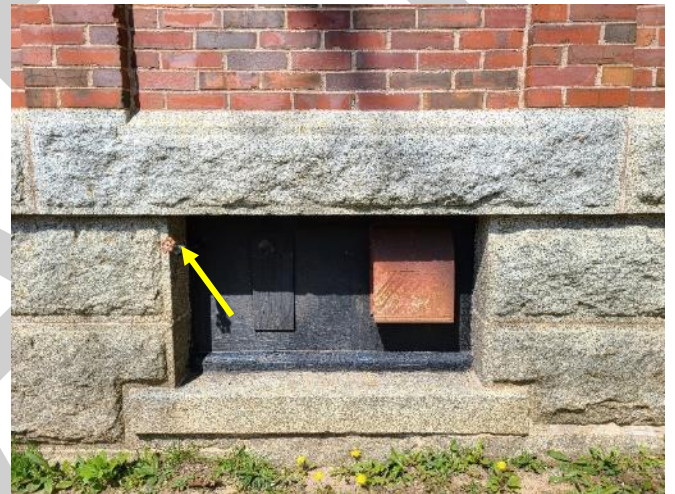
East Elevation

- Basement windows were observed to be infilled with painted plywood.
- A hose bibb (yellow arrow) penetration and hood vent were observed at this window penetration.
- A mechanical vent was observed to be corroded.

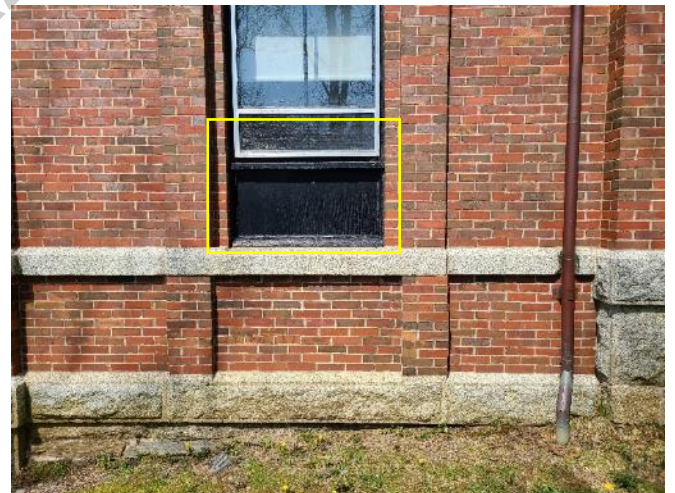
East Elevation

- Windows at the first floor of the east elevation were observed to be boxed out or sealed with varying plywood structures.

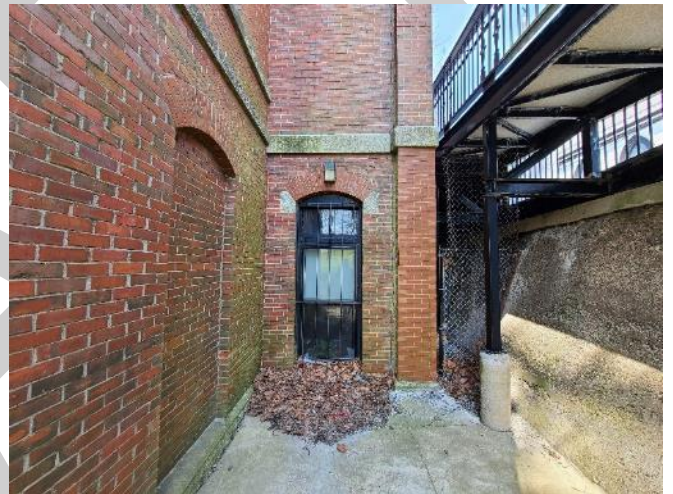
- Paint/stain at the upper arched window was observed to be deteriorated.
- The brickmould for the arch appears to be constructed of multiple pieces of quarter round. This does not appear to be of original construction. See following observation.

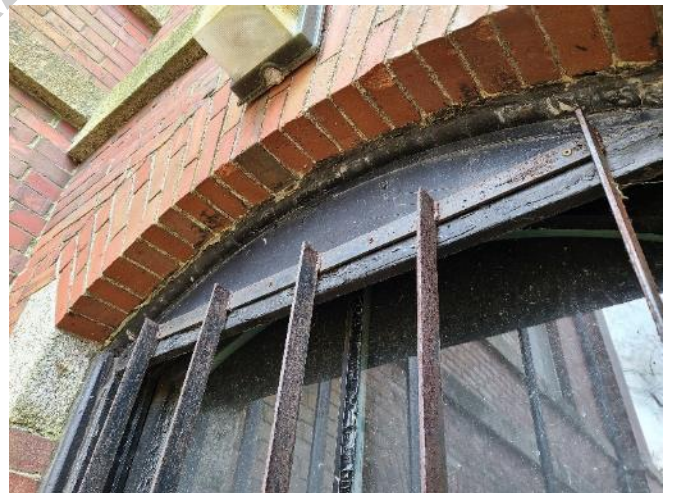
North Elevation – Ground level

- Same as above.
- Deteriorated paint/stain and sealant were observed at the wood frame and sash.

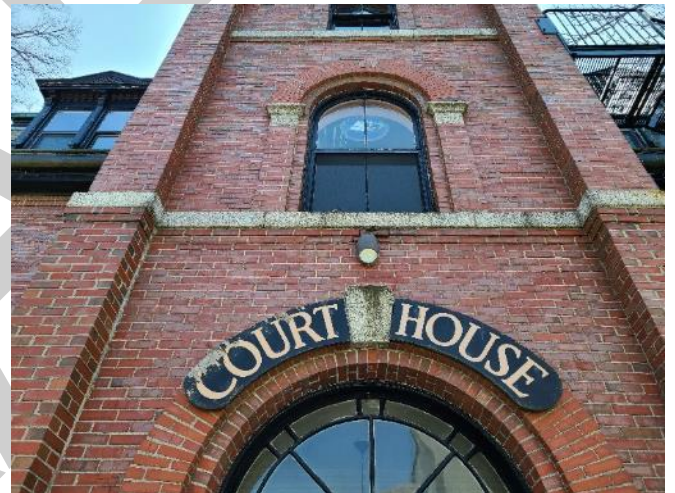
North Elevation – at entrance

- An arched window is observed at the second floor, over the north entrance.
- Deteriorated paint/stain and sealant was observed.

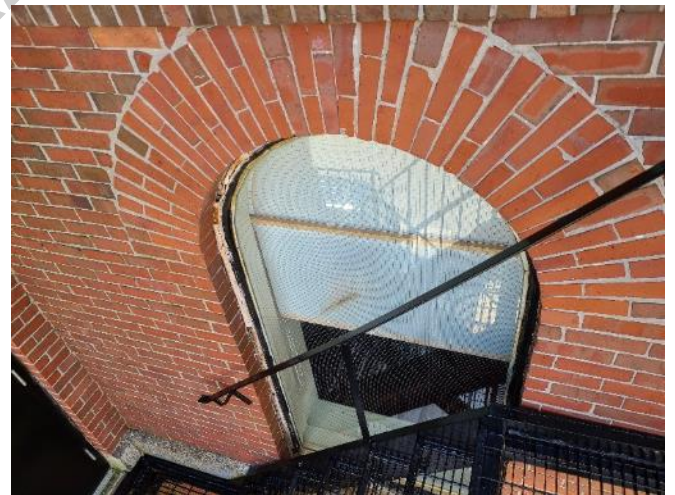
North Elevation – right of entrance

- The window pictured here was observed to be replaced with a Georgia-wire glass, likely as an increased security measure given the potential access provided by the exterior stairs.

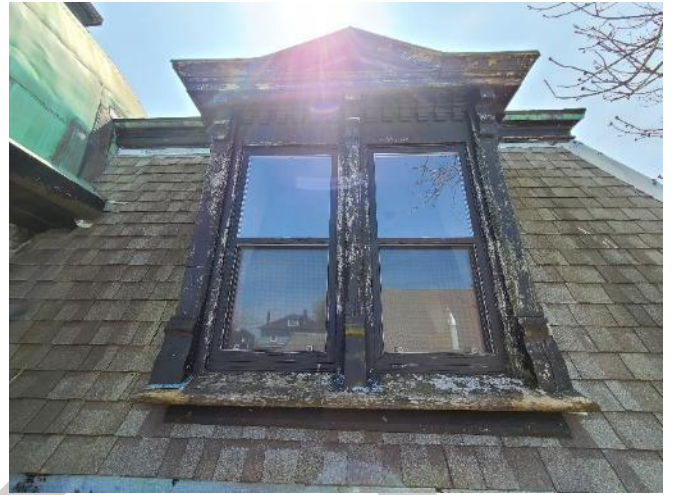
North Elevation – right of entrance

- In general, the design of dormer windows appears continuous around the building, although, single windows as opposed to the double window pictured here are also used.
- The wood framed dormers are generally in fair but deteriorating conditions.
- Paint/stain was observed to be deteriorated.
- Dormer windows were observed to be wood framed, vertical sliders. Some lites have been replaced with more efficient IGU's or the addition of aluminum storm windows.

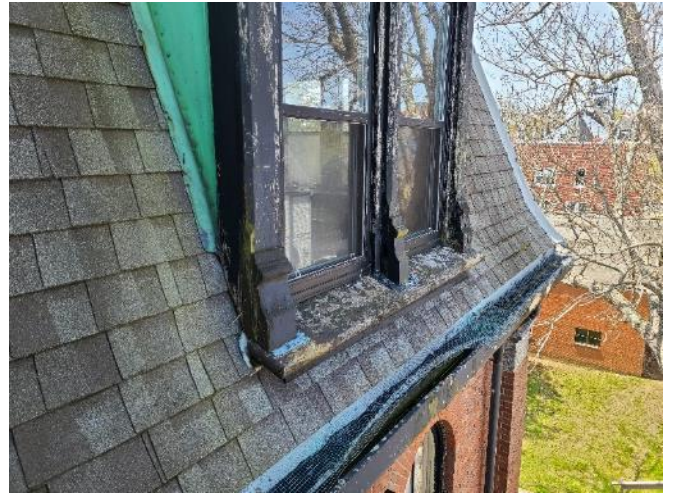
North Elevation – right of entrance

- Deteriorated wood sill and window frame was observed.
- The leaf guard at the gutter was observed to be damaged and poorly secure.

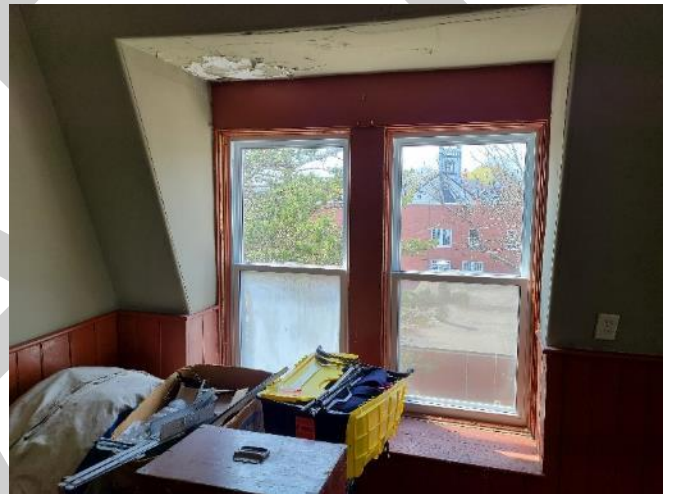
Dormers at the Interior

- Some dormers windows have been replaced with newer, double hung vinyl replacements.
- Significant water damage was observed at the interior at the dormer. See following observation.

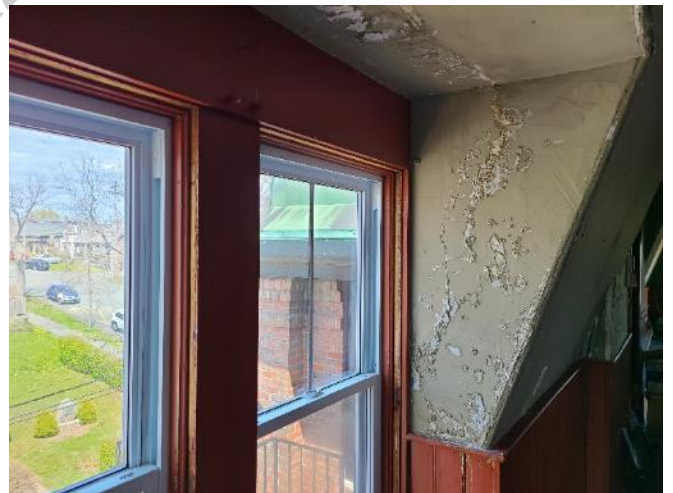
Dormers at the Interior

- Some dormers windows have been replaced with newer, double hung vinyl replacements.
- Significant water damage was observed at the interior at the dormer which appears to be aligned with the interface between the dormer and the adjacent mansard roof.

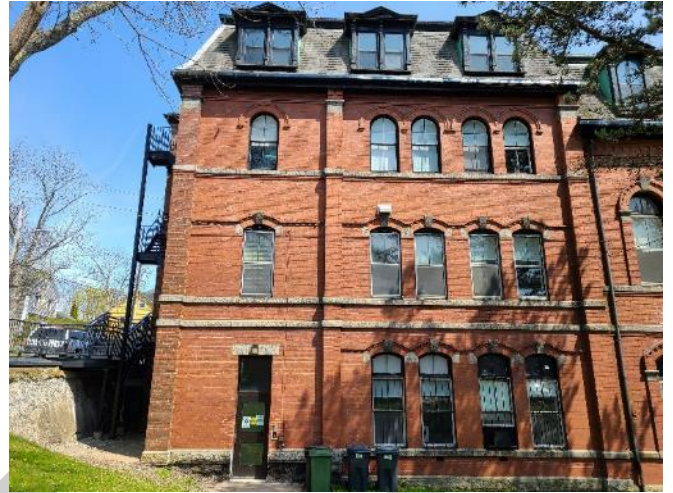
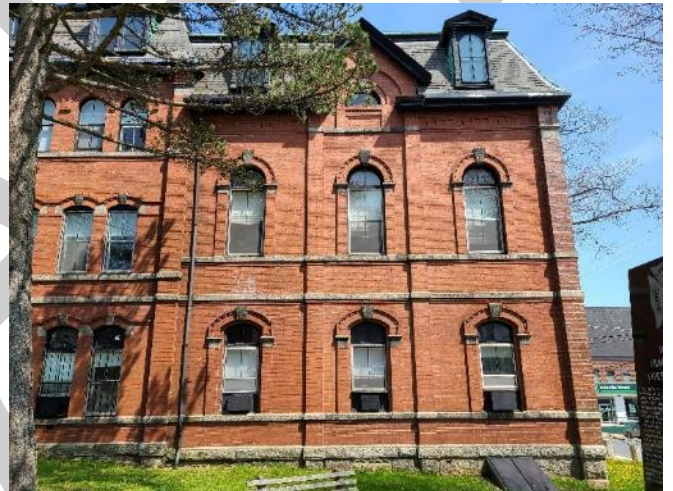
West Elevation – General images

- First floor windows across the west elevation feature arched heads. Multiple windows at this level are boxed out with plywood to accommodate various mechanical elements.
- Second floor windows are square with a decorative wood arch at the head of the window. These feature aluminum storm windows.
- Third floor windows are typically arched.
- All windows were generally found to be in fair but deteriorating conditions with paint/stain and sealant maintenance being required.

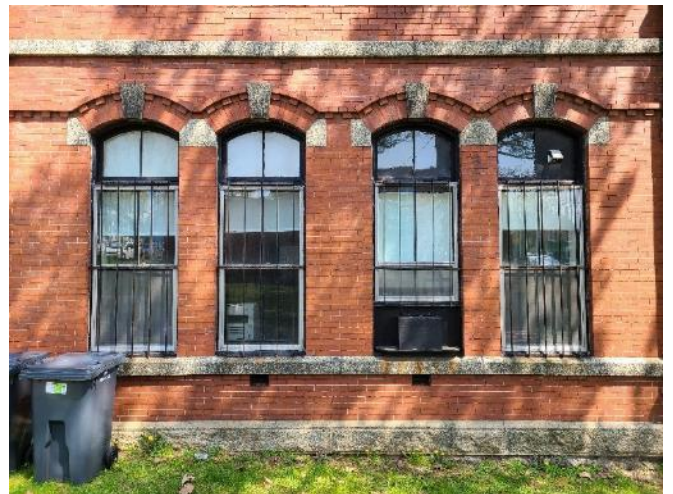
West Elevation

- Typical first floor windows feature metal security bars and aluminum storm windows.
- Corrosion was generally observed at metal security bars which in turn is staining the granite sill/ribbon below.
- Paint/stain at window frames and sashes was generally observed to be deteriorated and in need of maintenance. See following images.

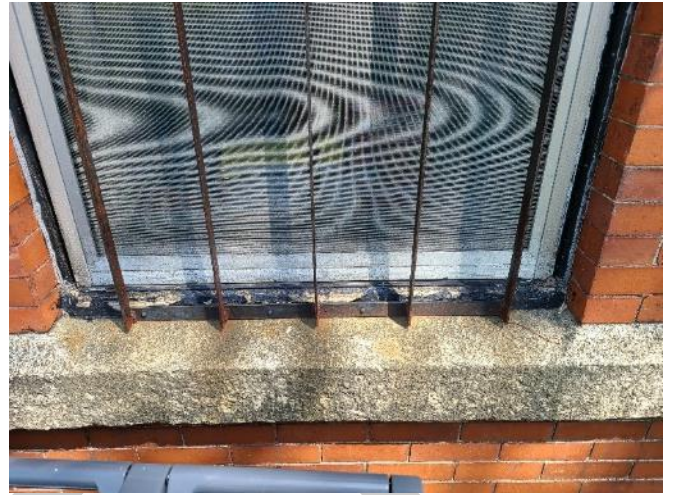
West Elevation

- Corrosion was generally observed at metal security bars which in turn is staining the granite sill/ribbon below.

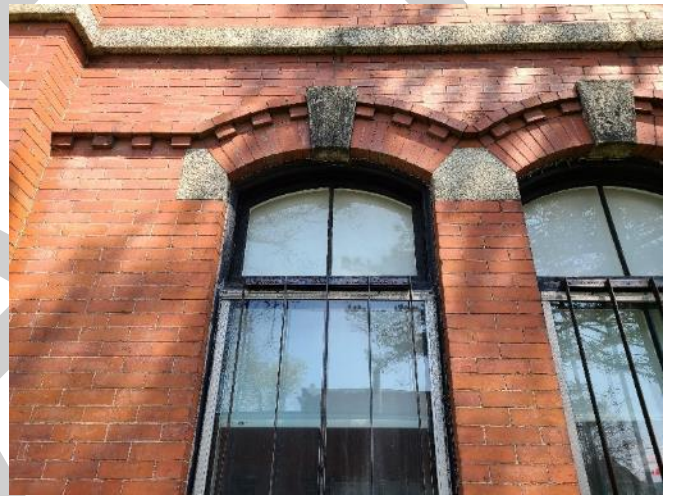
West Elevation

- Typical first floor windows feature metal security bars and aluminum storm windows.

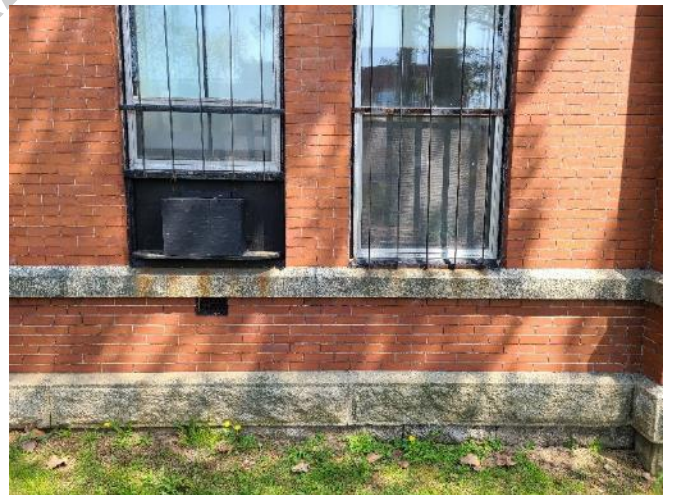
West Elevation

- Various alterations were observed to windows at all elevations.

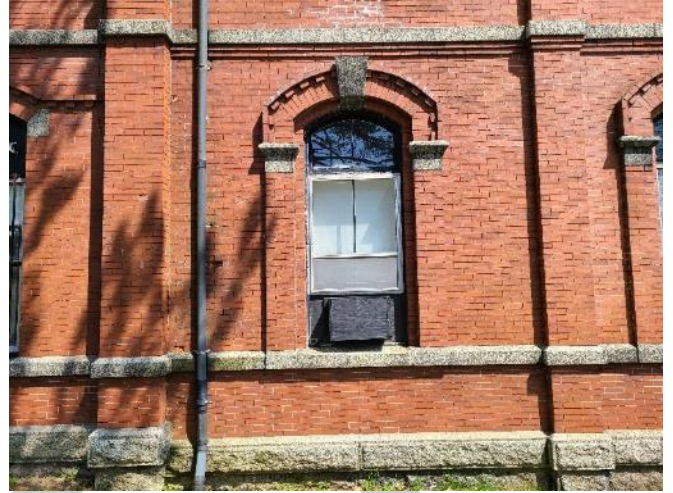
West Elevation

- First floor windows across the west elevation feature arched heads. The window pictured here features a squared arch. Multiple windows at this level are boxed out with plywood to accommodate various mechanical elements.
- Paint/stain was observed to be deteriorated at window frames, sashes and plywood components.

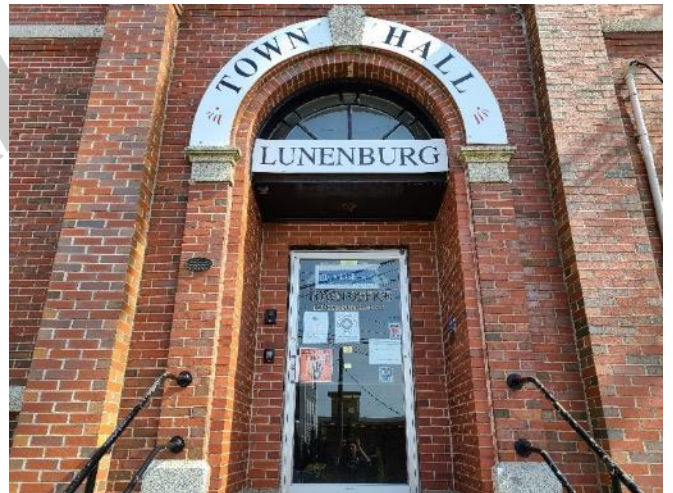
South Elevation

- The main entrance was likely remodelled to accommodate the existing aluminum entrance door. Note, the arched lite was preserved.

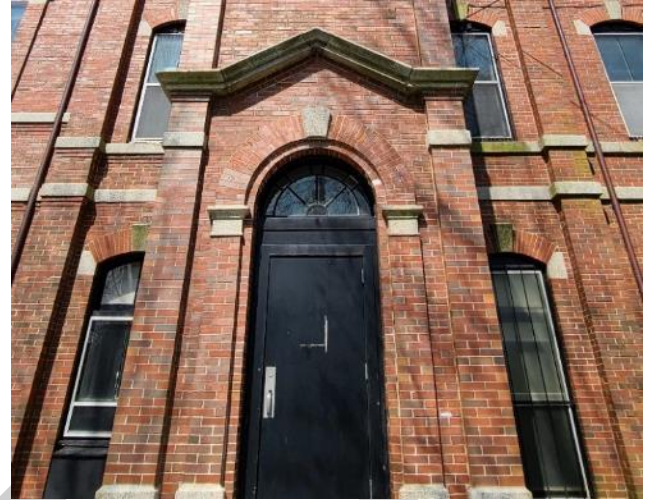
East Elevation

- A newer metal slab door has been installed. The arched lite above was preserved.

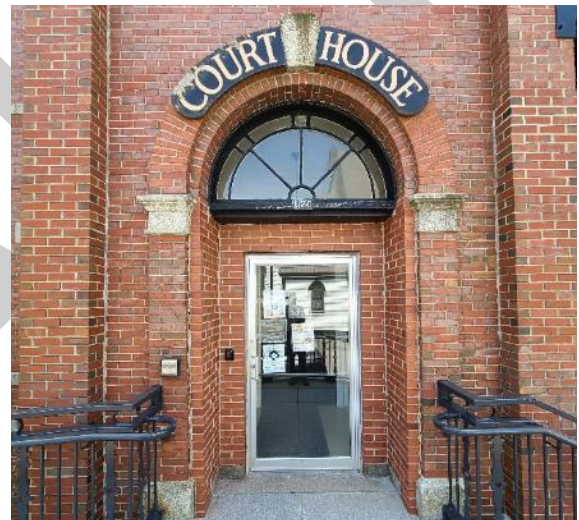
North Elevation

- The main entrance was likely remodelled to accommodate the existing aluminum entrance door. Note, the arched lite was preserved.

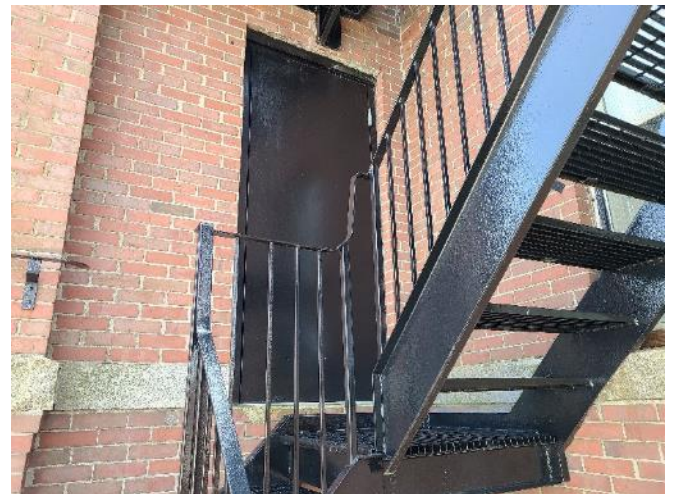
North Elevation – second floor

- Newly installed metal slab door for emergency egress at the second floor. This does not appear to be part of the original construction. Note, a lintel was not installed above the head of the door to effectively distribute the weight of the overhead masonry.

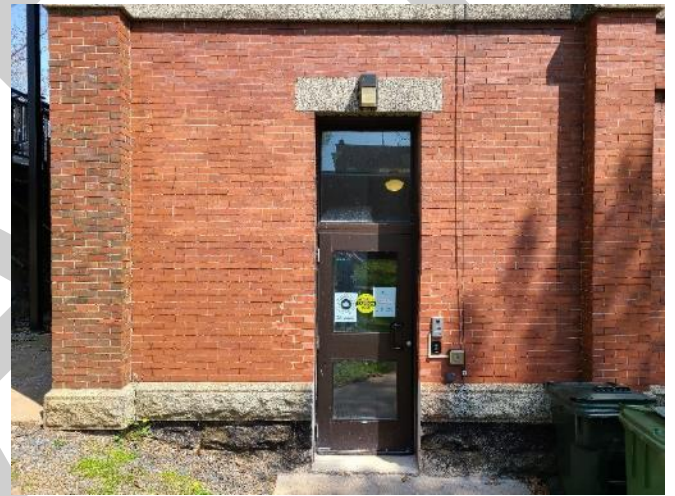
West Elevation

- An accessible aluminum entrance system with overhead lite was observed.

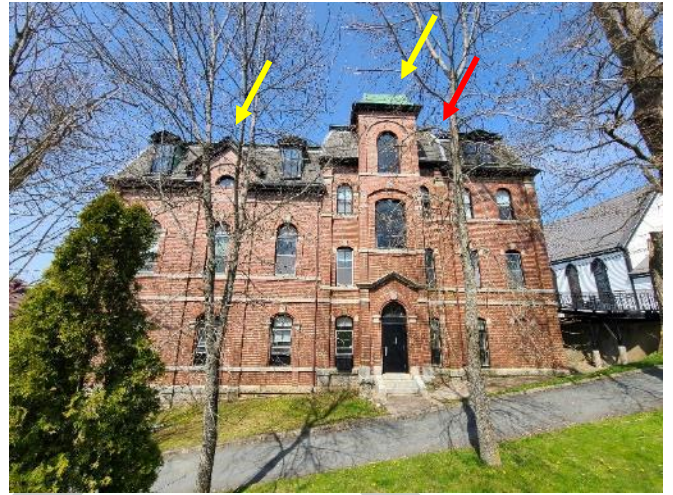
East Elevation

- Prominent mansard roof and dormers typical around the building.
- The east elevation also features a copper roof above the stairway tower and a unique gable roof towards the south elevation (yellow arrows).
- The style of the mansard roof at the hip changes to a rounded profile at this elevation. The hips, capped with lead are common around the building.

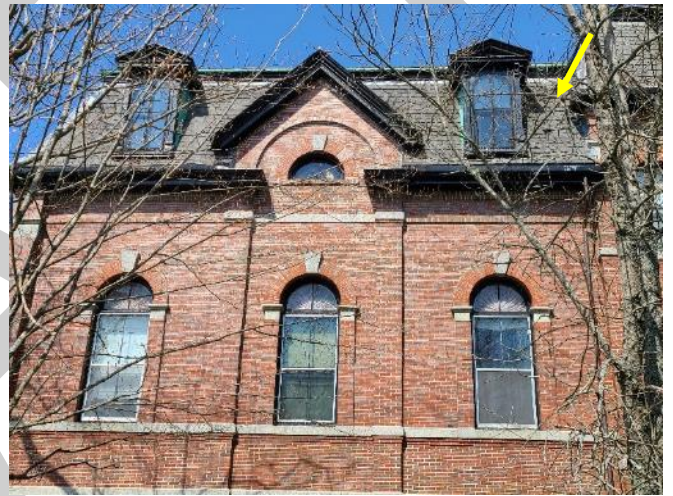
East Elevation

- General image of the hip roof and dormers at the east elevation.
- Deterioration of shingles was observed (yellow arrow). Shingles were torn, curled and in some areas missing. See following observation.

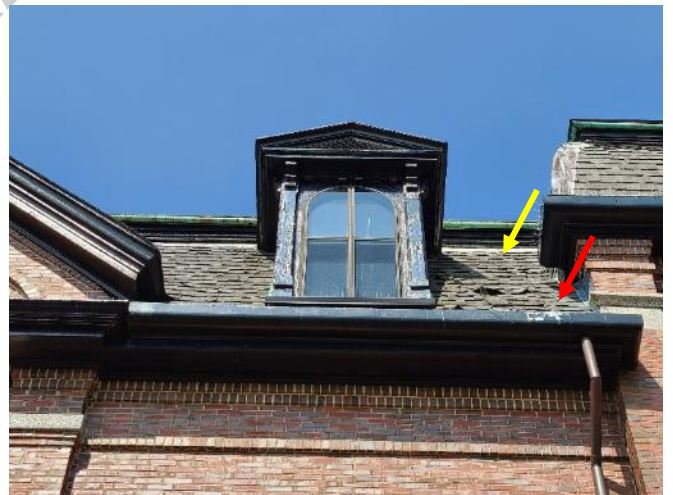
East Elevation

- Deterioration of shingles was observed (yellow arrow). Shingles were torn, curled and in some areas missing. See following observation.
- Paint/stain of the woodwork around the dormers was observed to be deteriorated and in need of repair/maintenance. This was typical of all elevations.
- Paint was observed to be flaking at the gutter to the right of the dormer. This was typical off all elevations.

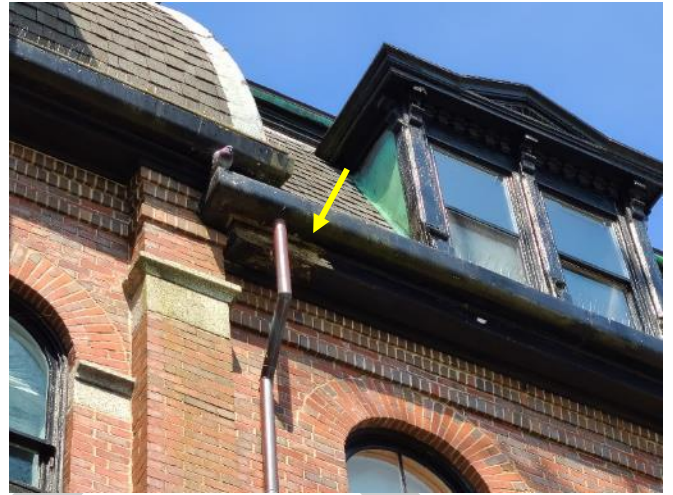
East Elevation

- Some deterioration was observed at soffits in isolated areas including deteriorated wood and flaking paint/stain. This was typical of all elevations.

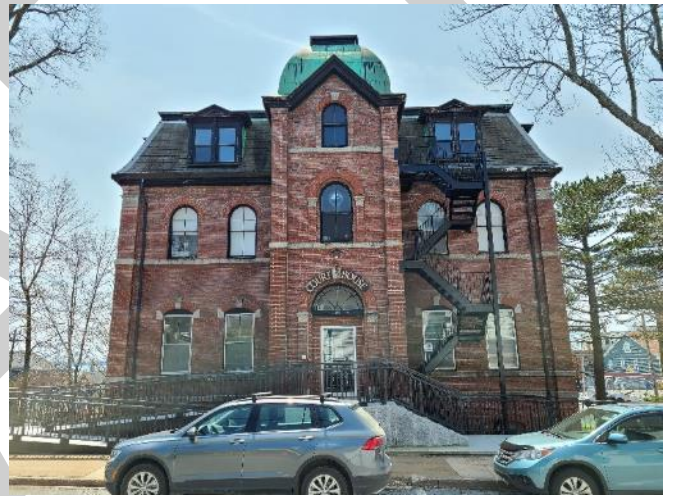
North Elevation

- General image of the roof at the north elevation.
- Prominent copper near-domed roof and dormers are visible.

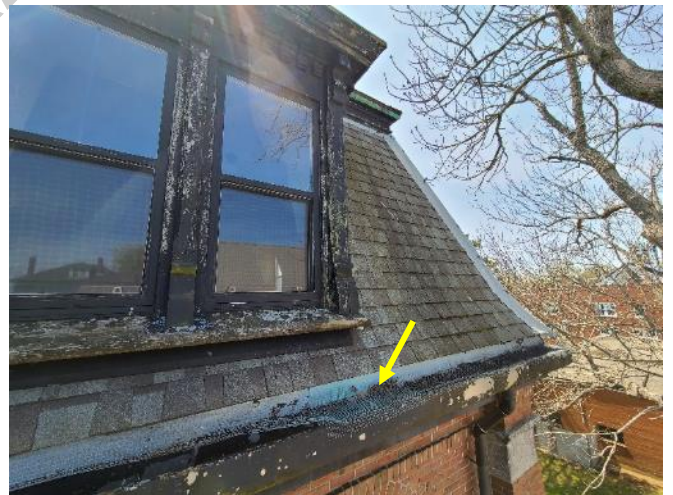
North Elevation

- Staining and organic growth was observed at the mansard. This elevation remains relatively shaded throughout the day due to its orientation and large trees.
- Mesh gutter guards were observed to be damaged and providing little protection. See following observation.

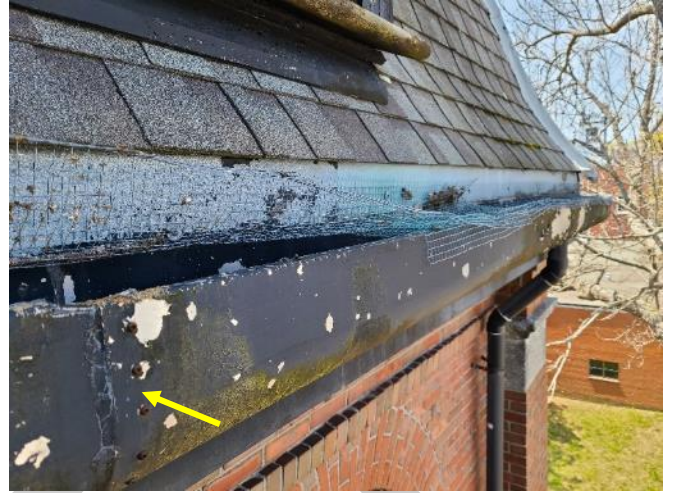
North Elevation

- Mesh gutter guards were observed to be damaged and providing little protection against debris accumulation in the gutters.
- Paint at the gutters was observed to be deteriorating.
- Organic growth was observed along the gutter.
- Sealant at joints in the gutter were observed to be deteriorated (yellow arrow).

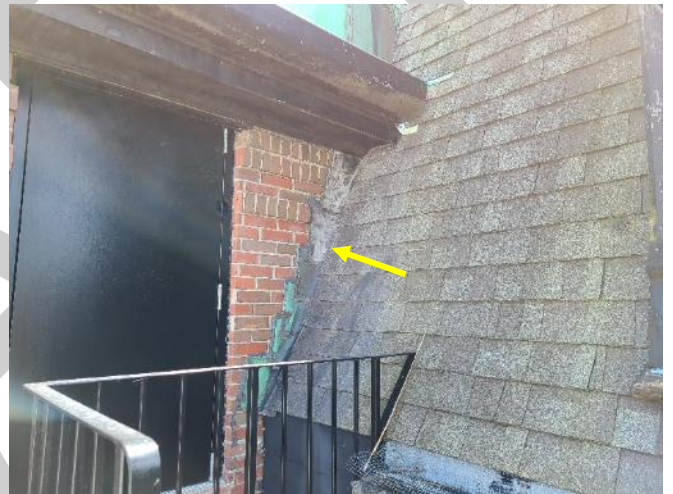
North Elevation

- Step flashing transitioning from lead to copper was observed at the intersection to masonry. Flashing is set into a reglet. See following observation.
- No interlapping with the original step – flashing. This creates a vulnerable flashing detail reliant on sealant.

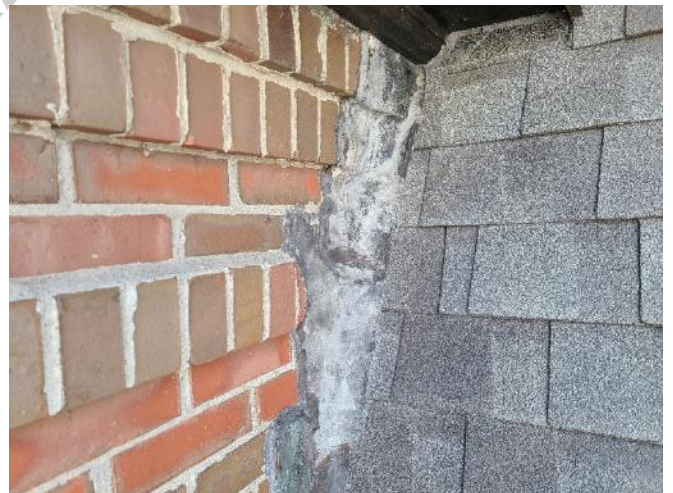
North Elevation

- General image of lead reglet step flashing. Sealant has been applied at the head of the joint and is beginning to deteriorate.
- No interlapping with the original step – flashing. This creates a vulnerable flashing detail reliant on sealant.

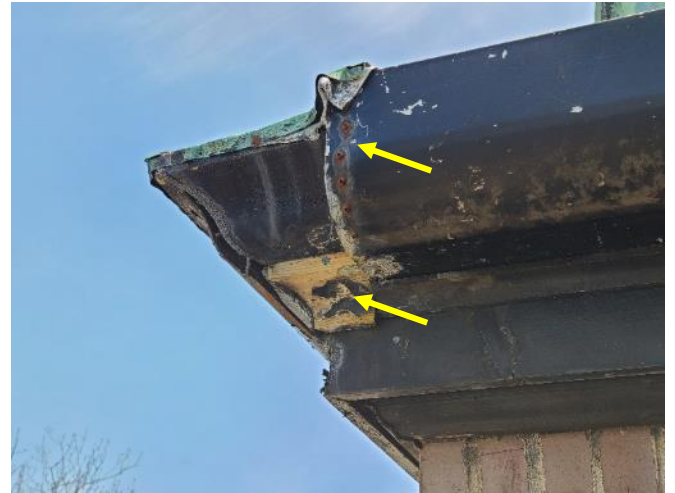
North Elevation

- Previous repairs were observed at the gutter.
- Dissimilar metals and corroded fasteners were observed.
- Untreated wood trim was observed beneath the gutter.

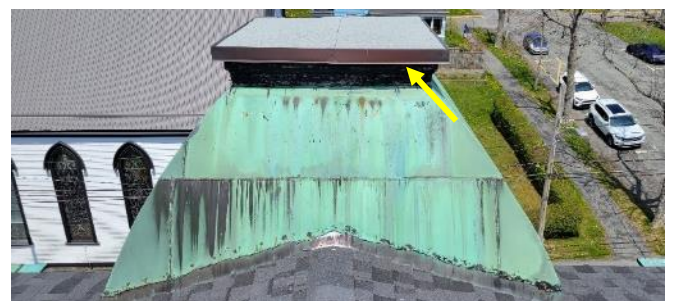
Copper Roof (Dome) – North tower

- In general, copper roofs were observed to have reached the end of their useful life.
- Deteriorated paint/stain was observed beneath the flat top of the copper roof.
- Corroded fasteners and dissimilar metals were observed especially at the foot of the copper roof. See following observations.
- There was no indication of step flashing between the shingle roof detail and the copper roof creating a transition vulnerable to water ingress.

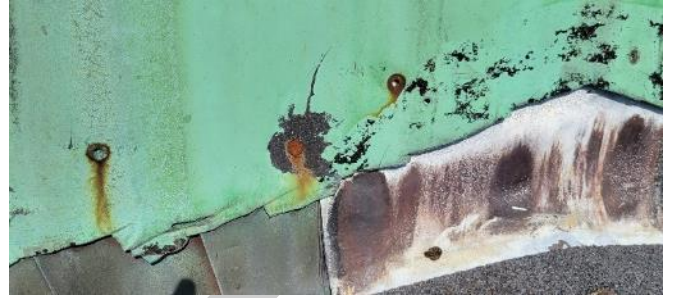
Copper Roof (Dome) – North tower

- Corroded fasteners and dissimilar metals were observed especially at the foot of the copper roof.

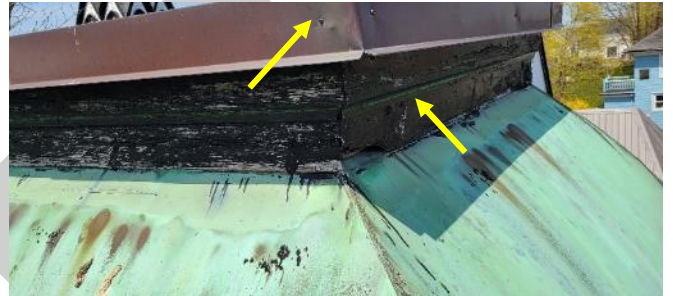
Copper Roof (Dome) – North tower

- Deteriorated paint/stain was observed at the wood and metal elements beneath the flat top of the copper roof.
- Missing fasteners were observed at the metal flashing.

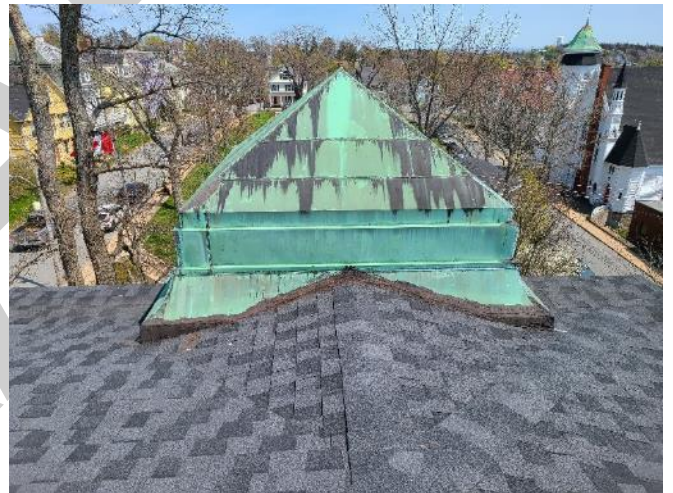
Copper Roof (Pyramid) – East Tower

- In general, copper roofs were observed to have reached the end of their useful life.
- Deteriorated sealant was observed at the foot of the copper roof. Furthermore, the use of mastics suggest no step flashing was used to transition the flashing upstand. See following image.

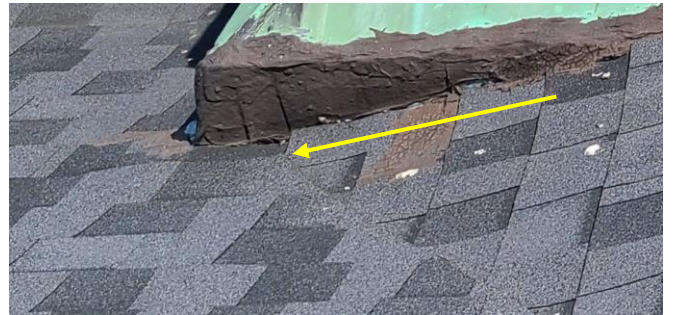
Copper Roof (Pyramid) – East Tower

- Roof valley results in water flow being directed under the shingles that are sloped to the eaves.

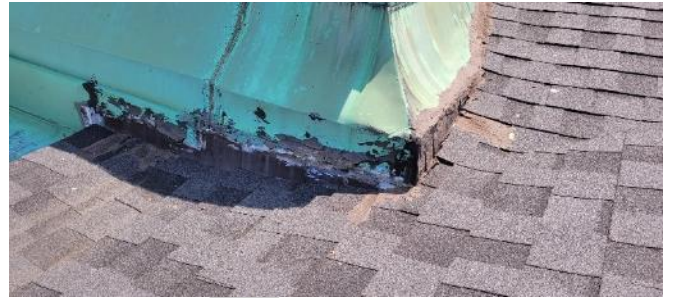
Copper Roof – facing east

- Detailing sealant, missing and ineffective fasteners were observed.
- No evidence of required step flashing resulting in a detail vulnerable to water intrusion.

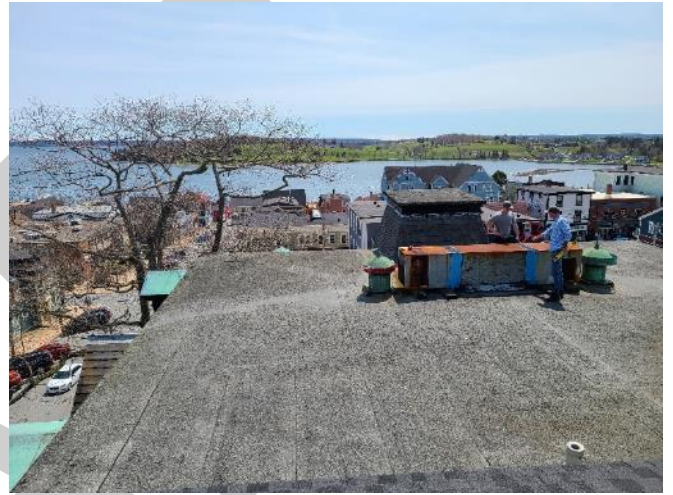
General Image – low slope/mod. bit. membrane roof area

- Low slope roof area is of modified bitumen (mod. bit.) membrane construction. In general, the roof area has reached the end of its useful life and needs replacement.
- The rooftop unit was observed to be severely corroded and placed on wooden sleepers which appeared to be loose-laid on the roof.
- See following observations.

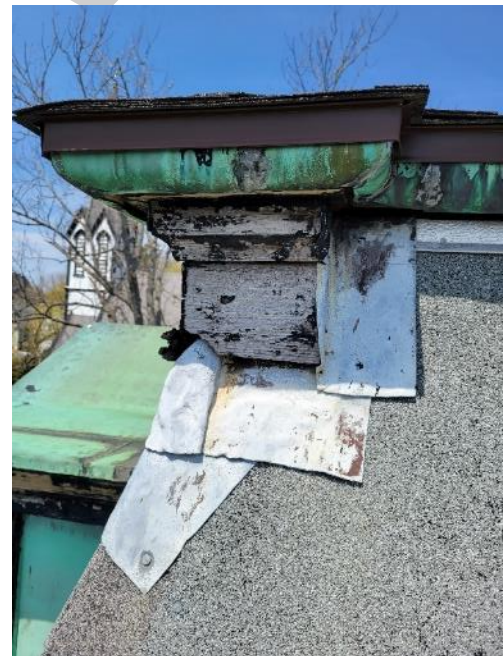
General Image – low slope/mod. bit. membrane roof area, facing north

- Deteriorated wood trim along with paint/stain were observed.
- Dissimilar metals and poorly detailed flashing components. New pre-painted roof edge flashings have been installed over older copper cornice components, lead flashings have been installed under existing wood and metal components and overlapped over newer mod. bit. membrane roof flashings
- Copper was observed to be oxidized with various sealants applied.
-

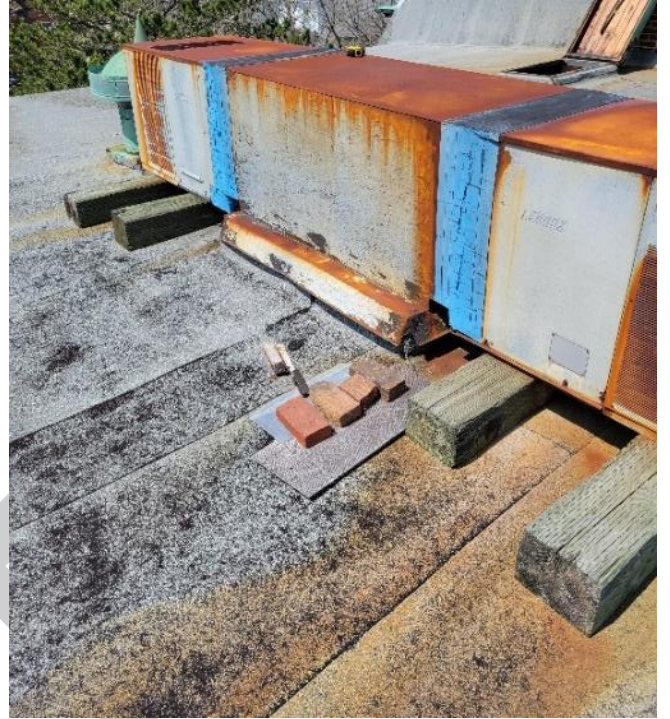
General Image – low slope/mod. bit. membrane roof area

- Low slope roof area is of mod. bit. membrane construction. In general, the roof area has reached the end of its useful, serviceable life and needs replacement.
- The rooftop unit (RTU) was observed to be severely corroded and placed on wooden sleepers which appeared to be loose laid on the roof resulting in potential for roof membrane damage and inadequate securement of the RTU

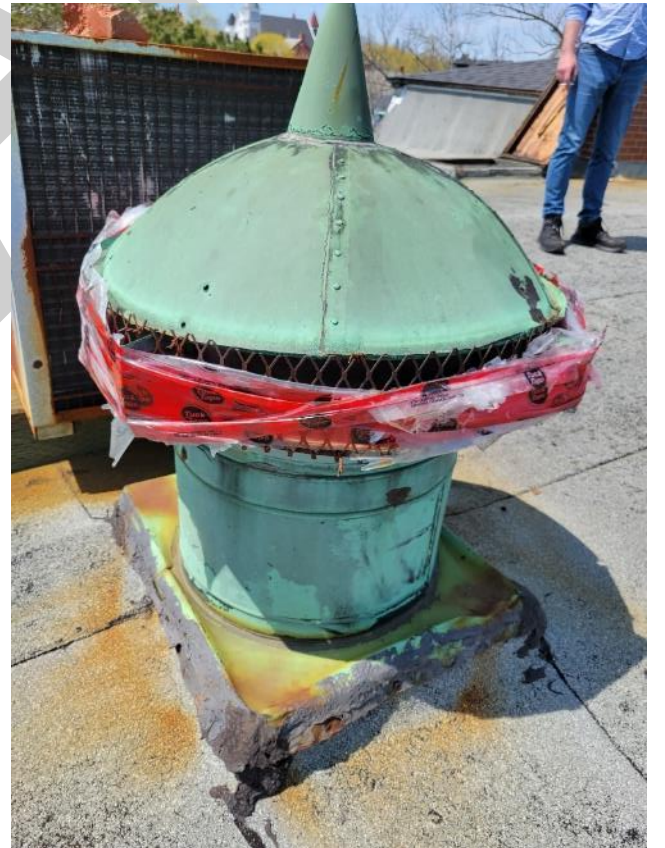
General Image – low slope/mod. bit. membrane roof area

- Copper roof vents were observed to have reached the end of their serviceable life. Many were observed to be damaged with various repairs made.
- Waterproofing and sealant at the foot of copper roof vents was observed to be deteriorated. See following observations.
- No separate membrane flashing ply was observed suggesting a weak transition that relies on mastics.

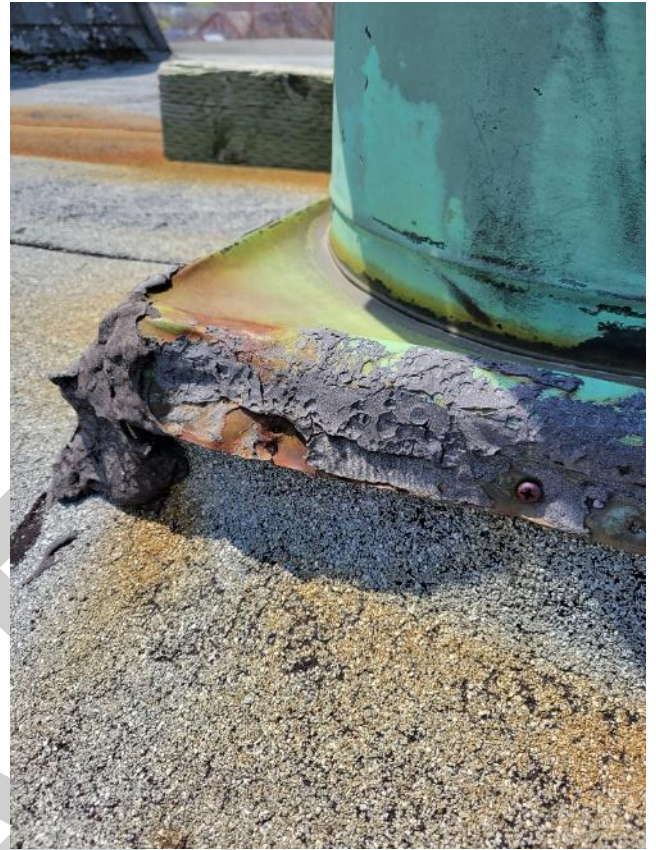
General Image – low slope/mod. bit. membrane roof area

- Waterproofing and sealant at the foot of copper roof vents was observed to be deteriorated.
- Fasteners were observed to be of non-compatible material.
- Note the deterioration of the mod. bit. membrane cap sheet flashing.
- No separate interlapping membrane flashing and unlikely any reinforcing gussets at corner details.

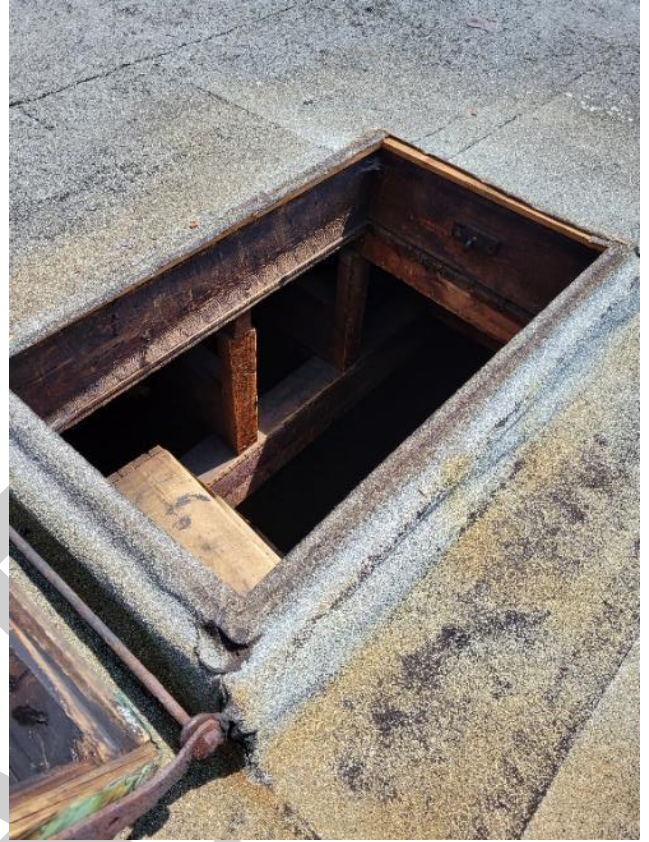
General Image – low slope/mod. bit. membrane roof area

- The roof hatch was observed to be uninsulated and poorly sealed.
- Mod. bit. membrane was observed to be substantially deteriorated.
- No use of interlapping flashing applications was observed which is recommended by all mod. bit. membrane manufacturers.

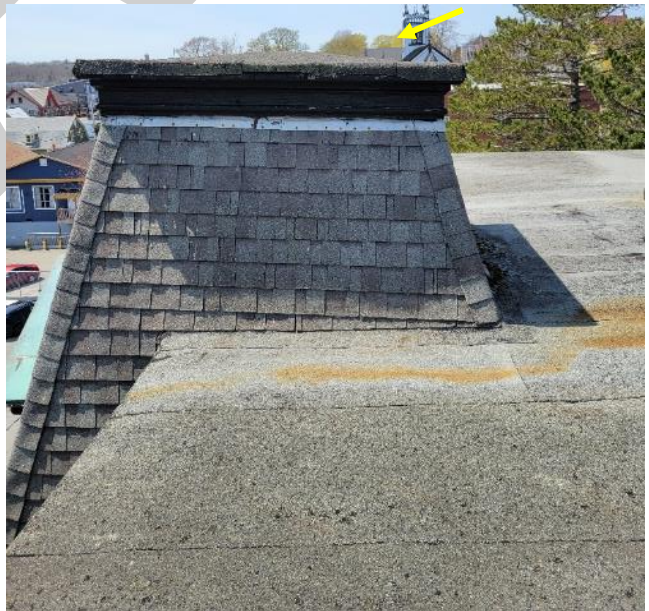
Shingled roof – south elevation

- Mod. bit. membrane was observed on the flat top of the roof area (yellow arrow) and has reached the end of its serviceable life.
- Deteriorated paint/stain was observed on the cornice elements beneath the flat top of the copper roof.

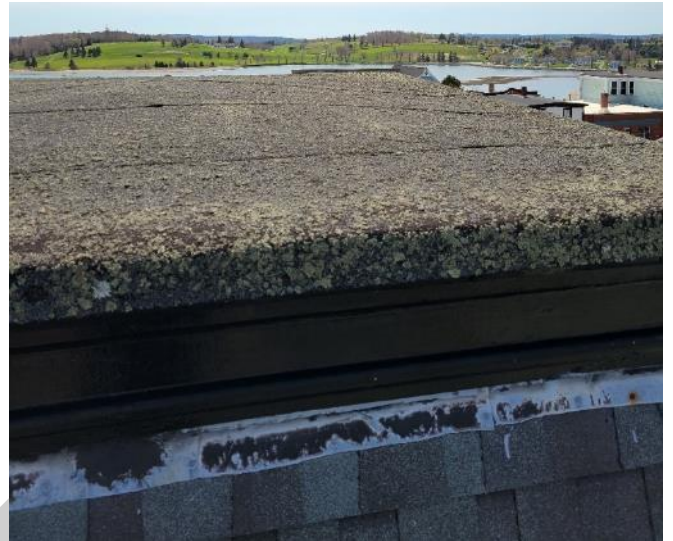
Shingled roof – south elevation

- Mod. bit. membrane roof covering was observed on the flat top of the roof area (yellow arrow) and has reached the end of its serviceable life.
- Significant organic growth on the surface of the membrane was observed.

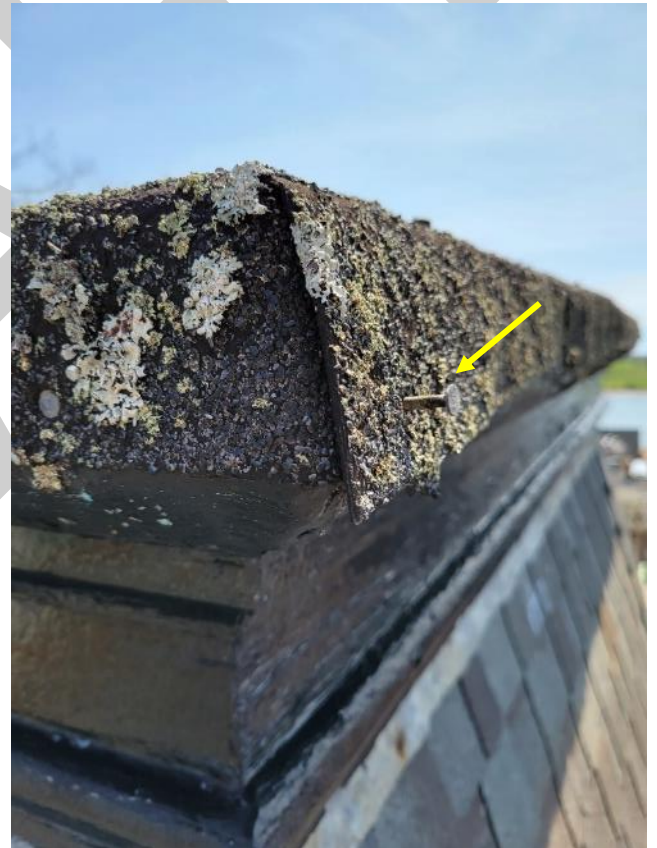
Shingled roof – south elevation

- Pulled fasteners securing the edge of the mod. bit. membrane were observed. Pulled fasteners no longer provide the intended securement.
- Note the substantial organic growth.

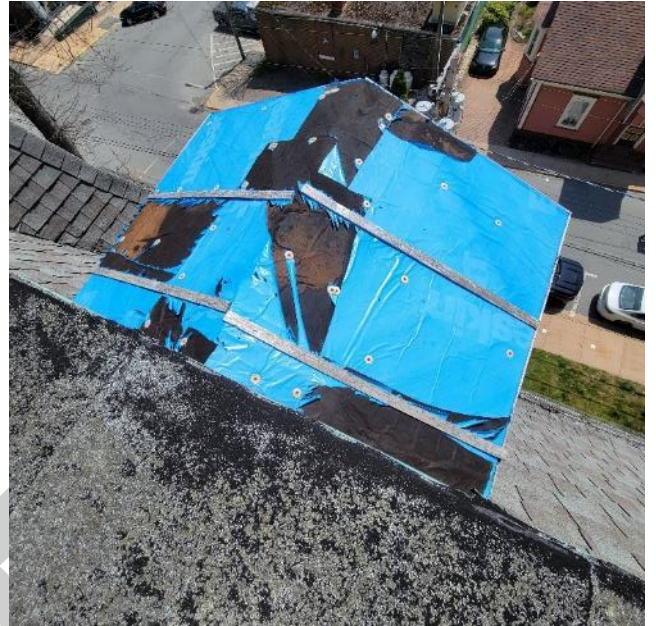
Dormer roof – south elevation

- The roof of the left dormer was observed to be temporarily repaired; however, the pressure sensitive material applied is now deteriorated, missing and no longer providing protection.
- Note the deterioration of the mod. bit. membrane cap sheet at the edge of the main roof visible in the foreground of the image.

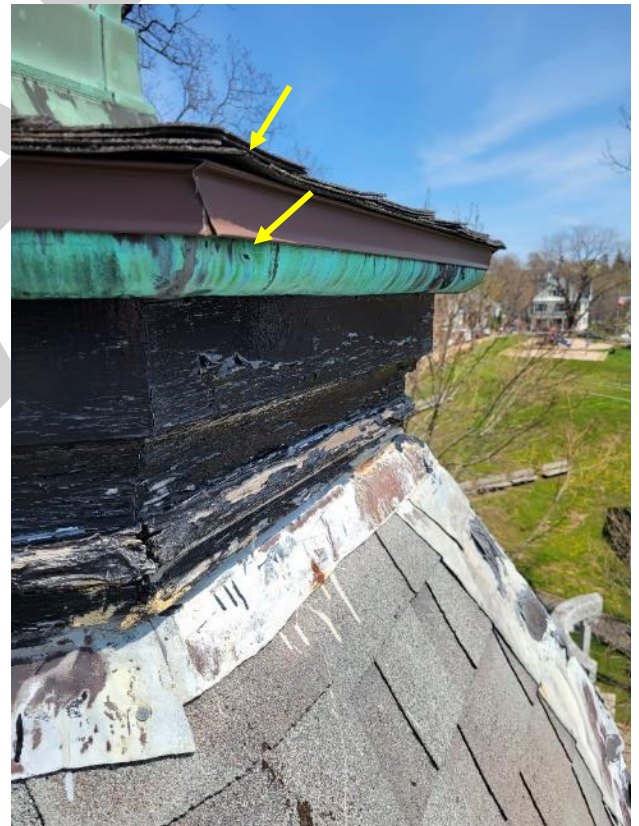
East Stair Tower Roof – facing east

- Shingles were observed to be poorly fastened at roof edge leaving gaps beneath the drip/starter flashing.
- Dissimilar metals were observed.
- Holes and missing fasteners were observed at the copper.
- Deteriorated paint/stain was observed at wood working.

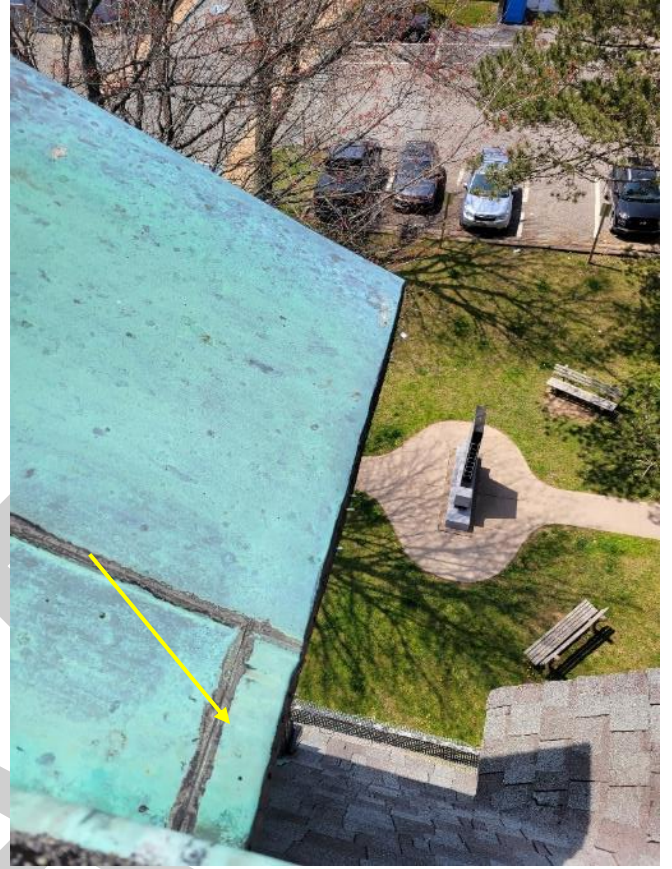
Dormers – facing east

- In general, copper roofs were observed to be pitted.
- Various repairs were observed including the use of sealant at copper seams. Sealant was observed to be deteriorated.
- Fasteners were observed to be pulled. Pulled fasteners no longer provide the intended securement. See following observation.
- An absence of solder at seams and poor sizing of copper sheets – see yellow arrow, suggest an inexperienced copper installer.

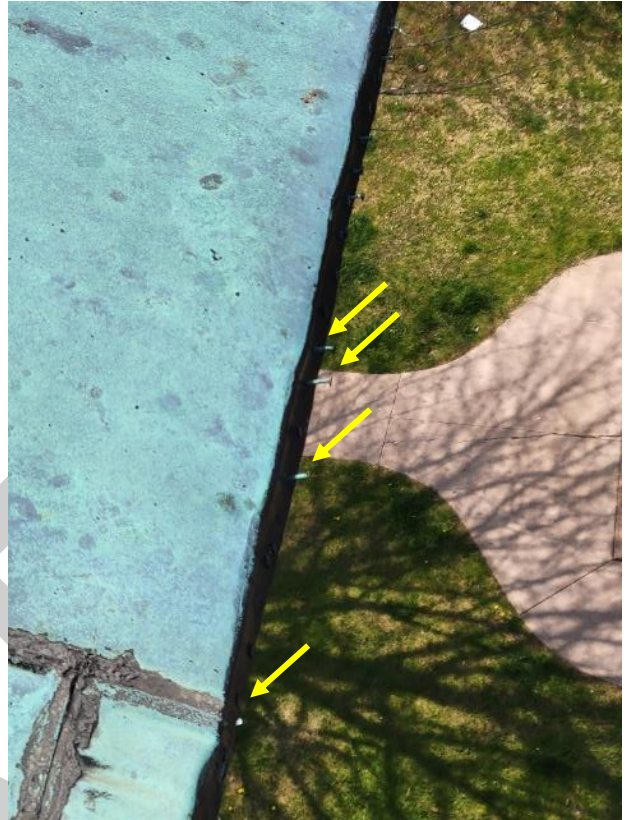
Dormers – facing east

- Fasteners were observed to be pulled. Pulled fasteners no longer provide the intended securement.
- The use of nails further indicates an absence of clips and cleats to secure copper and inexperienced workmanship.

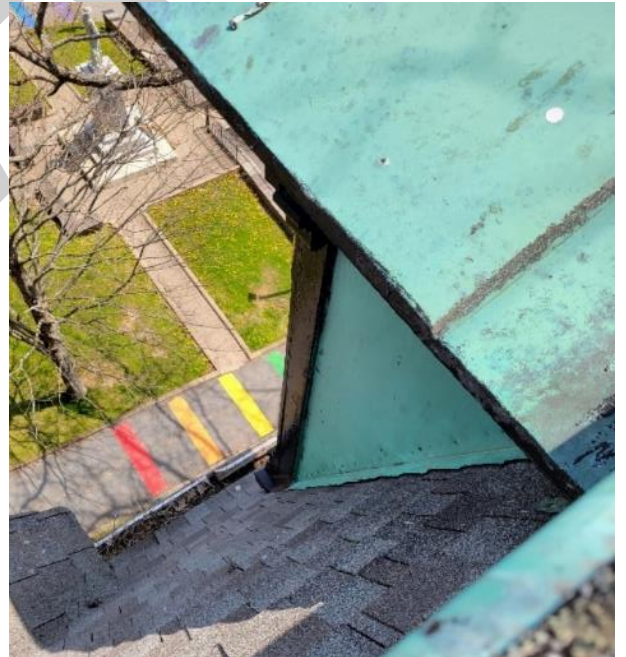
Dormers – facing east

- Damaged shingles were observed at the mansard roof along with debris in the gutters. See following image.

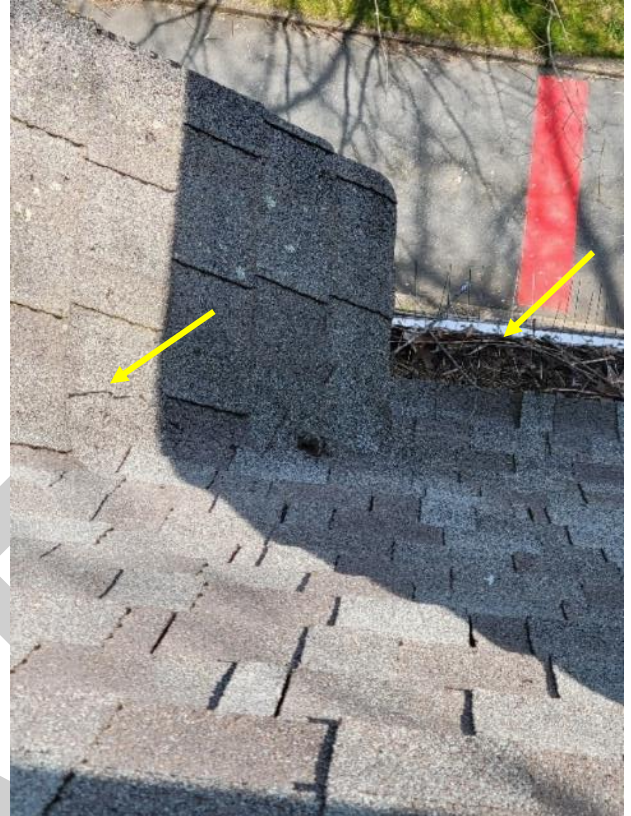
Dormers – facing east

- Damaged shingles were observed at the mansard roof along with debris in the gutters.
