Building Condition Assessment

Lunenburg Townhall
119 Cumberland Street
Lunenburg, Nova Scotia

FSA Project No.: 22057DA
2022-09-23

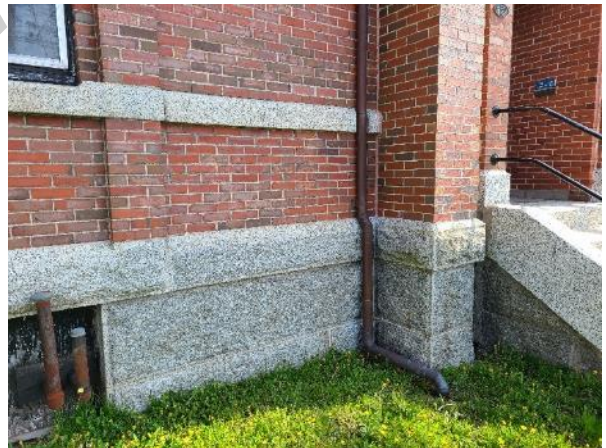
South Elevation

- Copper downspout to the west of the entrance stairs is assumed to tie-into a drainage system below grade. This was not confirmed.
- Uncontrolled roof drainage below grade may be contributing to the deteriorated condition of the support for the granite steps at the south elevation.

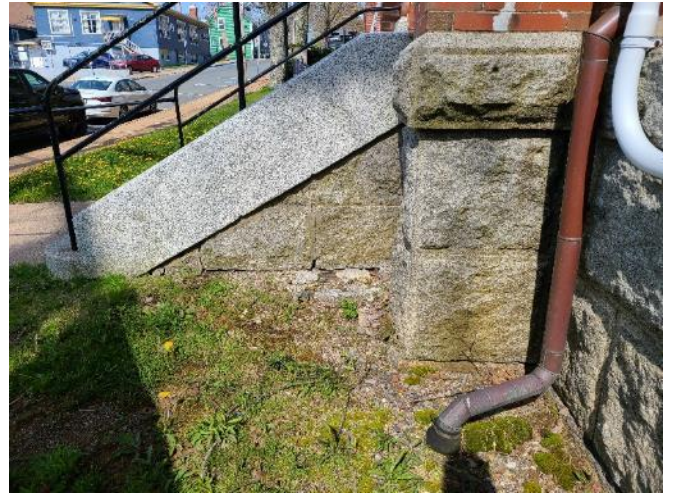
South Elevation

- Copper downspout to the east of the entrance stairs is assumed to tie-into a drainage system below grade. This was not confirmed.
- Uncontrolled roof drainage below grade may be contributing to the deteriorated condition of the support for the granite steps at the south elevation.

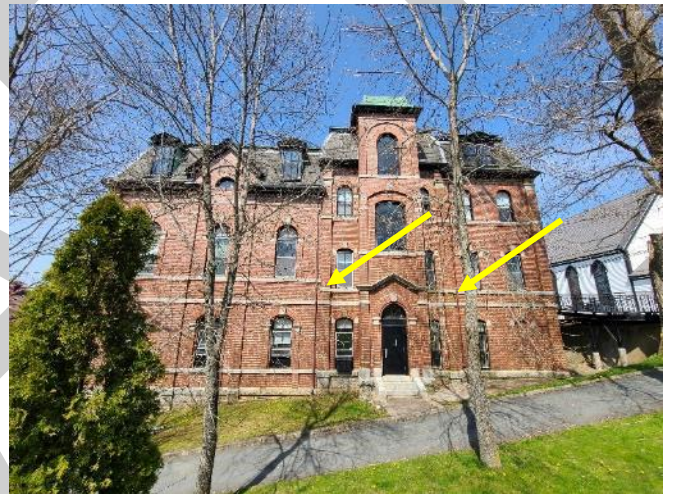
East Elevation

- Copper downspout to the north and south of the tower appear to tie-into a drainage system below grade. This was not confirmed.
- The downspout to the north of the tower was observed to be disconnected. See following observation.
- Uncontrolled roof drainage below grade may be contributing to the deteriorated condition of the support for the granite steps at the south elevation.

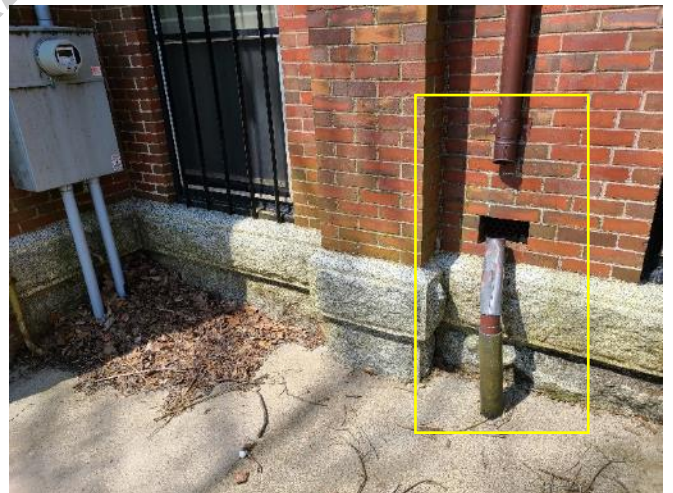
East Elevation

- The downspout to the north of the tower was observed to be disconnected. See following observation.

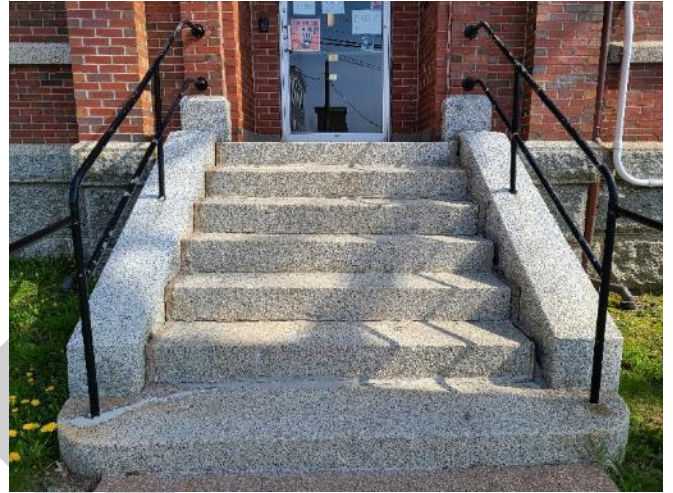
South Elevation

- The granite slab steps at the south entrance were observed to have settled. the right side riser appears to have shifted to the right and a significant crack has developed in the bottom tread.
- A large gap between the riser and treads was observed. See following image.

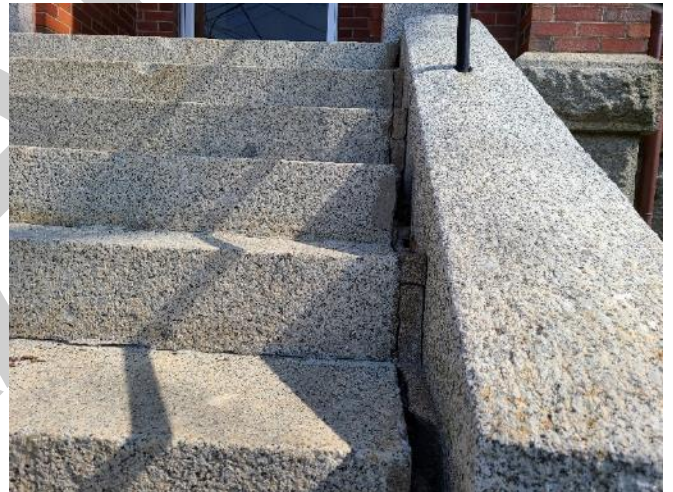
South Elevation

- A large gap between the riser and tread was observed.

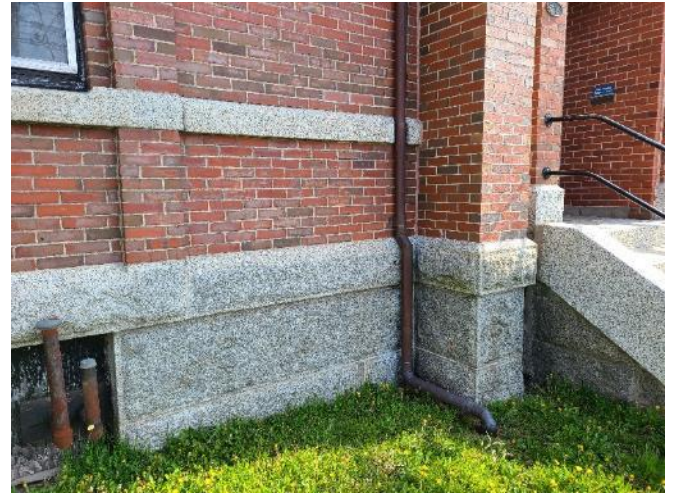
South Elevation

- Downspouts were observed to drain below grade at both the right and left of the south entrance steps. If the drainage is uncontrolled below grade, this could be contributing to the settling observed.

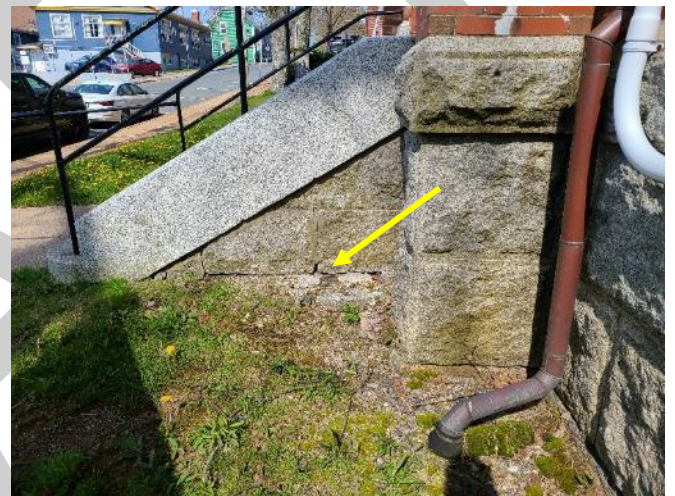
South Elevation

- Downspouts were observed to drain below grade at both the right and left of the south entrance steps. If the drainage is uncontrolled below grade, this could be contributing to the settling observed.
- Deteriorated mortar joints were observed at the right of the south entrance steps, especially at grade level (yellow arrow).

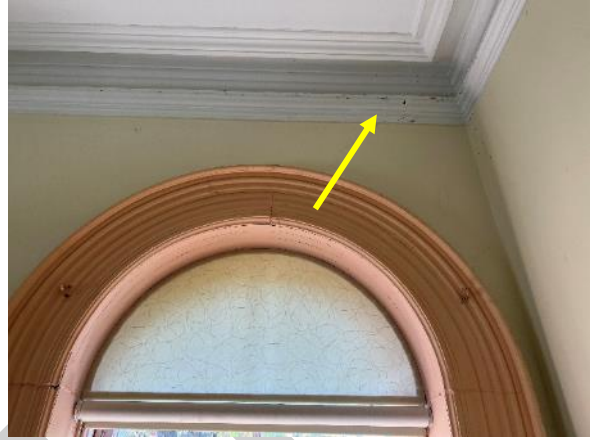
- Various diagonal cracks were observed in the plaster wall covering at the exterior walls throughout the building typical for the age and type of construction.

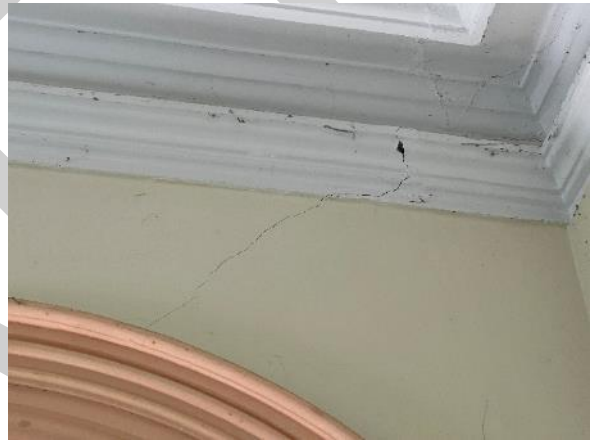
- Notice the diagonal crack traveling from the window casing towards the ceiling.

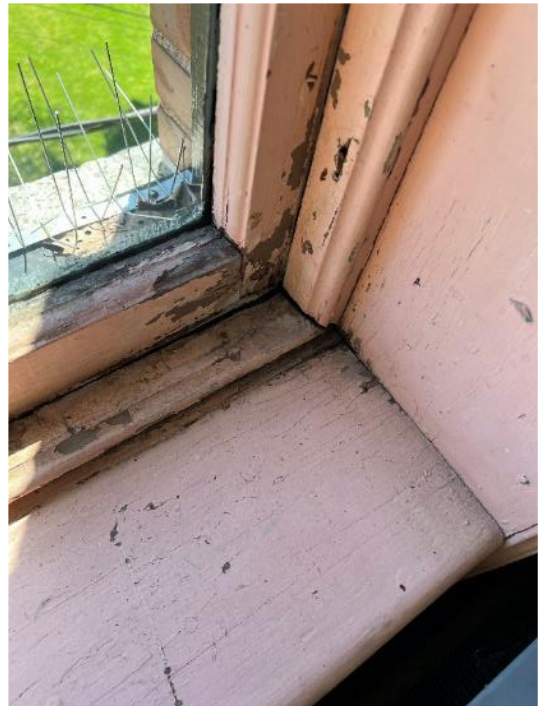
- Various window sills, frames and sashes throughout the building show signs of deterioration
- Indications of water intrusion and/or water damage due to condensation forming on the single glazing as these windows provide a limited thermal break.
- Signs of water intrusions may also be caused by deteriorated sealants and masonry at the exterior.

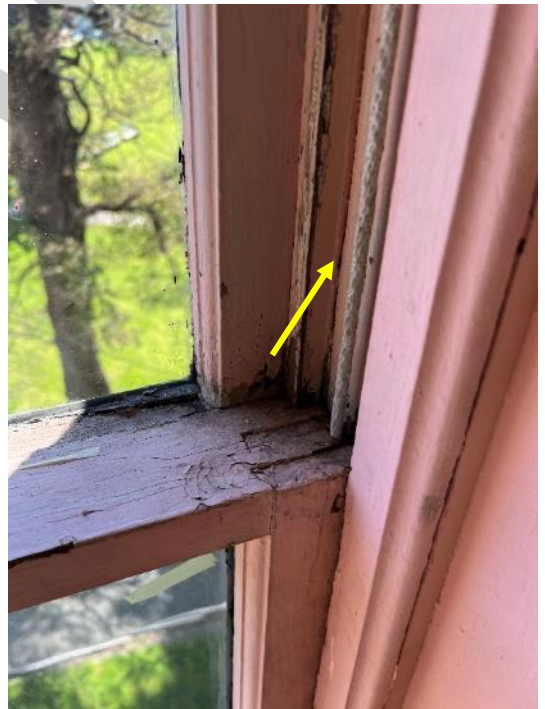
- New cordage was observed at multiple windows and these windows were observed to be operation.

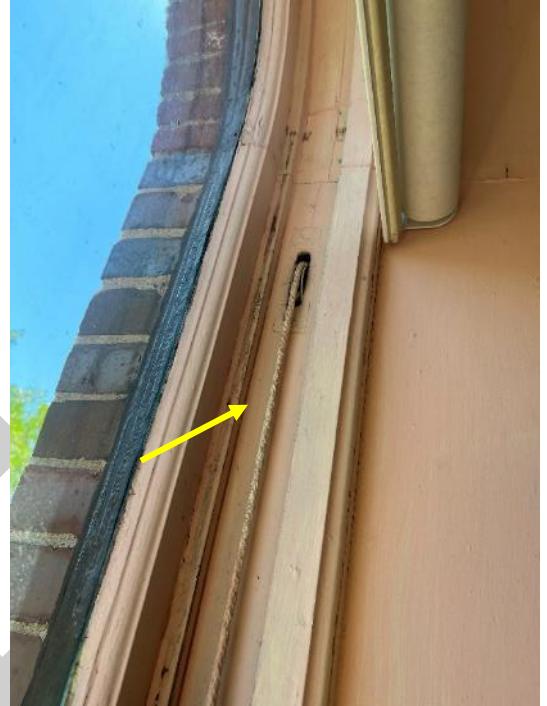
- New cordage was observed at the interior of multiple windows.

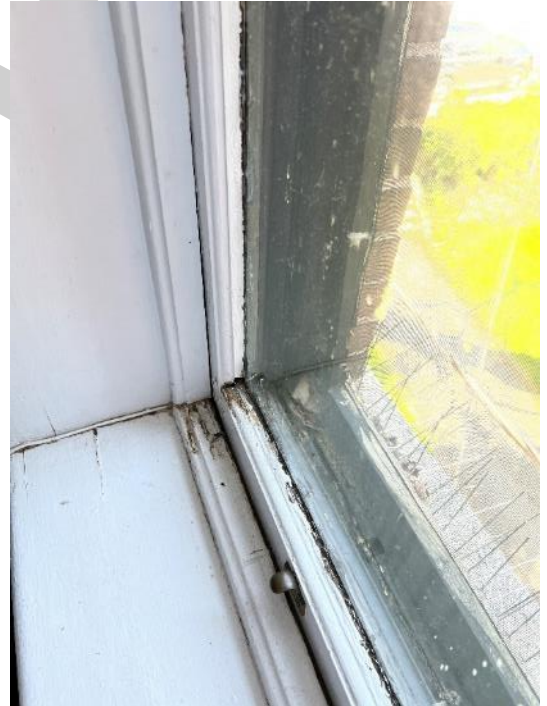
- Many window frames were observed to be in good condition, with only minor repairs needed.

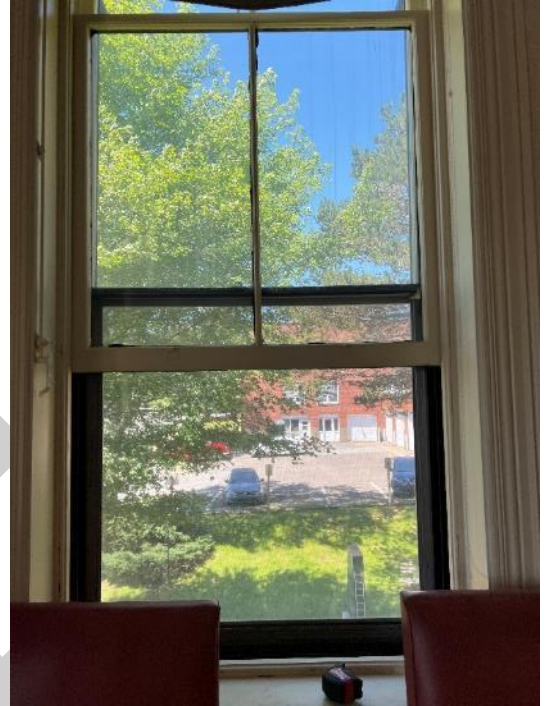
- At the interior of the courthouse, the single-hung windows were observed to be operational.

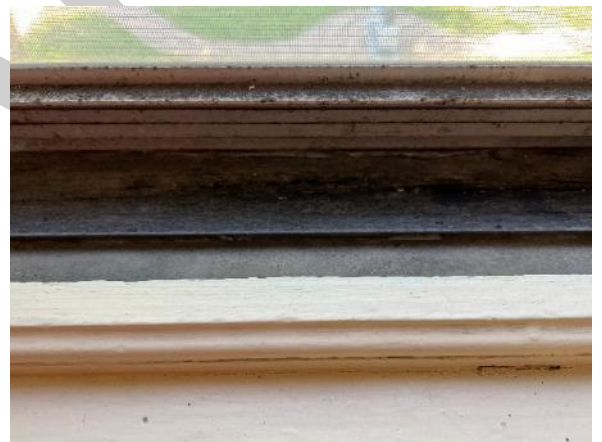
- The window interior windowsill was observed to be in fair condition requiring rejuvenation.
- This is typical of many windowsills. In general, sanding, minor repairs and paint/stain would address the deficiencies observed at the interior.

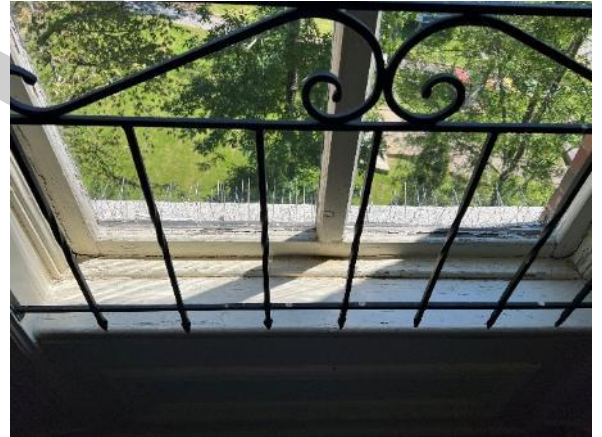
- Signs of water ingress and/or damaged caused by condensation were observed at the sill. See following image.

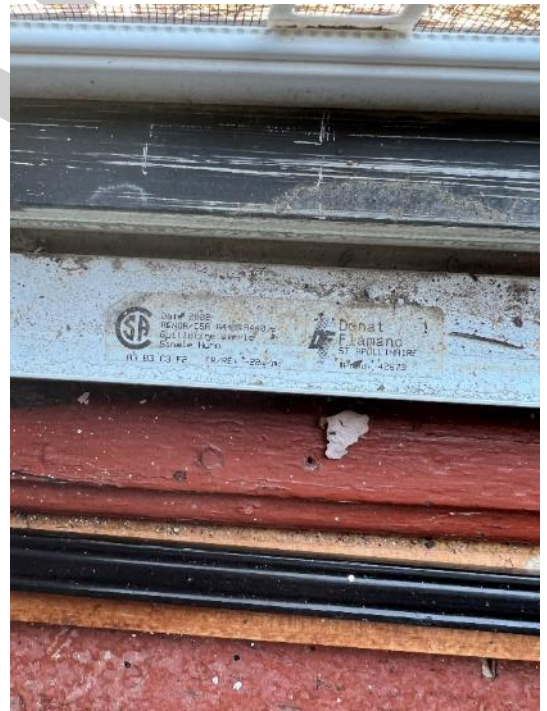
- Newer vinyl windows were observed to be date stamped 2002.
